FLIGHT SAFETY FOUNDATION

Accident Prevention

November-December 1998

After Smoke Detected in Cargo Compartment Crew Lands DC-10, Then Fire Destroys Aircraft

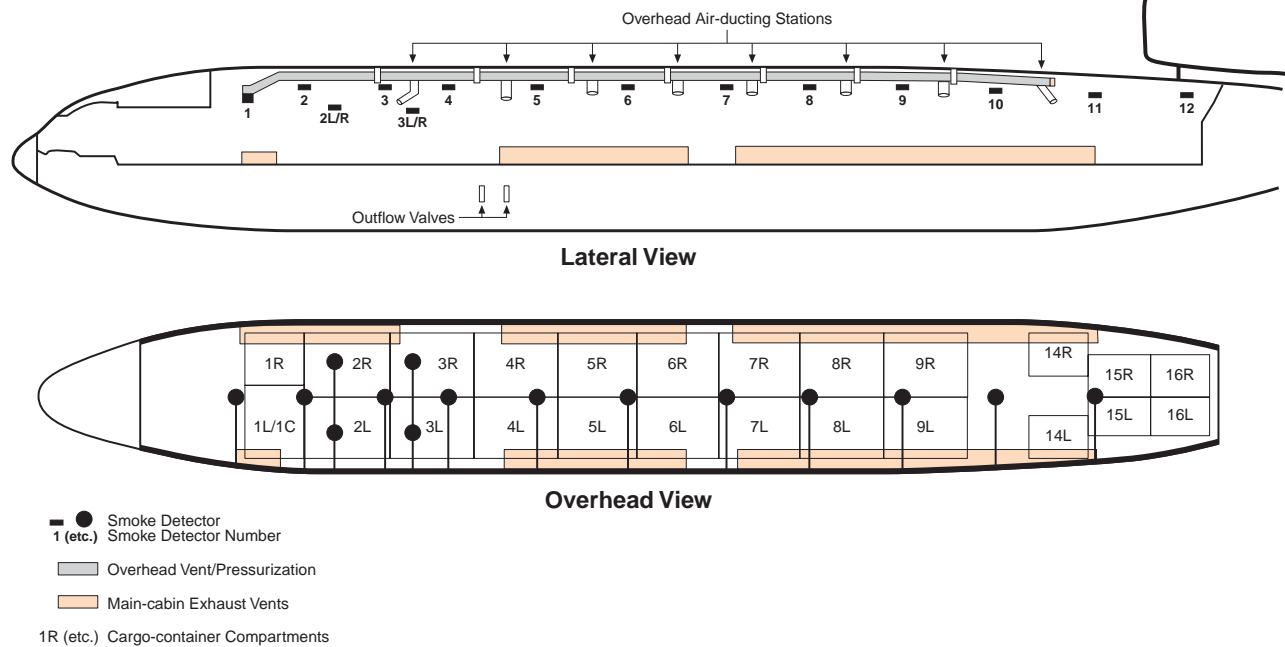
Figure 1

Systems and Cargo-container Compartments of DC-10-10CF, FedEx Flight 1406, Sept. 5, 1996

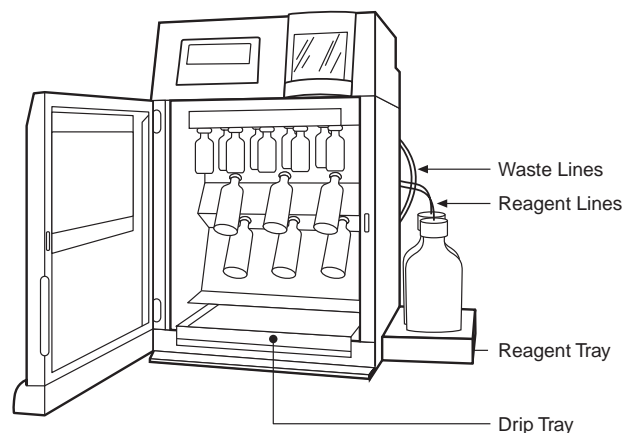
Figure 3

The report said, “The [DNA synthesizer] unit contained several bottles with labels that included flammability symbols, and some of the bottles contained liquid. One large bottle in the aft row had a very strong odor when it was removed from the unit. Because this unit was found at the lowest point of the ‘V’ burn pattern, the [NTSB] investigation evaluated and analyzed the liquids contained in this unit.

Expedite Model 8909 DNA Synthesizer

NTSB said that the evidence indicated that the DNA synthesizer had not been completely purged of hazardous chemicals before being placed on the accident aircraft.

found in the accident synthesizer. The most reasonable explanation for the presence of excessive quantities of chemicals in the synthesizer is that one or more of the bottles containing chemical reagents used in the DNA synthesis process (at least one of which contained THF) was not sufficiently emptied before the purging process began.”

The report said, “Tests of the liquids from the accident synthesizer showed that flammable chemicals (THF and acetonitrile) were still present in the bottles on the machine after the fire. The quantity of chemicals remaining in the synthesizer's bottles after the fire was insufficient to have caused the external fire damage to the synthesizer and the cargo container. However, it is likely that significant amounts of the chemicals were consumed in the prolonged and intense fire, and thus the synthesizer probably contained much larger quantities of these flammable chemicals before the fire.
