Flight Crew's Failure to Perform Landing Checklist Results in DC-9 Wheels-up Landing

FSF Editorial Staff

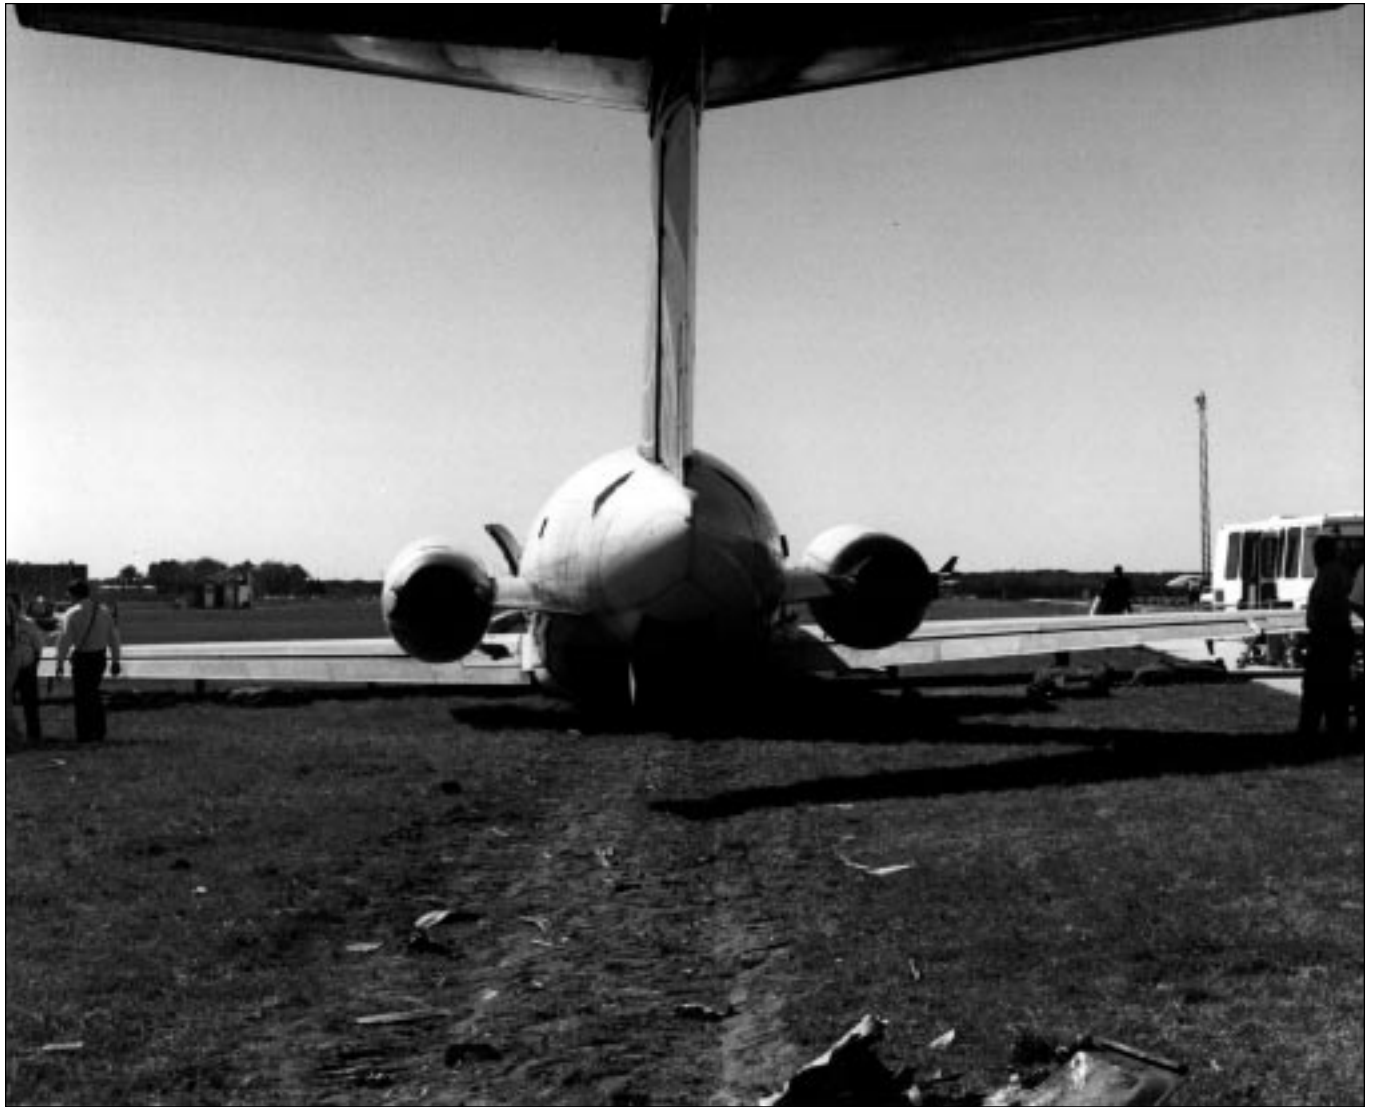
The crew of the Continental Airlines (COA) DC-9-32 landed wheels up on Runway 27 (photo, page 3) at Houston (Texas, U.S.) Intercontinental Airport (IAH). The airplane slid 2,089 meters (6,850 feet) before coming to rest in the grass about 43 meters (140 feet) left of the runway centerline (Figure 1, page 4).

After a wheels-up landing, the Continental Airlines DC-9-32 continued on a trajectory close to the runway centerline for 1,525 meters (5,000 feet), then departed the left side of the runway. The aircraft stopped on the grass adjacent to the upwind end of the runway. (Photo: U.S. National Transportation Safety Board)

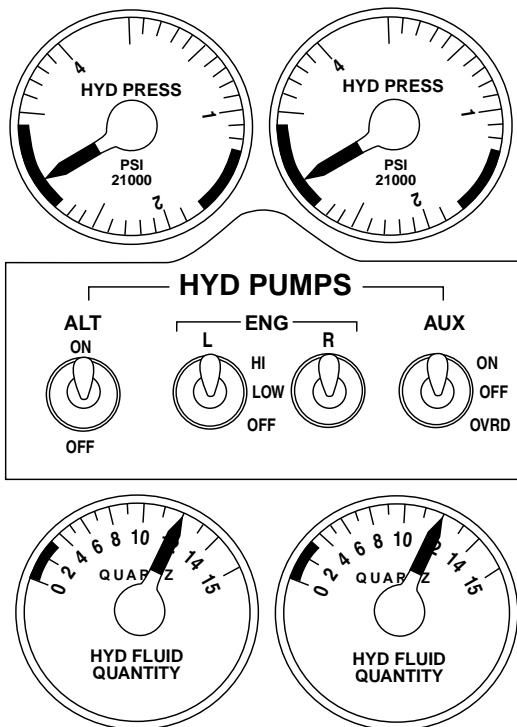
Figure 3

DC-9-32 Hydraulics Panel in High-pressure Configuration

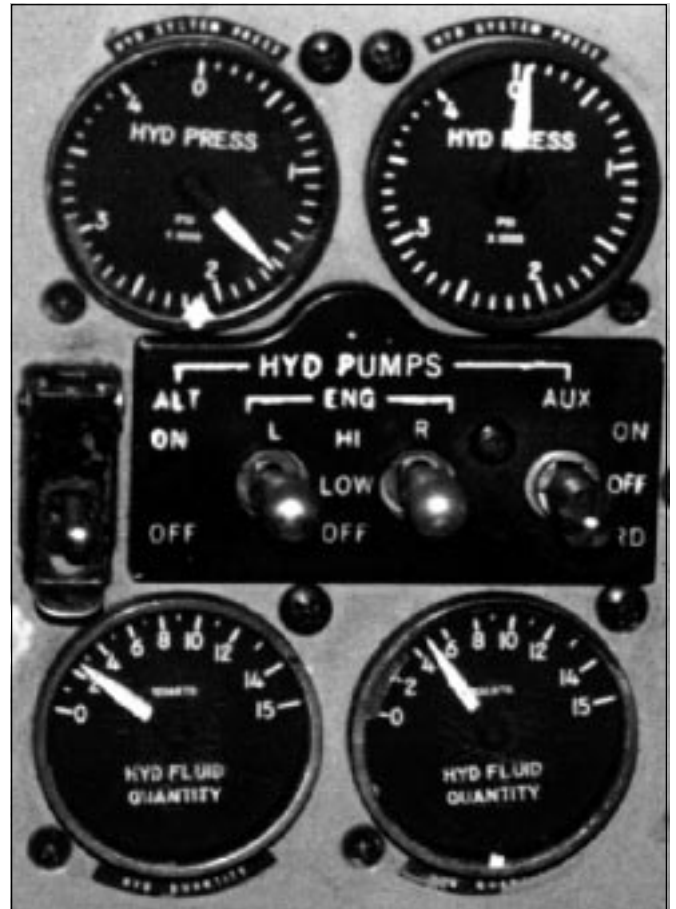
When investigators examined the cockpit, they found the landing-gear handle in the down position and the flap handle set to 50 degrees. “The left and right engine-driven hydraulic pump switches were in the ‘LOW’ position, and the ALT and AUX hydraulic pump switches were in the ‘OFF’ position.

Accident airplane's hydraulics panel in low-pressure configuration. (Photo: U.S. National Transportation Safety Board)

Because the airplane’s hydraulic system was not configured for landing, there was insufficient pressure to lower the landing gear and the flaps. “The flight crew failed to detect this configuration error and continued its approach into Houston,” the report said. “Comments on the CVR and postaccident statements by the flight crew indicate that both pilots recognized that the flaps did not deploy after the flaps were selected to 15 degrees, but the flight crew did not determine the cause of this problem or execute a go-around.”
