Flight Crew's Failure to Perform Landing Checklist Results in DC-9 Wheels-up Landing

FSF Editorial Staff

The crew of the Continental Airlines (COA) DC-9-32 landed wheels up on Runway 27 (photo, page 3) at Houston (Texas, U.S.) Intercontinental Airport (IAH). The airplane slid 2,089 meters (6,850 feet) before coming to rest in the grass about 43 meters (140 feet) left of the runway centerline (Figure 1, page 4).

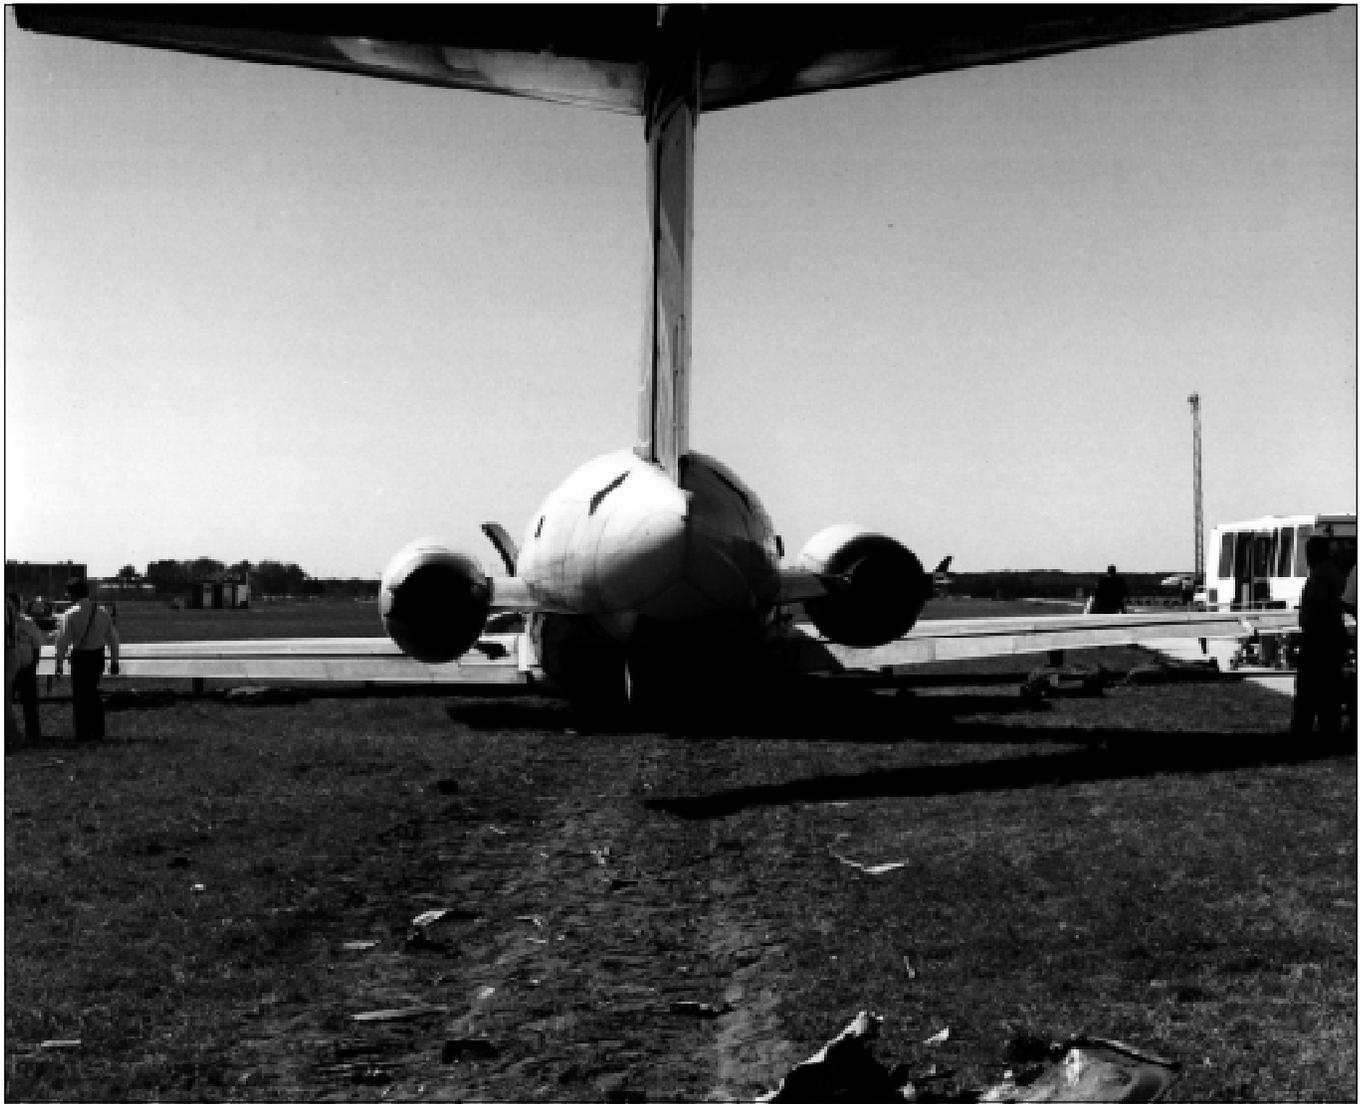
After a wheels-up landing, the Continental Airlines DC-9-32 continued on a trajectory close to the runway centerline for 1,525 meters (5,000 feet), then departed the left side of the runway. The aircraft stopped on the grass adjacent to the upwind end of the runway. (Photo: U.S. National Transportation Safety Board)

Eight seconds later, “the airplane touched down hard with the wheels up at [357 kph (193 knots)] indicated airspeed,” the report said. “As the airplane slid down the runway, two controllers on duty in the tower and two airport groundskeepers observed smoke and fire coming from beneath the airplane.”

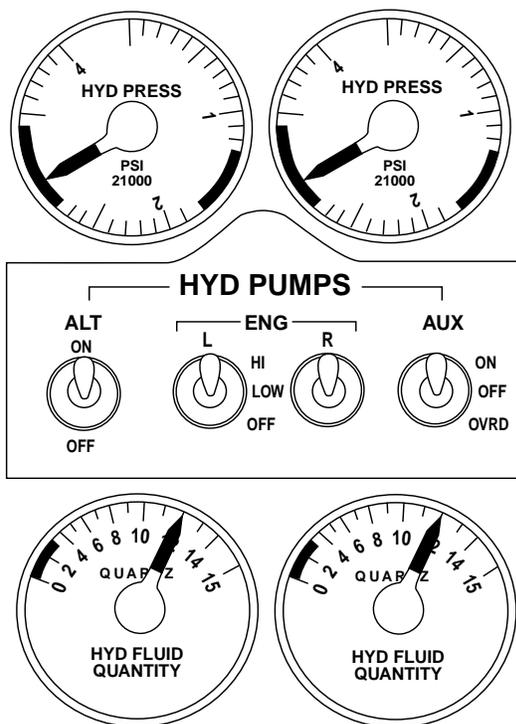
Figure 3

DC-9-32 Hydraulics Panel in High-pressure Configuration

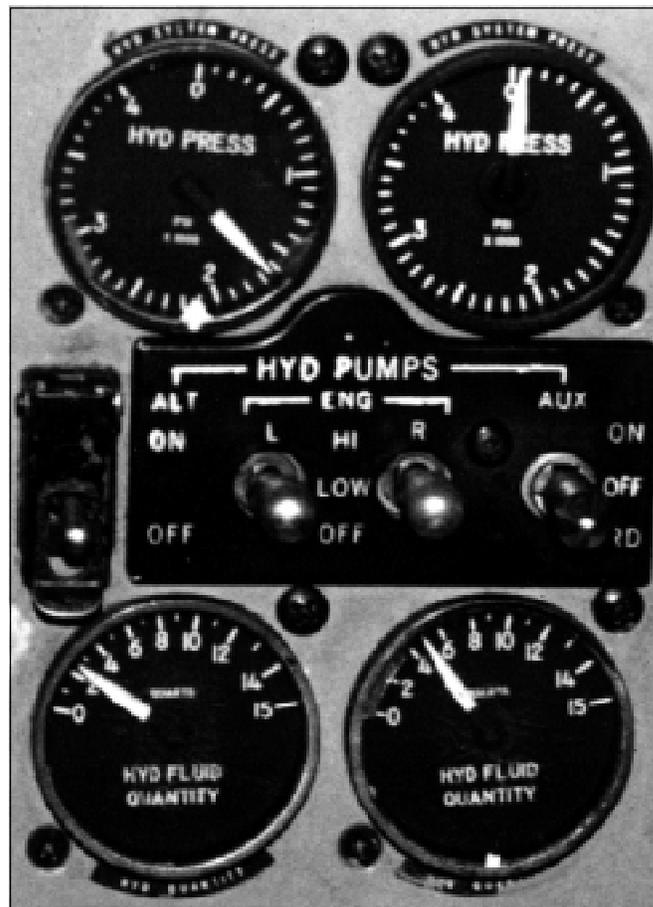
When investigators examined the cockpit, they found the landing-gear handle in the down position and the flap handle set to 50 degrees. “The left and right engine-driven hydraulic pump switches were in the ‘LOW’ position, and the ALT and AUX hydraulic pump switches were in the ‘OFF’ position.

Accident airplane's hydraulics panel in low-pressure configuration. (Photo: U.S. National Transportation Safety Board)

Because the airplane’s hydraulic system was not configured for landing, there was insufficient pressure to lower the landing gear and the flaps. “The flight crew failed to detect this configuration error and continued its approach into Houston,” the report said. “Comments on the CVR and postaccident statements by the flight crew indicate that both pilots recognized that the flaps did not deploy after the flaps were selected to 15 degrees, but the flight crew did not determine the cause of this problem or execute a go-around.”
