Failure of Stabilizer-trim System Blamed For Crew's Loss of Control of MD-83

FSF Editorial Staff

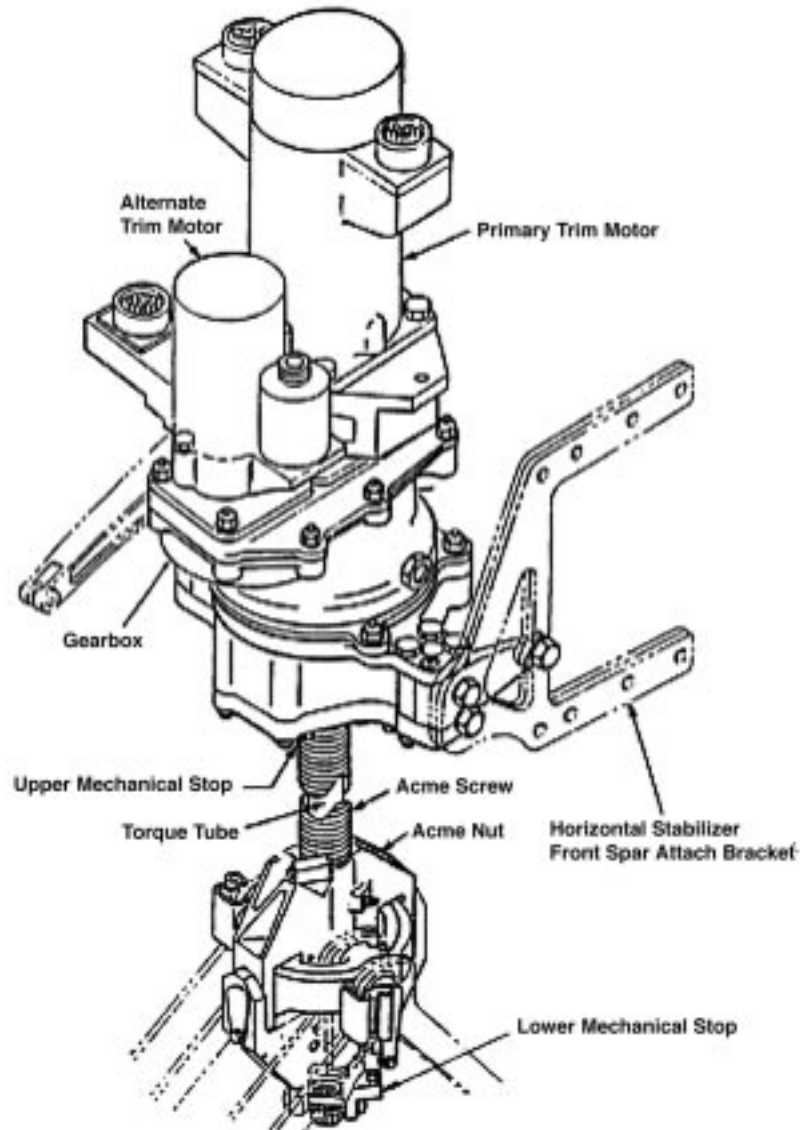
Figure 1

McDonnell Douglas MD-83 Horizontal-stabilizer-trim System

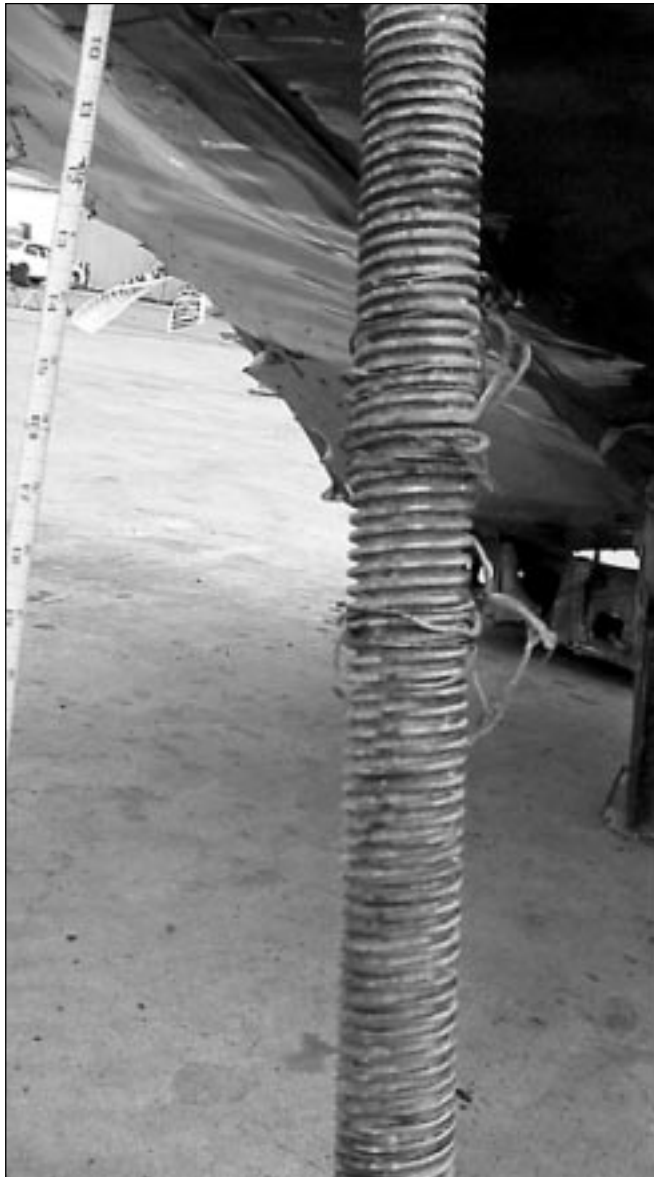
During examination of the wreckage, acme-nut-thread remnants were found wrapped around the acme screw (see photo, page 11).

“The condition of the recovered acme-nut-thread remnants indicated that approximately 90 percent of the thread thickness had worn away before the remainder of the threads sheared off,” the report said.

Corrosion pitting and red rust were found on most of the acme screw.

“Large areas of the acme screw were also found covered by white deposits, which chemical analysis determined were consistent with corrosion debris from the magnesium gearbox case attached to the top of the acme-screw assembly,” the report said.

No grease was found on the threads of the “working region” of the acme screw — that is, the section of the acme screw that normally comes in contact with the acme nut.

“Laboratory examinations found small flakes of dried and hardened grease attached to some of the thread remnants in this region,” the report said. “The acme screw’s lower threads (which are outside of the working region) were found partially packed with a mixture consistent with sand and grease. ... Parts of the acme screw’s upper six [threads] to eight threads had an oily sheen, and small deposits of greaselike material were found between the threads.”

Examination of the acme nut showed that most of the threads were missing.

Remnants of thread material sheared from the acme nut can be seen wrapped around this approximately 17-inch (43-centimeter) section of the acme screw. (NTSB photo)

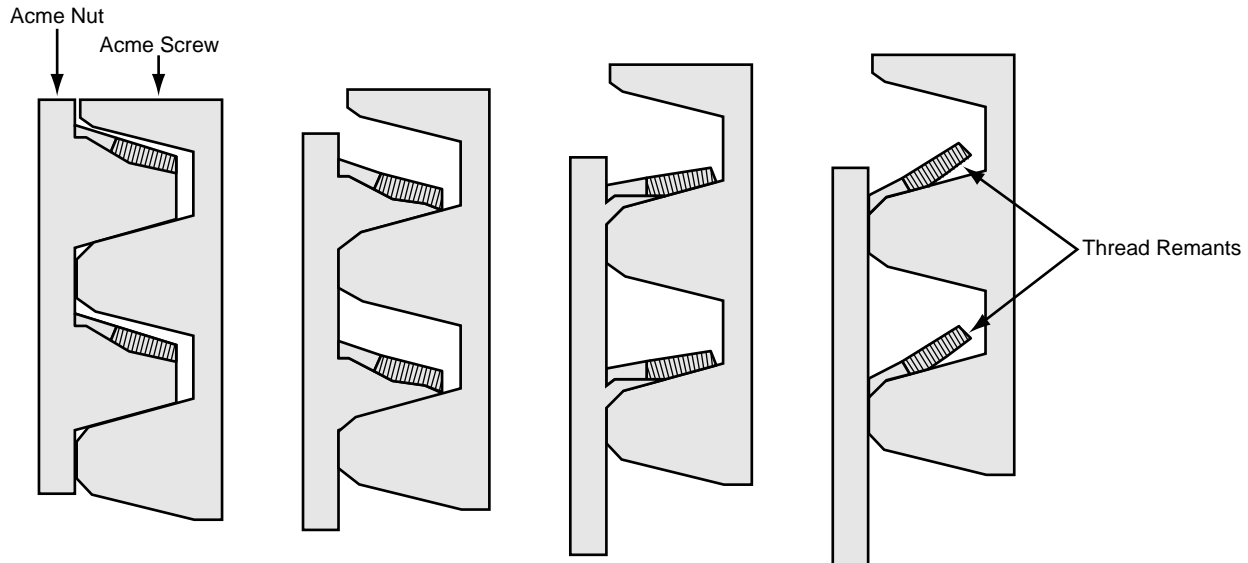
“The acme nut was designed with a softer material than the acme screw, and its threads were designed to wear,” the report said. “Acme-nut threads are made of an aluminum-bronze alloy . . . The acme-screw threads are made of case-hardened steel.”

Figure 4 (page 12) shows the stages of acme-nut-thread wear to the point of thread failure.

“The only portion of the jackscrew assembly that wears significantly is the aluminum-bronze acme nut,” the report said.

Stages of Acme-nut-thread Wear to Point of Bending-induced Shear
