**Controlled Flight Into Terrain
Beech King Air 200, N501RH
Stuart, Virginia
October 24, 2004**

NTSB/AAB-06/01

Accident Number: IAD05MA006
Aircraft and Registration: Beech King Air 200, N501RH
Location: Stuart, Virginia
Date: October 24, 2004
Adopted on: February 7, 2006

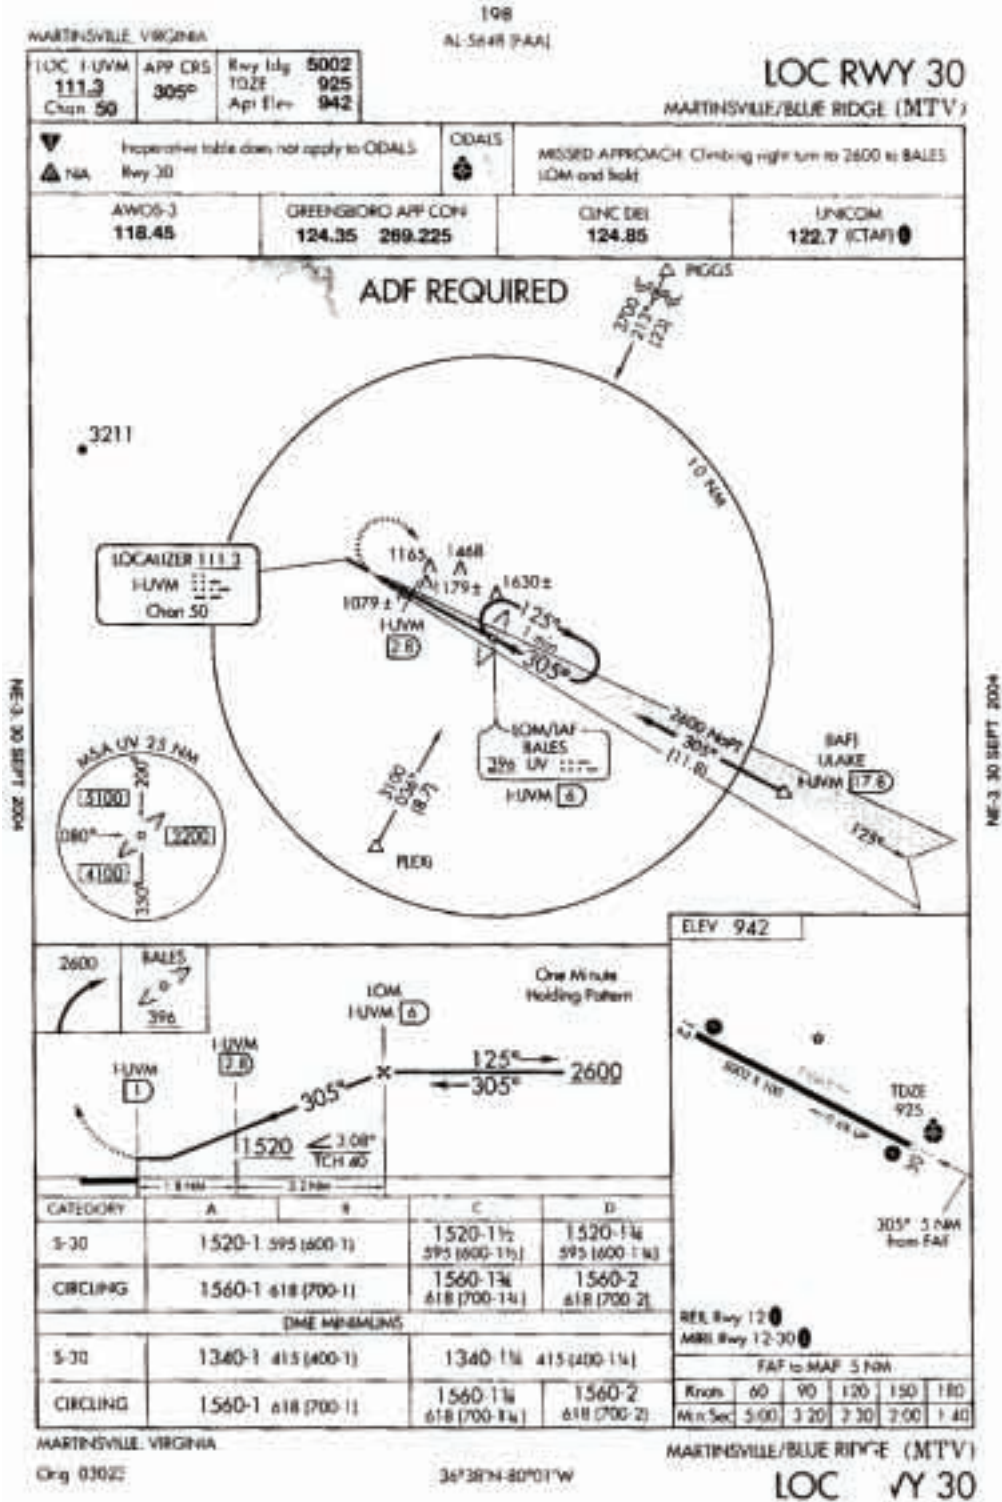
Figure 1. Localizer runway 30 approach.

The localizer runway 30 approach procedure (see figure 1) included an inbound course with a magnetic heading of 305°. The minimum descent altitude for the intermediate section of the approach and the holding pattern southeast of the BALES locator outer marker (LOM) was 2,600 feet. The BALES LOM is located at 6 distance

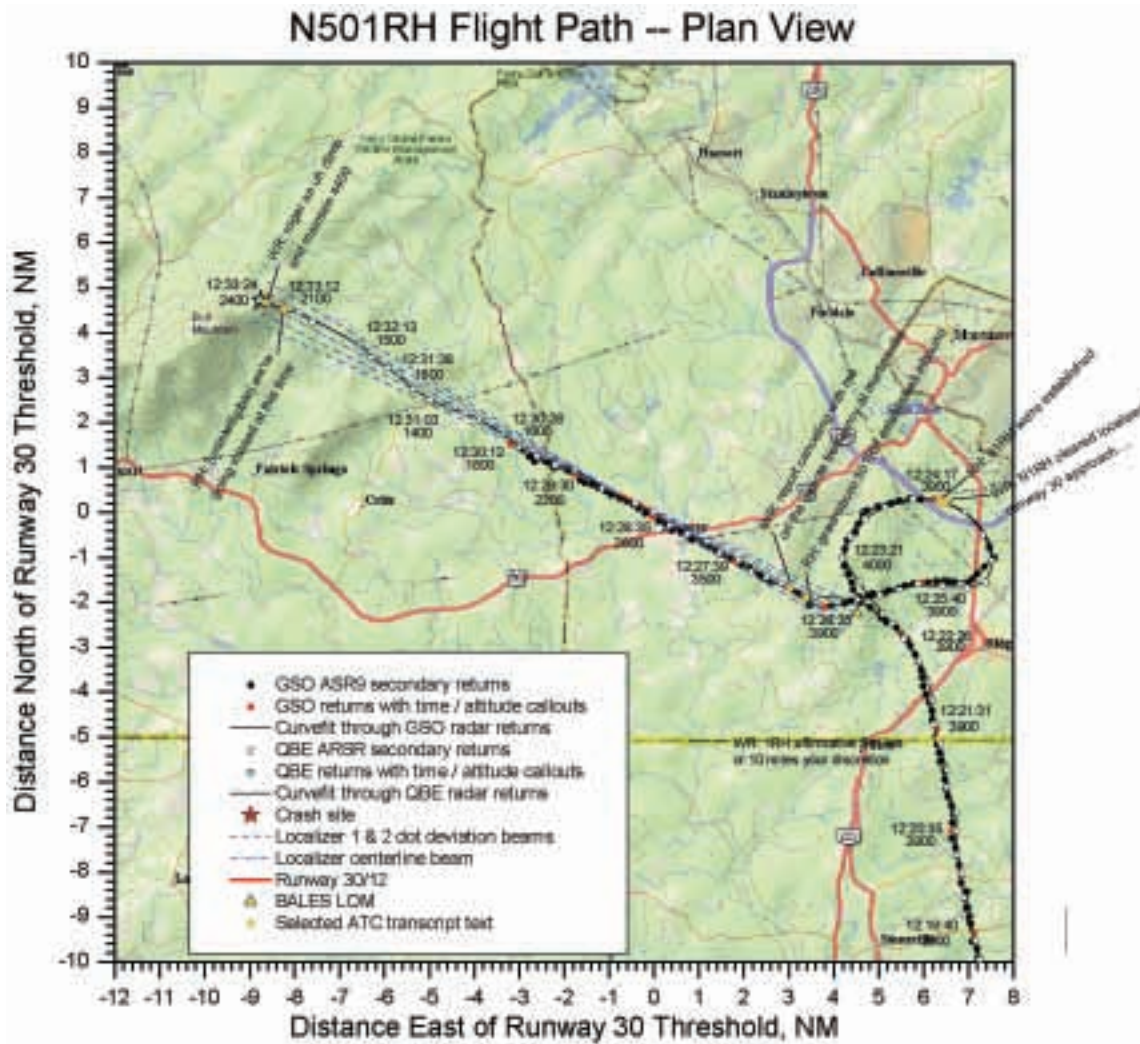
Figure 2. Accident airplane's flightpath.

The accident airplane approached the BALES LOM from the south (see figure 2), crossed BALES at 4,000 feet, and turned right toward the outbound leg of the holding pattern. About that time, the flight crewmembers of the airplane that preceded the accident airplane on the approach announced that they were canceling their IFR clearance after breaking out of the clouds during the approach and then proceeded to land at MTV.

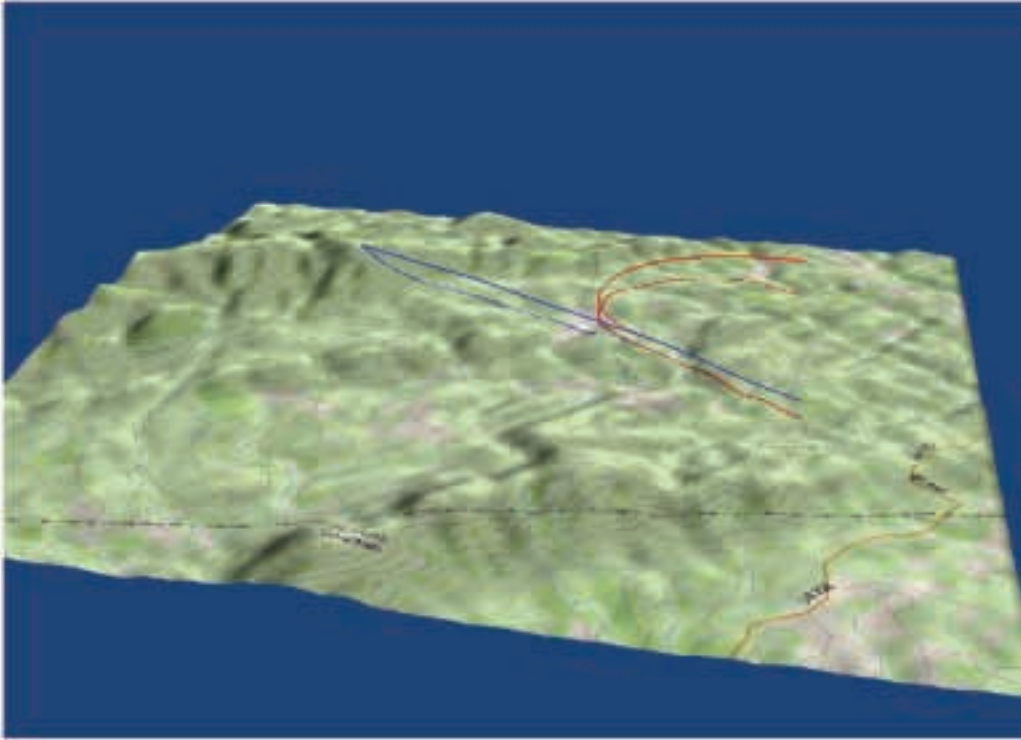
The published missed approach procedure called for a climbing right turn at the MAP, which is over the runway threshold. Radar data indicated that the flight crew initiated the missed approach 7.5 nm beyond the MAP. The airplane then entered a straight-ahead climb on the runway heading.

The aircraft performance study also presented the flightpath that the airplane would have flown if it had entered a climbing right turn at the point where the climb was initiated. Interpolation of nominal climb rates and a standard turn rate depicted a flightpath that would have kept the airplane clear of terrain. Figure 4 compares the airplane's flightpath (in blue) with the flightpath that would have resulted if the airplane had entered a standard-rate right turn during the climb (in red).

Figure 4. Depiction of the accident flightpath (blue) and the flightpath incorporating a climbing right turn (red) along with terrain elevations.
