AVIATION INVESTIGATION REPORT

A04Q0188

RUNWAY EXCURSION ON LANDING

AVIATION CMP INC.
BEECH B300 (SUPER KING AIR) C-FMHD
SAINT-GEORGES, QUEBEC
01 DECEMBER 2004

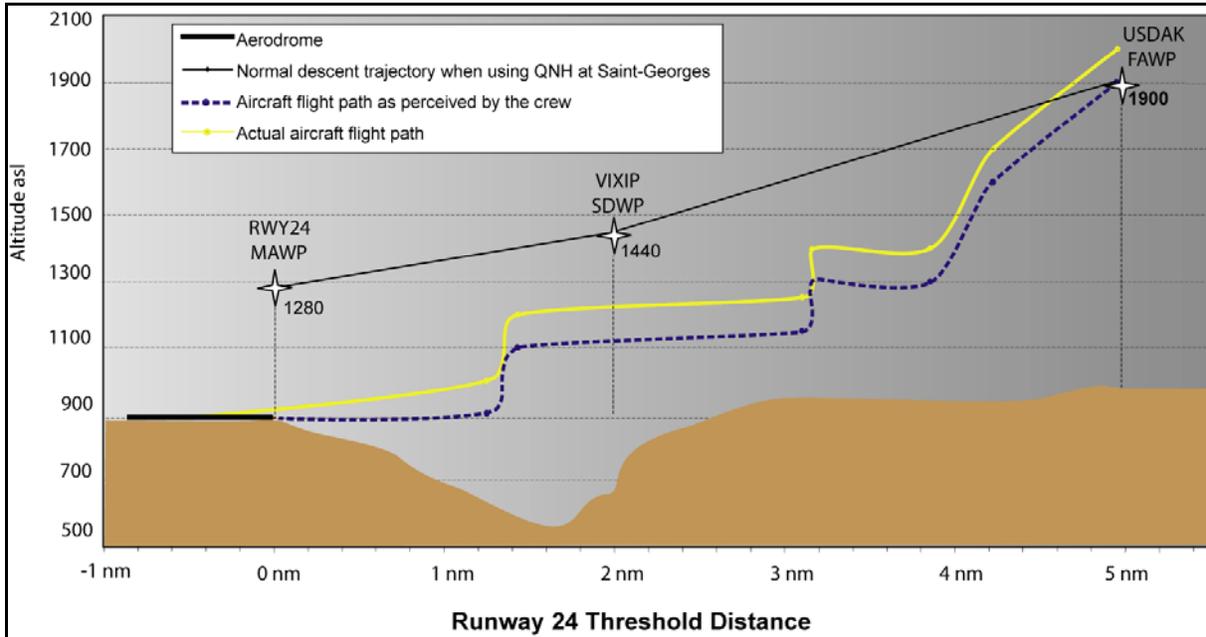
Figure 1. Estimated flight profile of Runway 24 approach

The approach profile⁶ includes three levels: over ITRAL, the aircraft can descend to 1900 feet; at 5 nm from the runway threshold, over USDAK, the final approach waypoint (FAWP), the aircraft can continue descent to 1440 feet; and, at 2 nm from the threshold, at the descent waypoint (SDWP) VIXIP, it can descend to the minimum descent altitude (MDA) of 1280 feet (see Appendix B). The missed approach waypoint (MAWP) is over the runway threshold (see Figure 1).

When planning the approach, the briefings were not completed in accordance with company standard operating procedures (SOPs). The crew did not discuss approach procedures or a missed approach procedure. About 3 nm from USDAK and 1900 feet asl (about 1000 feet above ground), the co-pilot saw the ground. He immediately reported the position of the aircraft in reference to the ground and reported the weather conditions. A few seconds later, the pilot-in-command set the altitude selector to 1100 feet, 200 feet below the MDA, and set the radio altimeter to 380 feet, the height above aerodrome (HAA) at the MDA. At a little over 3 nm from the threshold, the aircraft was 200 feet above the ground.
