Incident
on 18 January 2003
at Paris Charles de Gaulle airport
to the Boeing 747-412F
registered 9V-SFH
operated by Singapore Airlines Cargo

REPORT
9v-h030118a

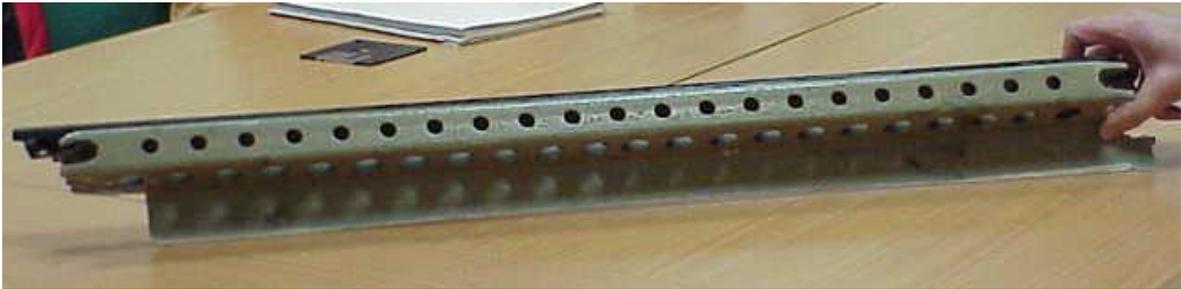
The airplane was damaged at the level of leading edge flap ⁽³⁾ 26 E on the right wing ⁽⁴⁾. The wing leading edge was also slightly damaged.

A part of flap 26 E was found on the northern edge of runway 26 right between taxiways S4 and S3.

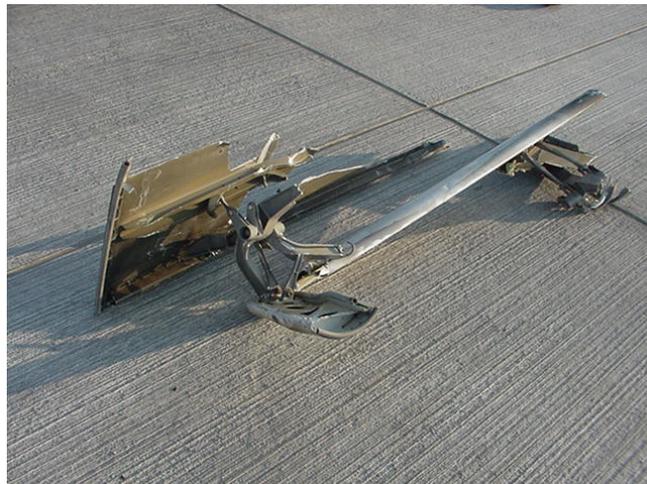
The main damaged part of flap 26 E was found at Dubai.

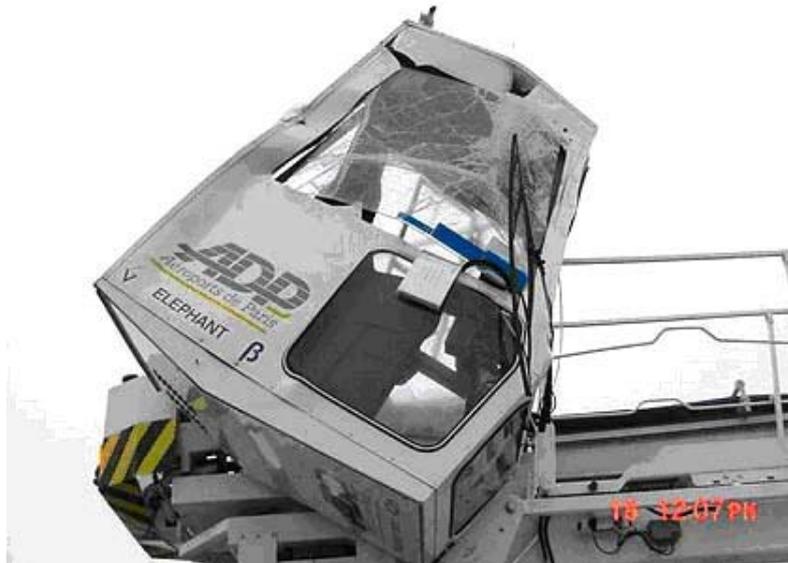
The operator's control cabin on the de-icing vehicle was damaged.

When the wing struck the de-icing vehicle's control cabin, the latter moved slightly, thus absorbing a part of the energy, which probably disguised the shock from the crew. Since no alarms were set off and the airplane's condition was nominal, the crew did not notice anything. They thus took off and performed the whole flight with a damaged airplane.

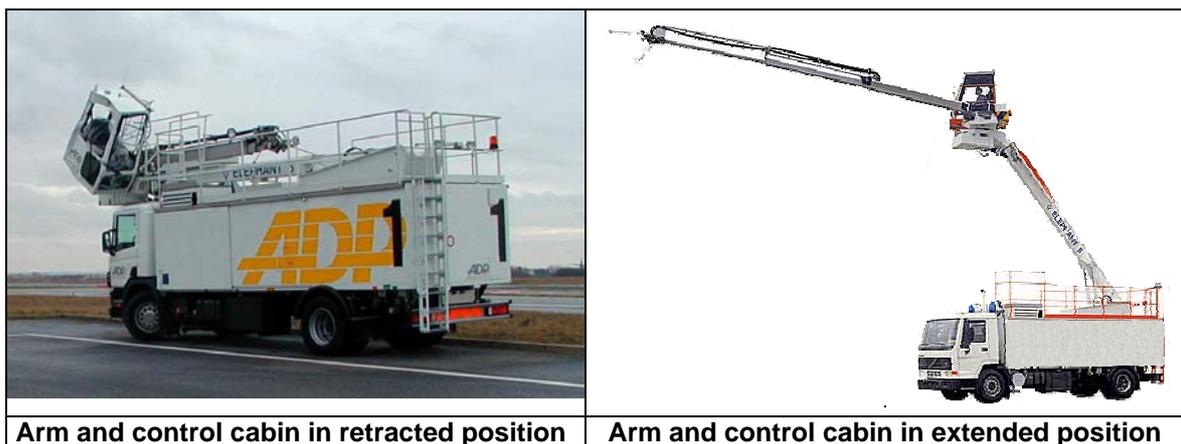
These autonomous vehicles allow heated de-icing liquids to be sprayed via a rotating cannon located at the end of the telescopic boom. The operator gets into the rotating cabin. There is a flashing light at a height of 4.10 m.

When the arm is retracted, the cabin can be in a high position (during use) or in a low position (during vehicle movements). The overall height of the vehicle is then 5.20 m and 4.10 m respectively. At the time of the collision, the cabin was in the high position, with the arm retracted.

- the fact that the de-icing vehicle's flashing light was not at the highest point on the vehicle, whereas the crew thought this to be the case, leading the pilots to estimate that the wing would not collide with the obstacle;
- the likely procedural drift represented by the undefined procedure for pre-positioning the de-icing vehicles;
- incomplete and imprecise documentation on the de-icing zones;
- the absence of checks on the positioning of vehicles in the procedures for setting up the de-icing areas.

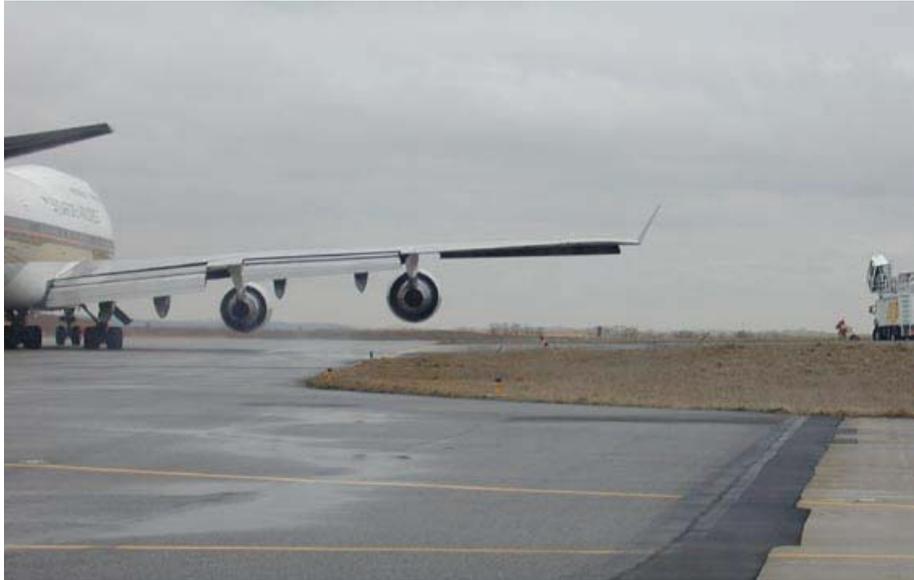
When vehicles are positioned beyond the markings, their position allows a Boeing 747-400 to pass with a lateral margin estimated at about ten meters, as shown in the photo.

The dissymmetry between the surfaces defined by the painted lines should be noted: the surface to the north of the area is clearly larger than that to the south. As a result, the vehicle has to be parked parallel to the taxiway in order to remain within the defined area whereas to the north it can be oriented in any direction.

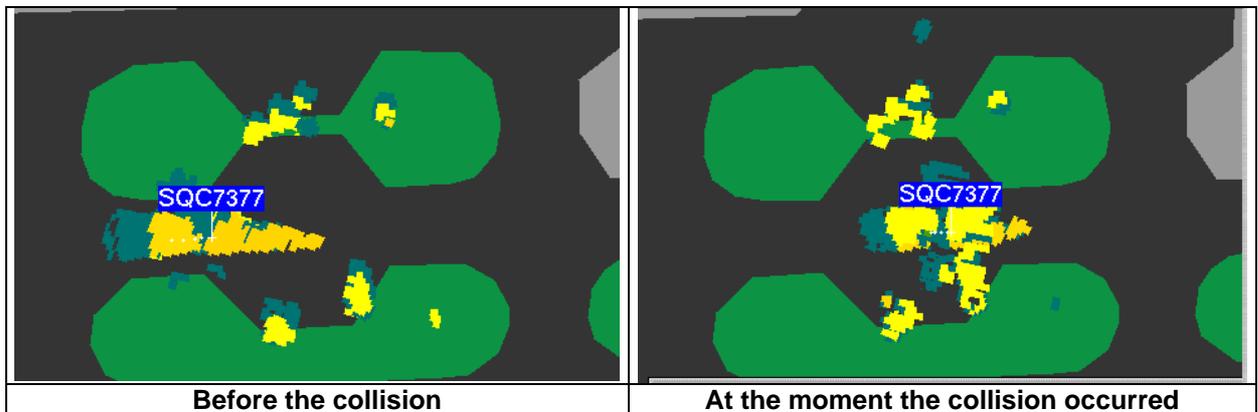
The ground radar recorded the airplane's movements from taxiing to take-off. The following photos are taken from the recorded images. They show the situation just before and during the collision. The surrounding area is shown in various colors: black is for the taxiways (the hexagonal shape of SE1 included), green is for the verges and orange or yellow for radar returns from fixed or mobile objects. The precision and sampling rate do not allow the outlines of the various vehicles to be defined exactly. The group of yellow and orange dots at the center of the area, moving from west to east, corresponds to the airplane. The tag indicating the flight number is superimposed on the radar return of the airplane.

These images show that the de-icing vehicle parked to the south-east is positioned differently than the three others, in a more withdrawn position (group of yellow dots).

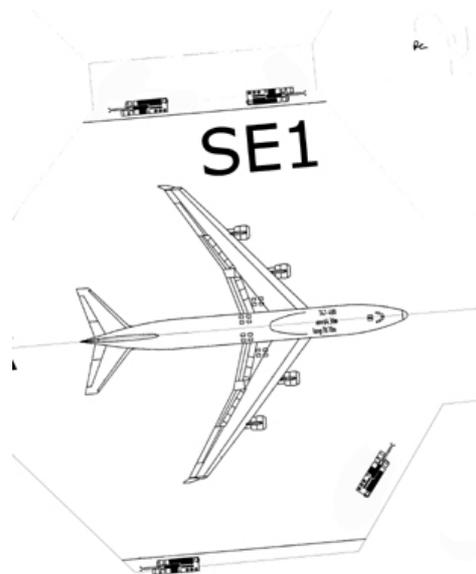
This radar data and on-site observations after the collision showed the approximate position of the vehicles on the de-icing zone a few seconds before the collision:

This person positioned the de-icing vehicle perpendicular to the Romeo taxiway on the eastern edge of the tarred SE 1 zone. The fog and the dark prevented him from ascertaining that the vehicle was badly positioned.

It should be noted that in the weeks that followed the event, ADP put in place systematic checks on the positioning of vehicles by the supervisor and by the driver of the vehicle on the opposite side.

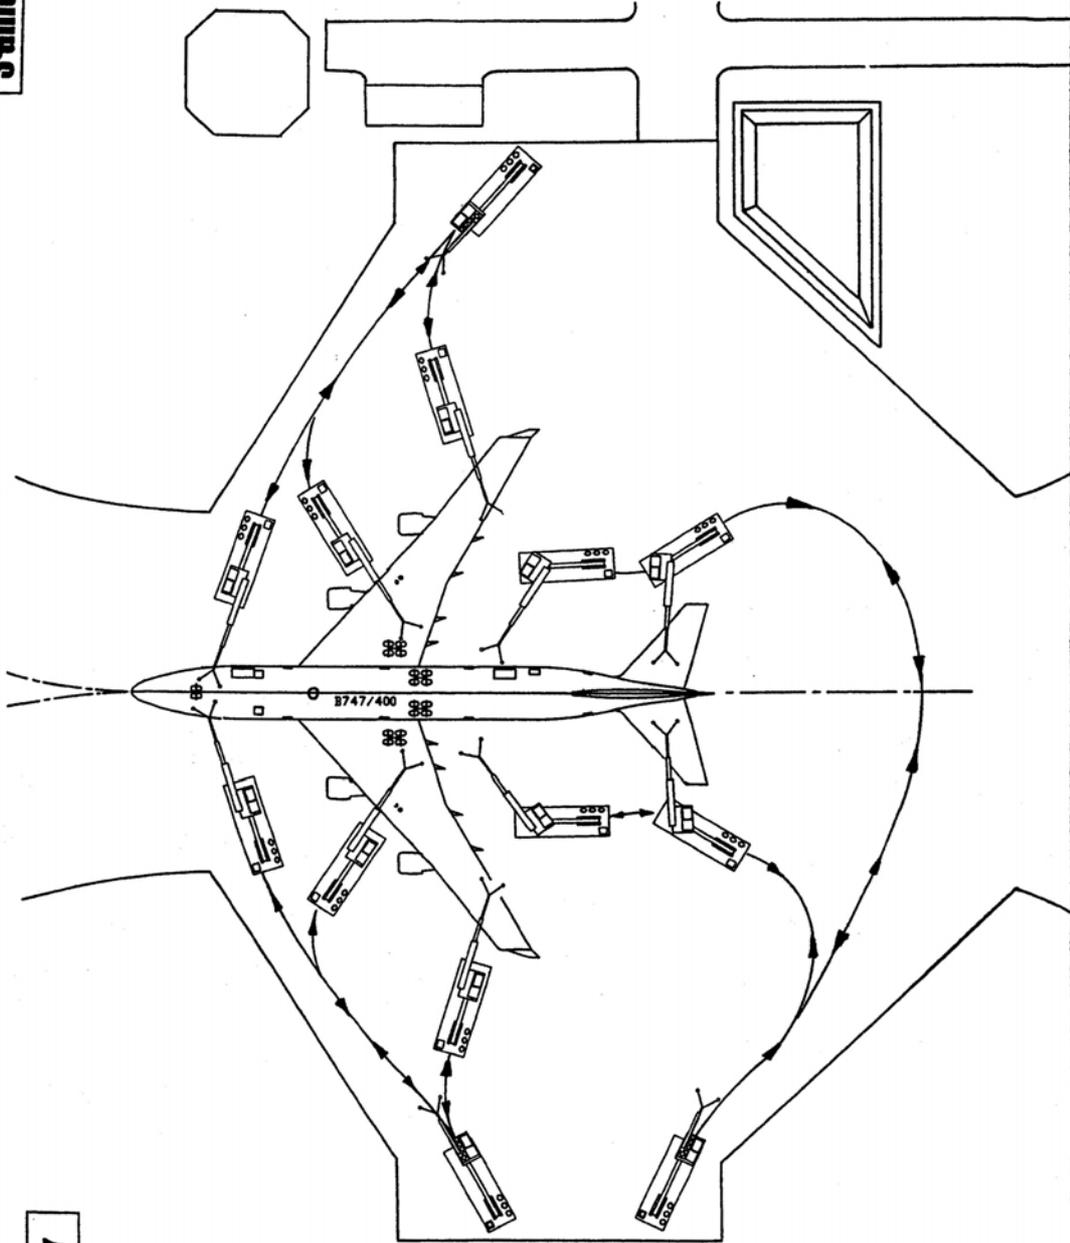
Schematic diagram of B747-400 de-icing from the de-icing operations manual

The dissymmetry of zone SE1 described in 1.10.3. is not featured in the documents given to de-icing operators. Nor is it mentioned that the illustrations are not to scale (see schematic in appendix).
