## AVIATION INVESTIGATION REPORT

A02O0349

### AIRCRAFT DIFFICULT TO CONTROL

de HAVILLAND DHC8-311, C-FACF

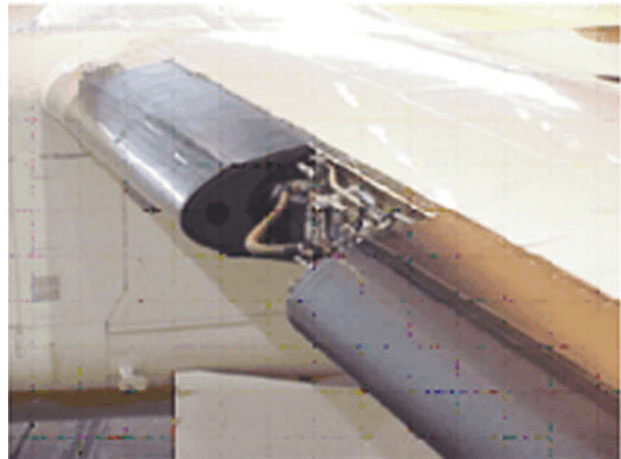
**Photo 1.** Missing number 4, left, leading-edge panel

The aircraft sat all day Wednesday and Thursday, until Thursday night when it was assigned to Flight 7956. No work card had been generated to seal either the bottom of the left wing leading-edge section or the right wing leading-edge section. The missing screws from the bottom of the left wing leading edge were not located.

Jazz Air Inc. added a general maintenance procedure (GMP) to Section 1 of its *Maintenance Procedures Manual*, requiring an independent visual inspection of the leading-edge installation. GMP number 14 states:

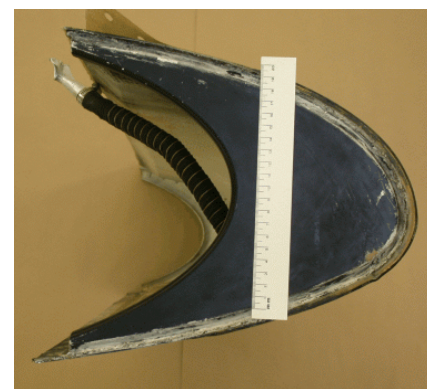
**Photo 2.** Cross-section of the left leading edge

The number 4 leading-edge panel is approximately 38 inches long, D shaped, with 11 inches between the top and bottom rows of screws. The leading-edge panel is painted black and has a black pneumatic de-ice boot across the leading edge. It is secured to the wing structure by 14 brass-coloured, countersunk screws on the top, and another 14 on the bottom. Although there is some paint in the countersunk recess of the leading edge, most of the screw holes have a significant amount of bare aluminium showing. All of the screws securing all of the leading-edge sections are unpainted.

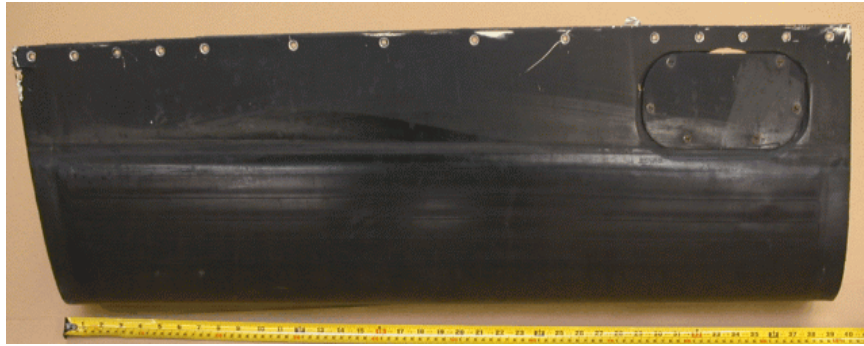
Photo 3. Left leading-edge section

The unpainted, brass-coloured screws that hold the leading-edge sections in place are highly contrasted by the black paint and pneumatic boot on the leading edges. All of the leading-edge screw holes are countersunk, and there is little paint remaining on the shoulders of these countersunk holes. The contrast provided by the bare aluminum of the leading-edge structure is similar to that of an unpainted screw. Thus, unless someone, an AME or pilot, is looking specifically for the screws, it would not be obvious that the screws had not been installed.
