AVIATION INVESTIGATION REPORT

A05C0187

LOSS OF CONTROL AND COLLISION WITH TERRAIN

CESSNA 208B CARAVAN C-FEXS

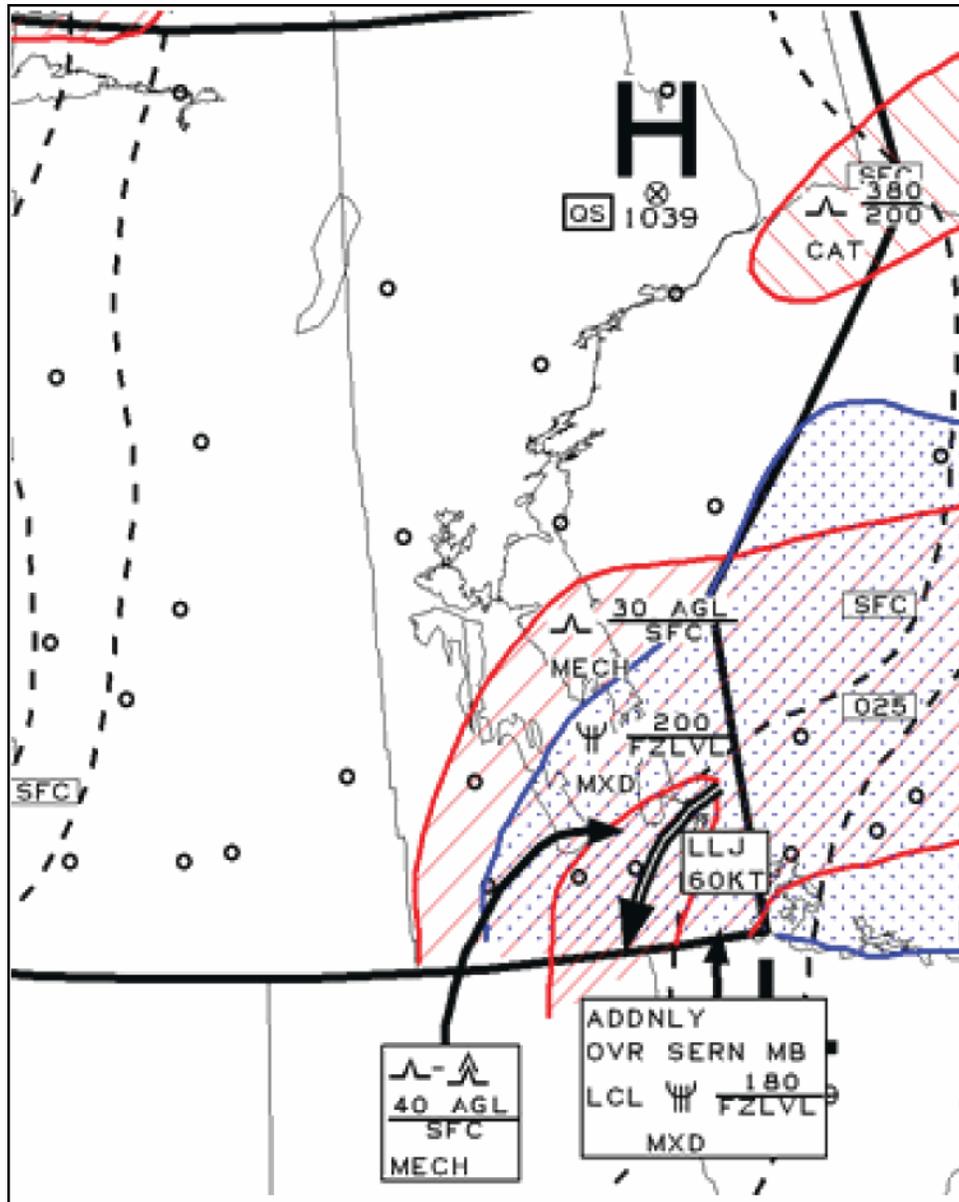
Icing and Turbulence, Winnipeg area (valid October 6 at 0600 UTC)

The icing conditions over Winnipeg were still forecast as moderate at the time of the accident, 0543. Aircraft that operated in the Winnipeg area were encountering in-flight icing conditions at the time of the accident and as late as 0615, although the forecast called for icing conditions to have moved to the east of Winnipeg before the end of the forecast period, 0700. Lower-than-forecast cloud ceilings persisted as late as 0700, indicating that the weather system over the Winnipeg area was moving somewhat more slowly than forecast. As a result of the slower weather system movement, icing conditions prevailed in the Winnipeg area longer than anticipated.

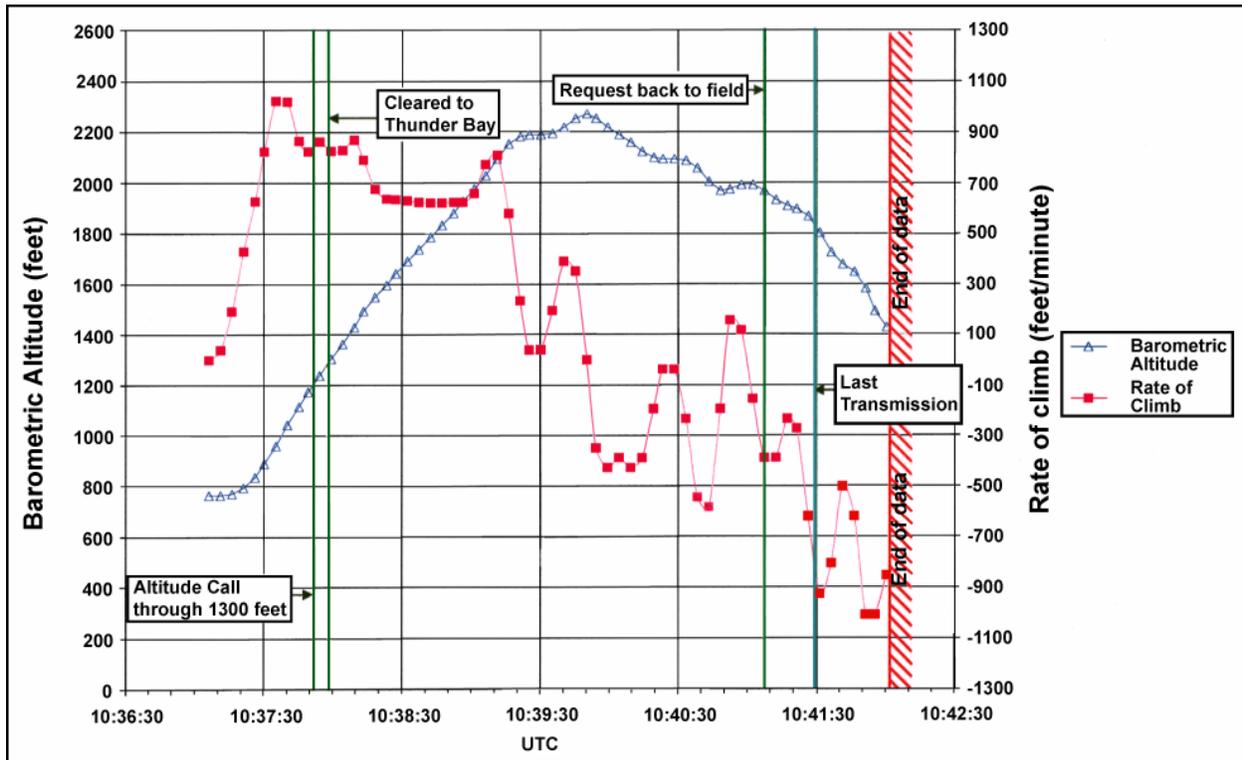
Appendix D – Altitude versus Rate of Climb/Descent

The aircraft departed the Winnipeg International Airport about three per cent over its maximum gross weight. Its rate of climb on departure was somewhat less than the rate indicated in the AFM for an aircraft at maximum gross weight. However, turbulence and gusty wind conditions prevailed at Winnipeg at the time of take-off, and these conditions, along with the aircraft's overweight condition, would have degraded performance. It was therefore concluded that the aircraft was mechanically serviceable at take-off, and departed without significant critical surface contamination.

Aircraft performance deteriorated progressively after the aircraft climbed through 1000 feet agl. Cloud ceilings were observed at Winnipeg at 700 feet agl, and were forecast at 1000 feet agl. The reduction in aircraft performance began soon after the aircraft entered cloud and was likely the result of the icing conditions, which were forecast to prevail over Winnipeg at that time and were experienced by other crews.

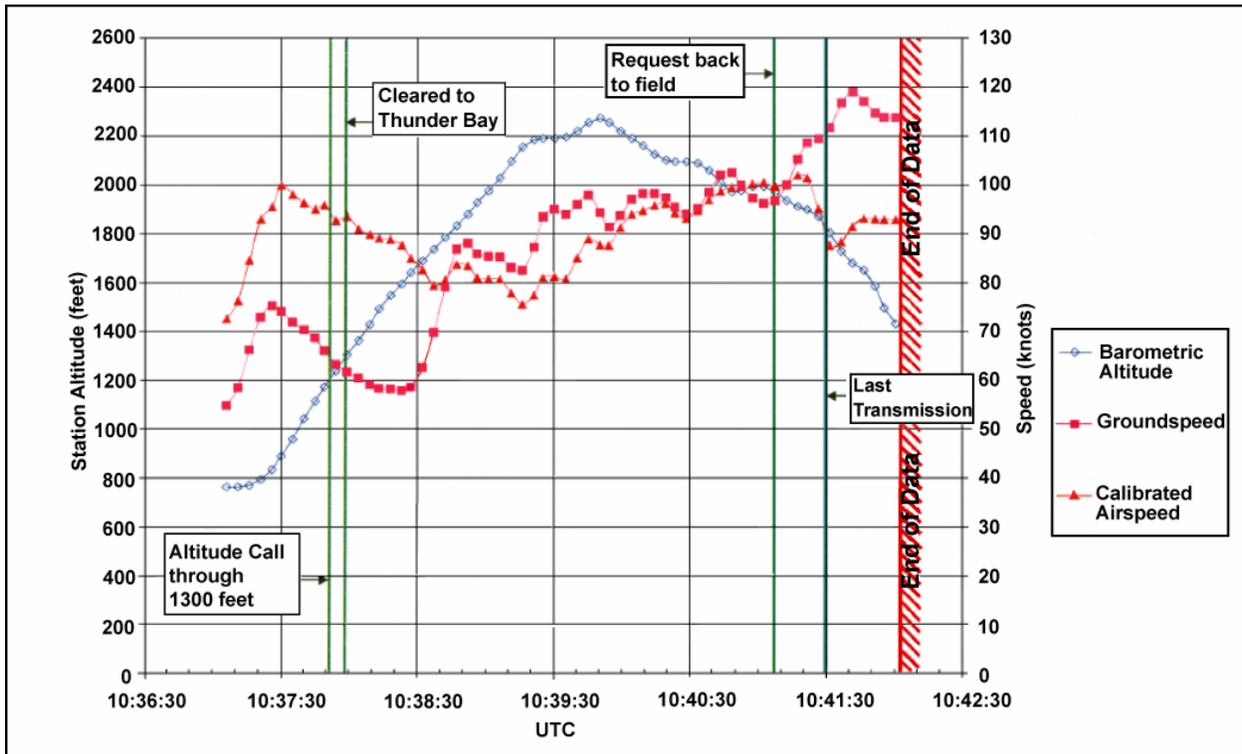
Appendix E – Altitude versus Groundspeed/Airspeed

The aircraft's calculated airspeed fluctuated during the flight, as might be expected in the gusty wind conditions and turbulence. Most of the flight was conducted at airspeeds below the 0° flap V_y (best rate of climb airspeed) and below the 0° flap minimum airspeed in icing conditions. It would, however, have been at or above the 20° flap V_y . Although the flaps were retracted at impact, the flap settings used throughout the flight could not be determined. Without information as to the flap settings, the suitability of the airspeeds during the flight cannot be determined. If the aircraft entered icing conditions in cloud with 0° flap, the airspeeds would have been below the minimum airspeed for those conditions. However, if flaps had been extended during the climb, the 105-knot minimum airspeed would not have applied.
