In-Flight Engine Failure and Subsequent Ditching

Air Sunshine, Inc., Flight 527

Cessna 402C, N314AB

NTSB/AAR-04/03

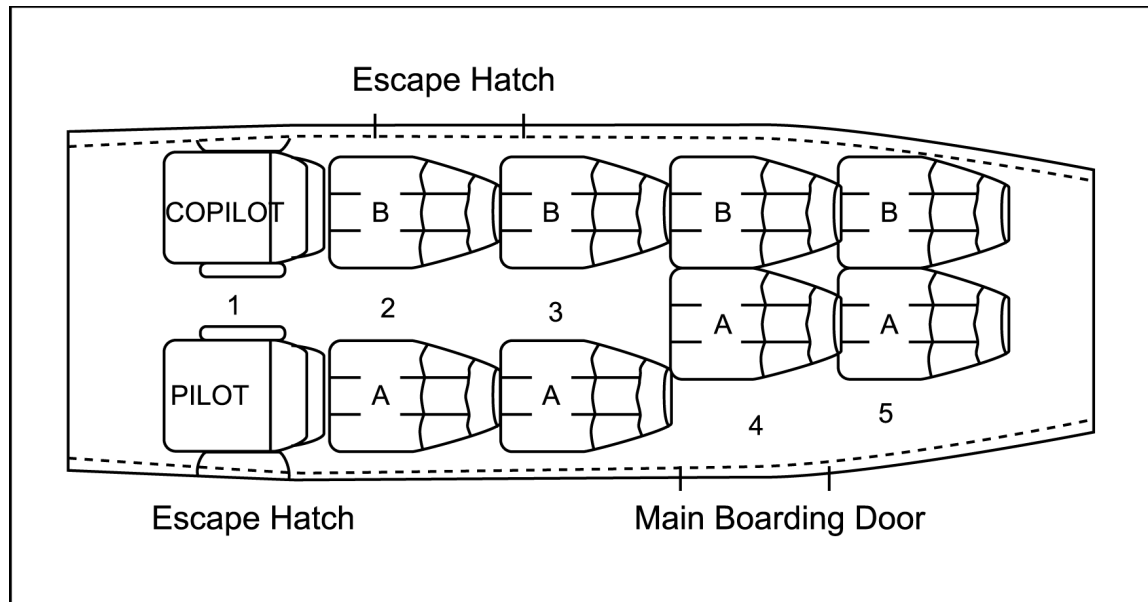
Figure 1. Interior configuration of the accident airplane.

All seats were found attached to the floor and were undamaged. All lapbelts were present and were found to operate normally. The seatback stowage pockets for seats 2A and 2B did not contain safety briefing cards;⁴³ all of the other stowage pockets contained briefing cards.

Six packaged PFDs were found in the airplane. One PFD was found forward of the pilot seat, and one PFD was found forward of the copilot seat. The remaining four PFDs were found in their stowage areas (under seats 2A, 2B, 3A, and 5A). The PFDs were brought to the Safety Board's headquarters in Washington, D.C., and were examined on August 28, 2003. The sealed plastic pouches were opened, and the PFDs were inflated by pulling the inflation rings. All of the PFDs were undamaged and were found to operate normally. Inspection records found inside the plastic pouches containing the PFDs indicated that they had been inspected within the past 5 years, in accordance with Federal regulations.

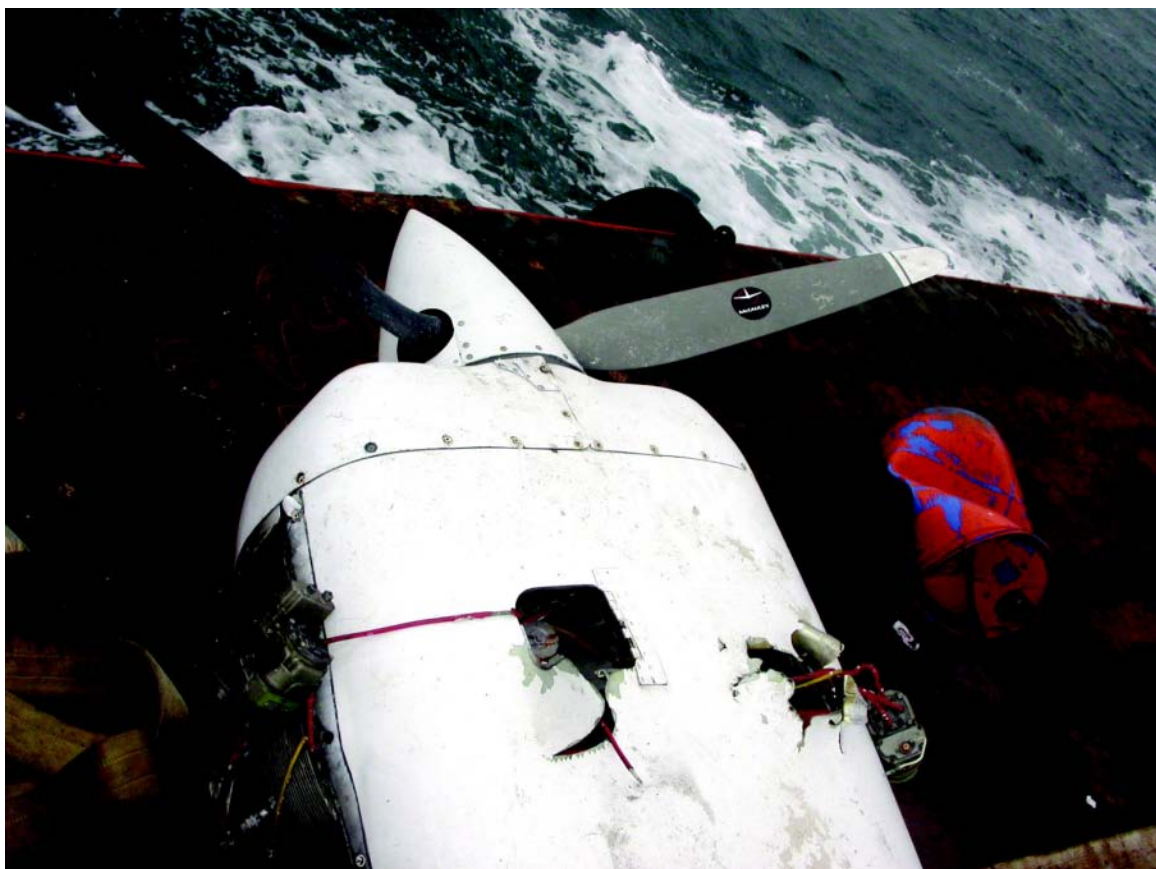
Figure 3. Exterior of the upper outboard engine cowling.

The right engine was attached to the airframe in its normal position, and the propeller was attached to the engine. Damage was noted on the leading edge skin from the engine outboard to the wing tip; the leading edge skin from the engine nacelle inboard of the wing root was crushed up and aft. The lower inboard engine cowling was separated and was not recovered; the lower outboard engine cowling was in place.
