Cessna 560 Citation, D-CAUW

AAIB Bulletin No: 9/2003	Ref: EW/G2003/05/04	Category: 1.1
Aircraft Type and Registration:	Cessna 560 Citation, D-CAUW	
No & Type of Engines:	2 Pratt & Whitney 535A turboprop engines	
Year of Manufacture:	2001	
Date & Time (UTC):	28 May 2003 at 1325 hrs	
Location:	Leeds Bradford International Airport, Leeds	
Type of Flight:	Public Transport	
Persons on Board:	Crew - 2	Passengers - 8
Injuries:	Crew - None	Passengers - None
Nature of Damage:	Nosewheel detached, radome damaged, dent in leading edge of right wing, bent main gear doors	
Commander's Licence:	Airline Transport Pilot's Licence	
Commander's Age:	59 years	
Commander's Flying Experience:	8,000 hours (of which 5,000 were on type)	
	Last 90 days - 70 hours	
	Last 28 days - 33 hours	
Information Source:	AAIB Field Investigation

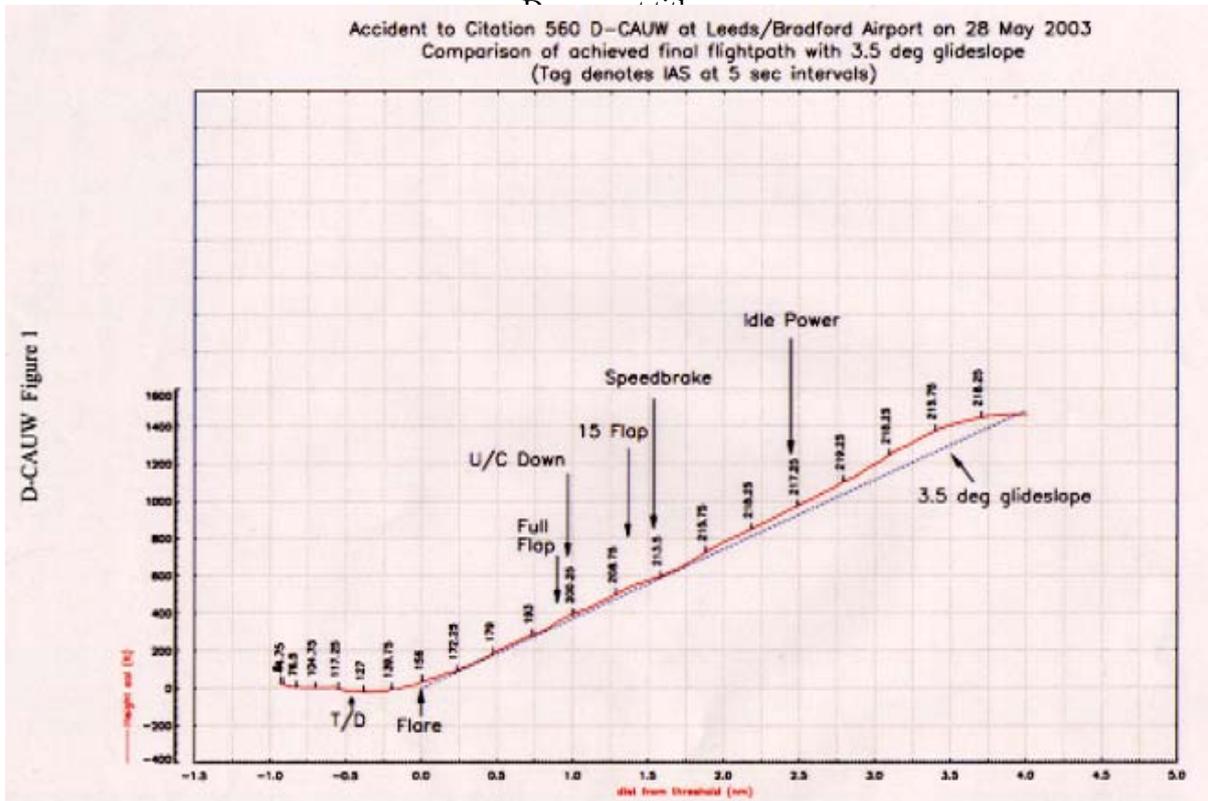
D-CAUW Figure 1

The FDR data shows that for the final five miles of the approach, the aircraft maintained approximately the 3.5° glideslope. (See Figure 1.) The height above aerodrome level (aal) was derived from the barometric altitude (standard 1013 mb) recorded on the FDR. A time history of relevant flight data parameters is shown at Figure 2, from which the following information has been derived. Thrust was reduced to idle at 1,000 feet aal, 2.5 nm from the threshold. The speedbrakes were extended when the aircraft was at 580 feet aal and 1.5 nm from the threshold, and they remained extended throughout the remainder of the approach and landing. The airspeed was above 200 kt until the aircraft was at 400 feet aal and 1 nm from the threshold, with approach flap deployed. At 350 feet aal and 0.75 nm, further flap was selected, the landing gear was selected down and the speed reduced steadily to 195 kt by which speed full flap was achieved. Airspeed continued to reduce to reach 155 kt at the commencement of the flare. There was a protracted float along the runway for some 12 seconds with the speed reducing until touchdown, which occurred at an estimated speed of 121 kt. In the absence of any recorded weight on wheels parameter, the touchdown point was deduced from the observed change in pitch attitude.

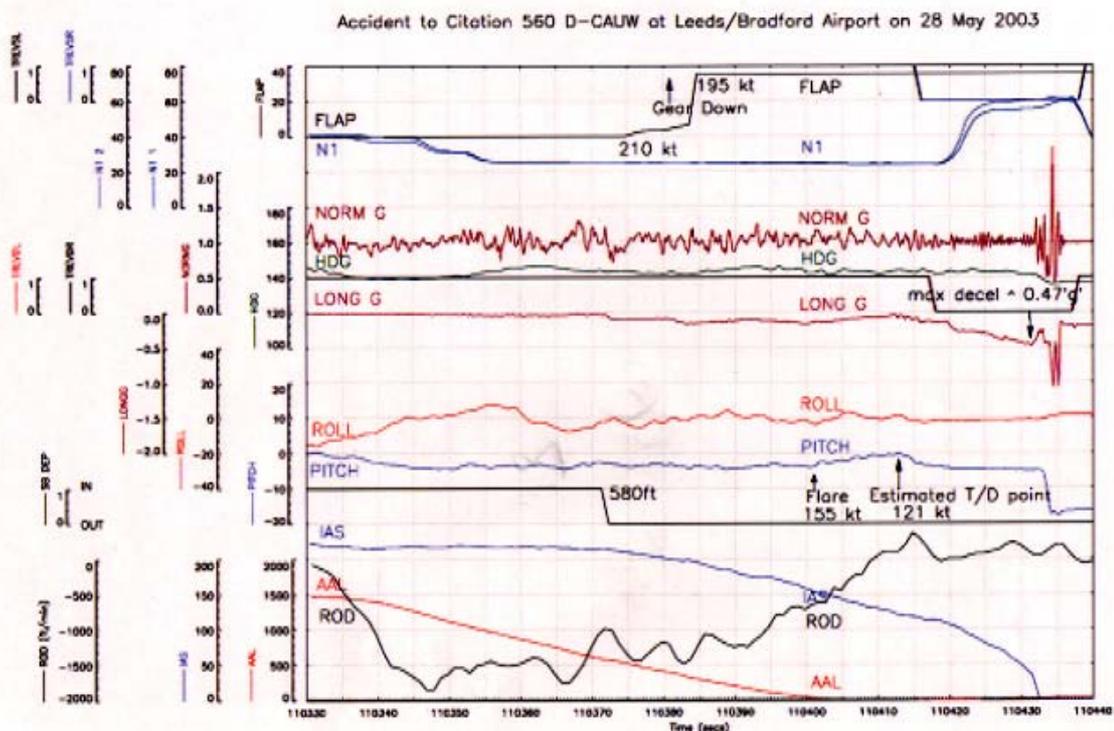
D-CAUW Figure 2

Shortly after touchdown, reverse thrust was selected and the engine N_1 RPMs increased to 60%. The initial retarding deceleration was about 0.2 'g', which was consistent with data from previous landings where reverse thrust alone was used. The increase in deceleration above this figure, to a maximum value of about 0.47 'g' during the landing roll, probably indicates the point at which the wheelbrakes were applied.

Calculations based on the FDR data indicate that the aircraft floated for about 2,700 feet from the initiation of the flare at 155 kt until touchdown at 121 kt. They also show that the actual landing roll was about 2,700 feet, including the overrun onto the grass. Even if worst case errors in calculation of the landing roll are included, the data suggests that the landing roll could have been no more than 3,000 feet. This means that the aircraft must have touched down at or more than half way along Runway 14.
