Cessna 550 Citation II, CS-DHB

AAIB Bulletin No: 12/2003	Ref: EW/C2003/01/06	Category: 1.1
Aircraft Type and Registration:	Cessna 550 Citation II, CS-DHB	
No & Type of Engines:	2 Pratt & Whitney JT15D-4 turbofan engines	
Year of Manufacture:	2002	
Date & Time (UTC):	27 January 2003 at 2013 hrs	
Location:	Aberdeen Airport, Scotland	
Type of Flight:	Public Transport	
Persons on Board:	Crew - 2	Passengers - None
Injuries:	Crew - None	Passengers - N/A
Nature of Damage:	Disintegrated nose wheel, numerous small dents in the fuselage skin and minor damage to right flap	
Commander's Licence:	Airline Transport Pilot's Licence	
Commander's Age:	52 years	
Commander's Flying Experience:	5,800 hours (of which 930 were on type)	
	Last 90 days - 104 hours	
	Last 28 days - 26 hours	
Information Source:	AAIB Field Investigation

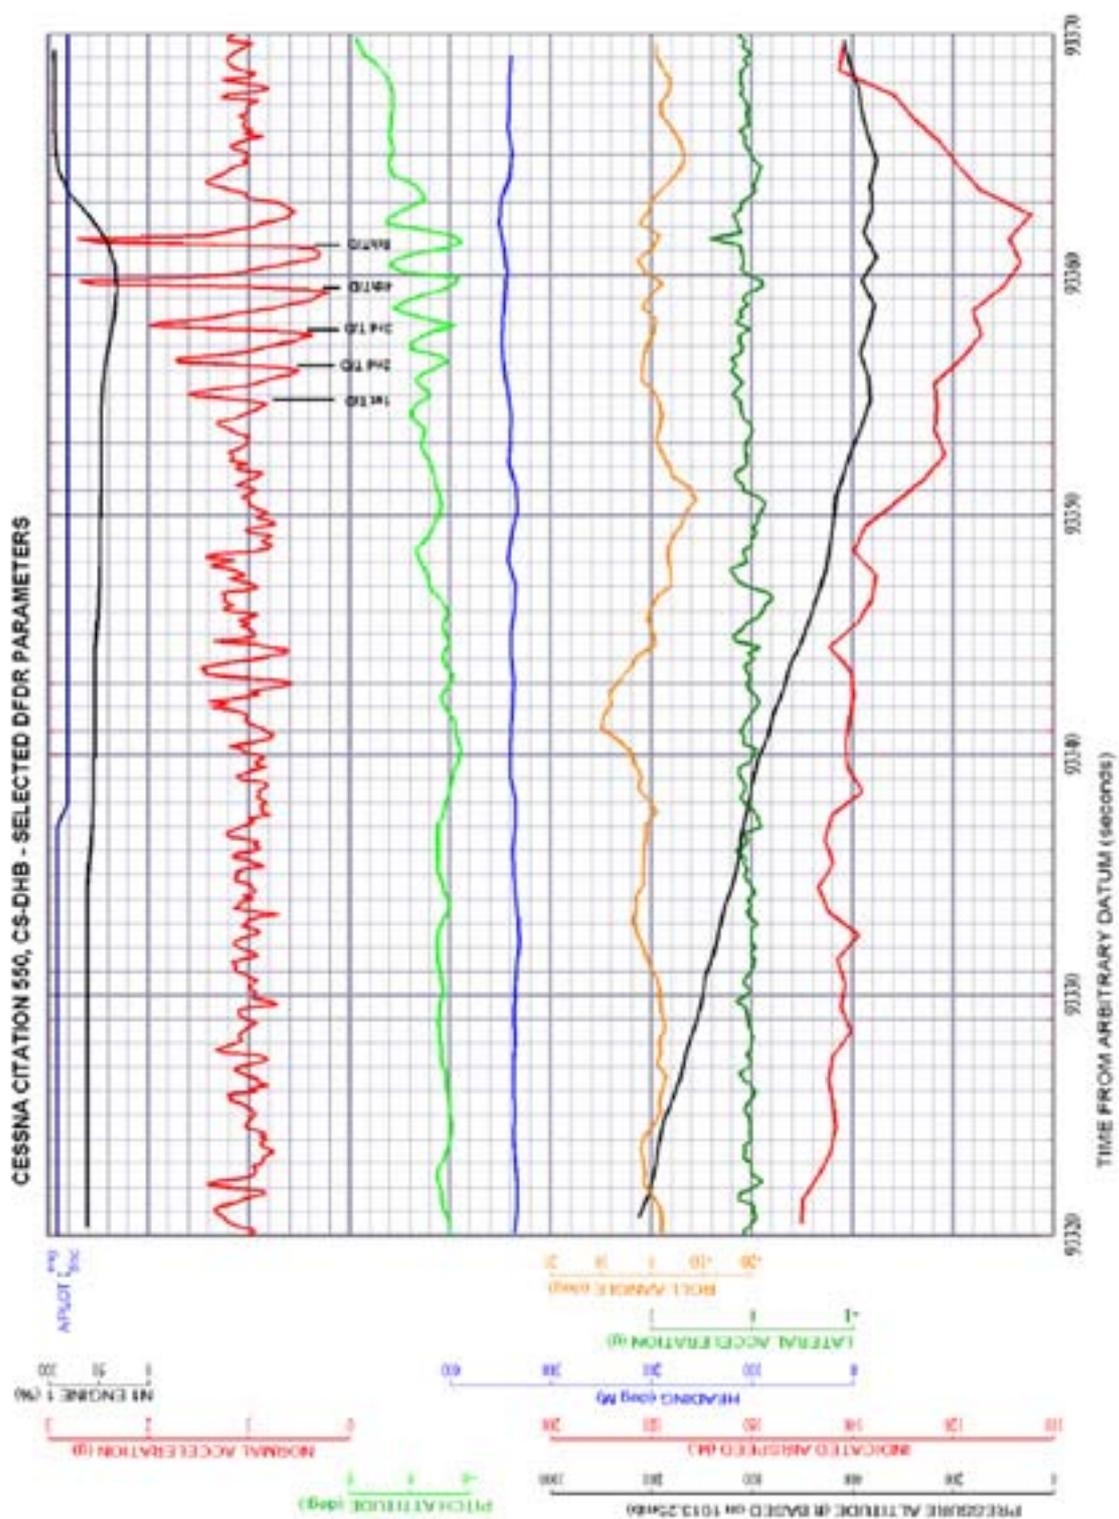
Over the period from autopilot disconnect, initially the roll angle increased from generally wings level to 10 degrees right wing down, then reversed over the following 9 seconds to 9° left wing down before returning to about 2° left wing down at first touchdown. At this point the engines N1 RPM had been at 46% but then started to reduce. After the first touchdown, the aircraft went through a series of 'porpoising' manoeuvres and touched down a further four times (five in total). These manoeuvres increased in severity and coincident with the fourth, engine power started to increase from 30% N1. After the fifth touchdown the aircraft left the runway at a minimum recorded speed of 105 kt. It then slowly pitched up, accelerated and climbed away.

A copy of selected FDR (Flight Data Recorder) parameters is shown at Figure 1. On this aircraft, control positions were not recorded, nor were they required to be recorded; therefore, the influence of control movements on the aircraft manoeuvres could not be assessed.
