# NATIONAL TRANSPORTATION SAFETY BOARD

## AIRCRAFT ACCIDENT REPORT

IN-FLIGHT FIRE/EMERGENCY LANDING  
FEDERAL EXPRESS FLIGHT 1406  
DOUGLAS DC-1 0-10, N68055  
NEWBURGH, NEW YORK  
SEPTEMBER 5, 1996

**Adopted: July 22, 1998  
Notation 6800B**

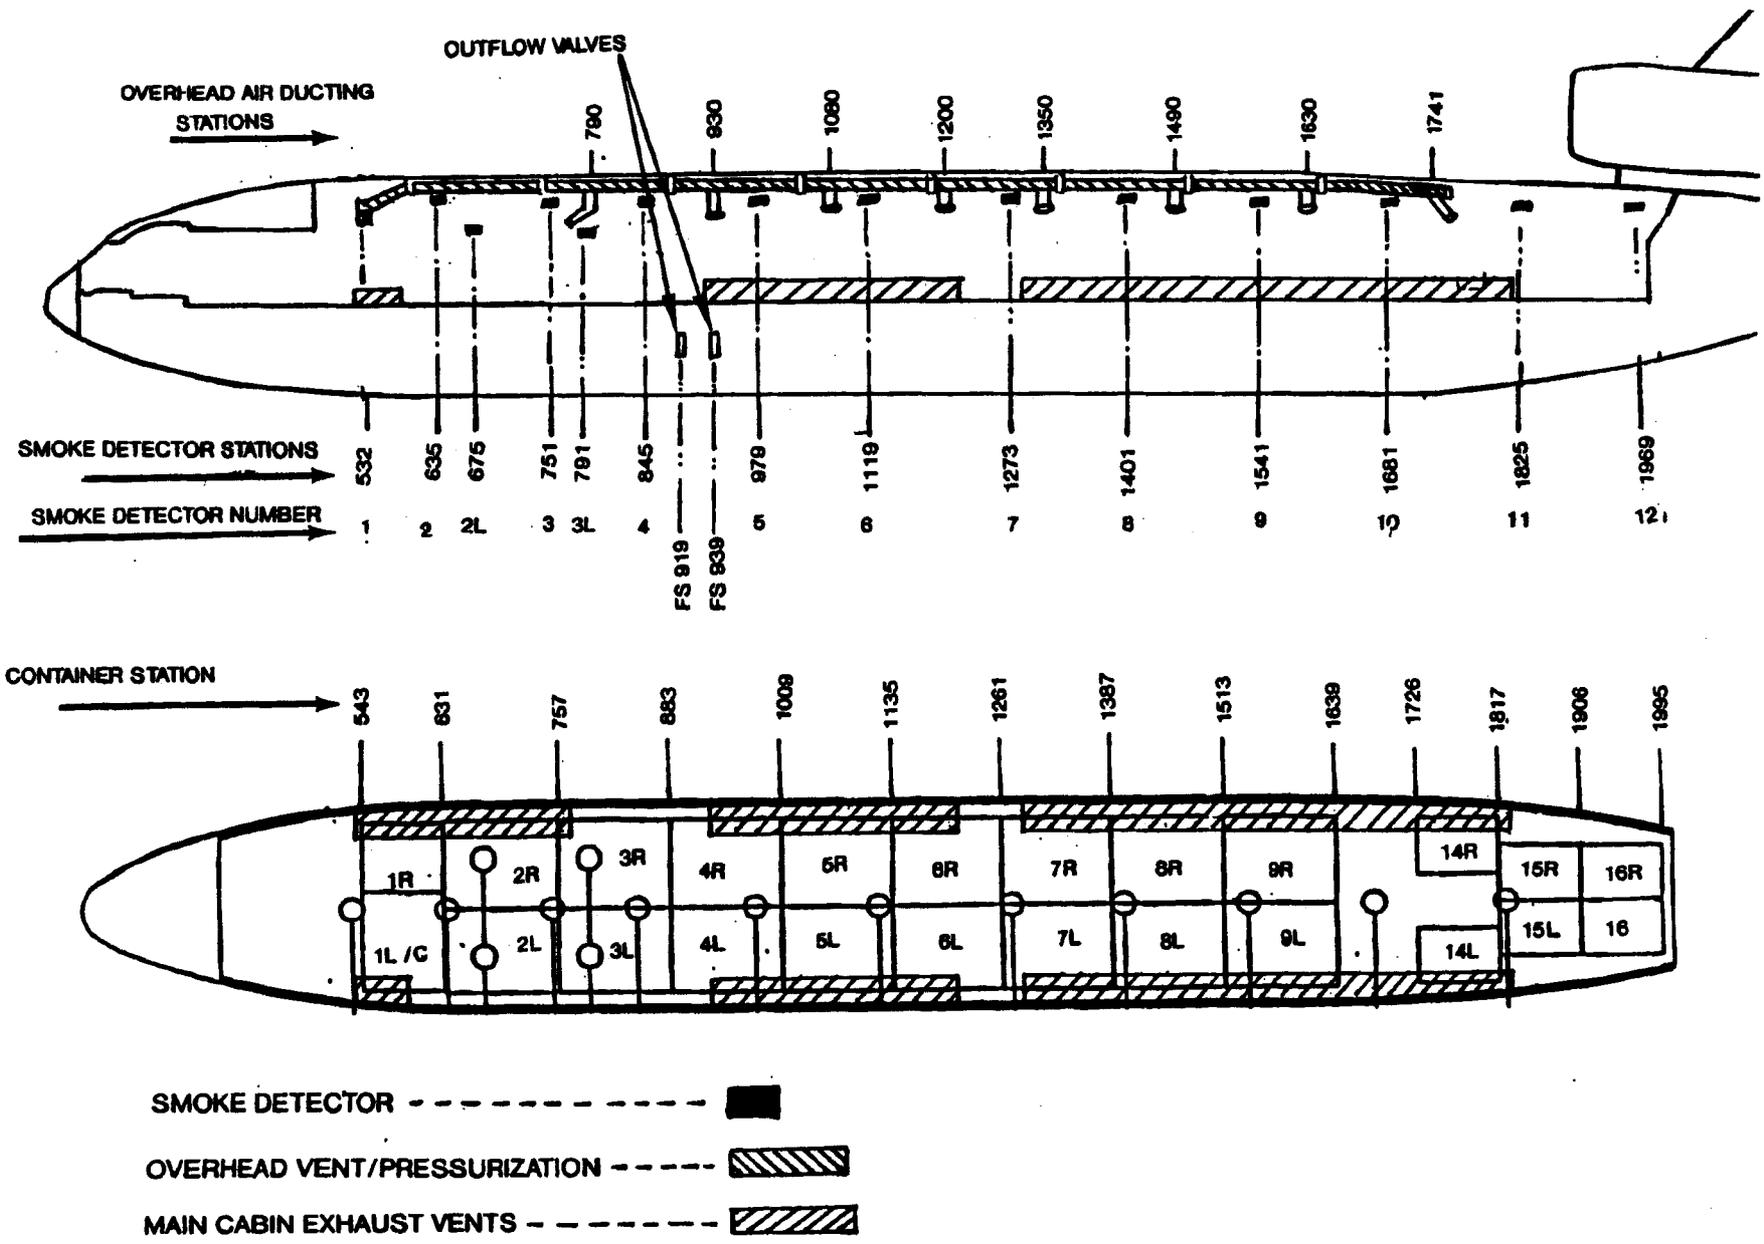
Figure 5.—DC-10-10, N68055, cargo container, smoke detector, and main cabin overhead ducting locations.

Smoke detection systems were installed in the main cargo cabin and lower cargo areas. The smoke detection system consisted of 16 main deck smoke detectors suspended from the cabin ceiling, each of which was connected to an indicator light in the cockpit, and 4 lower forward cargo compartment detectors. Postaccident examination of the smoke detection systems in the upper cabin cargo area revealed that they had been destroyed by fire. The lower cargo compartment detectors were in place and were not damaged. The system could not be functionally tested because of the damage to the upper cabin system and the associated wiring bundles.

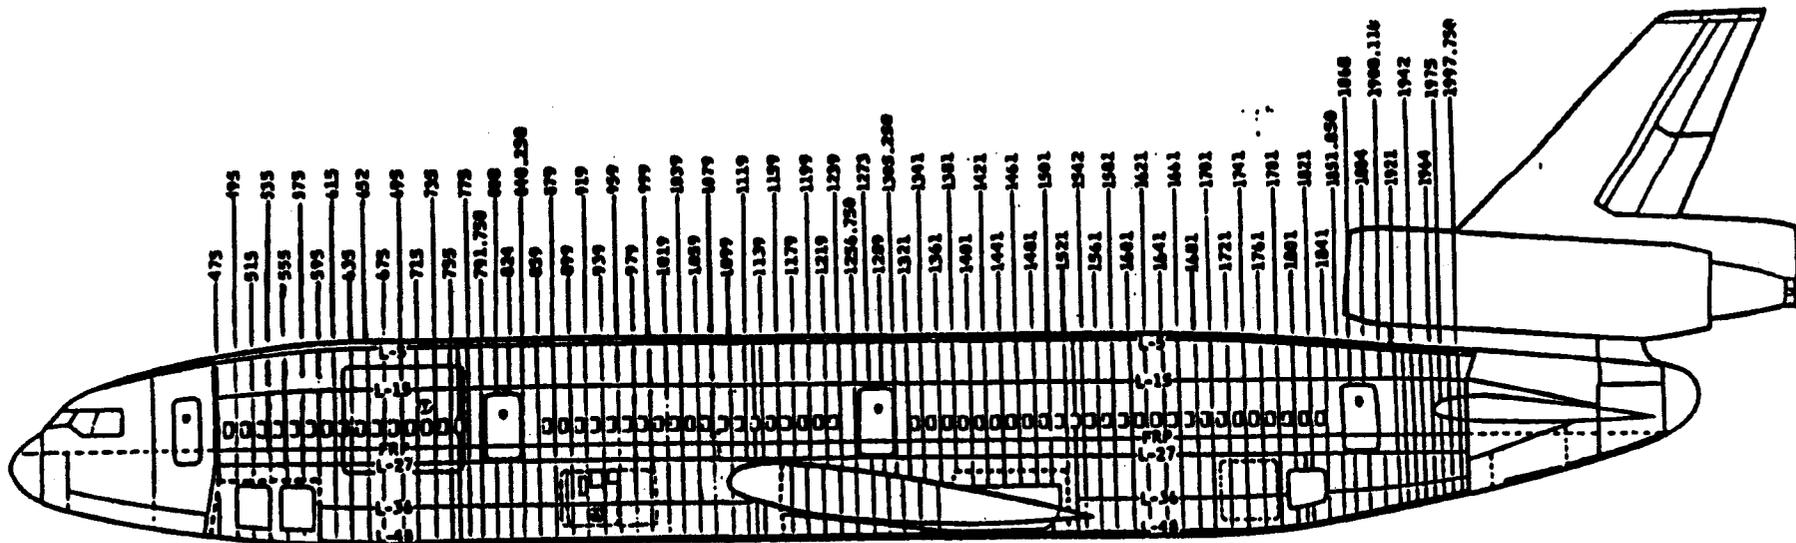
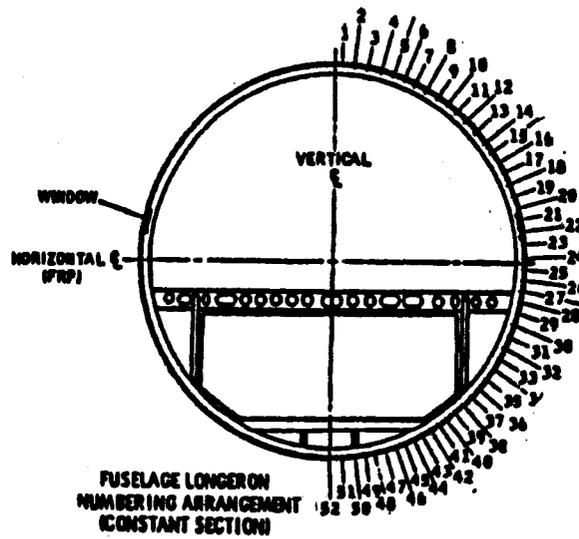
Figure 6.—DC-10-10, N68055, fuselage station and longeron number locations.

At the separated empennage section, the upper interior fuselage crown and the canted area of the aft pressure bulkhead were heavily sooted between longeron 15 left and longeron 23 right. Four of the upper fuselage ring frames were burned and melted between longeron 1 left and the upper canted bulkhead, parallel to longerons 18 left and right. The No. 2 engine bleed air duct was separated about 3 feet forward of the bulkhead. Electrical wires protruded about 20 feet from the aft pressure bulkhead and had cut and separated ends. The wire insulation remained intact on the wires that protruded from the left side of the aft pressure bulkhead, and the wire insulation was burned around the wires that protruded from the right side of the aft pressure bulkhead. No evidence of arcing of airplane wiring was seen. The lower section of the aft pressure bulkhead that was common to the lower cargo area was undamaged and had no soot or fire damage.

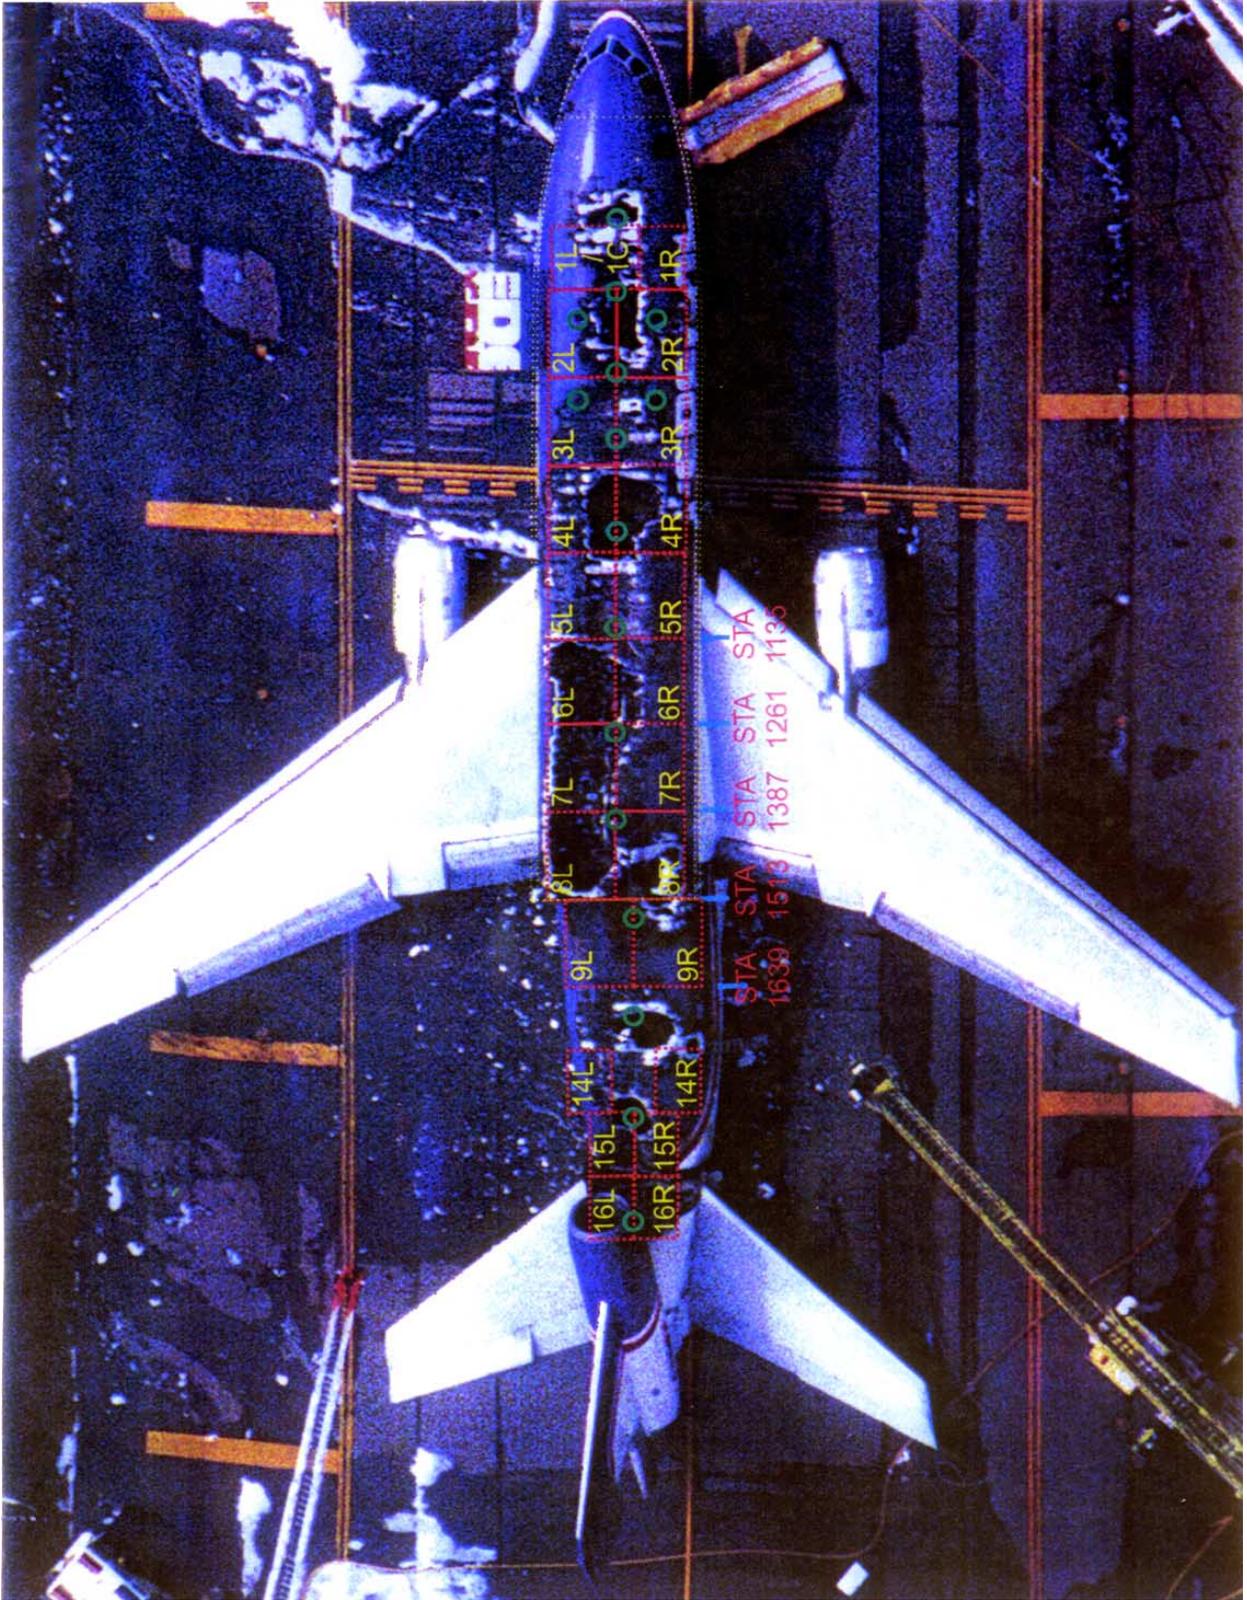
Figure 7.—DC-10-10, N68055, airplane with overlaid cargo container positions

The cabin sidewall panels were lightly sooted and remained attached to the left side of the fuselage between FS 450 and 840, above container position 3L. Burned and sooted upper sidewall panels hung down directly above the attached lower sidewall panels. The right side of the fuselage between FS 808 and FS 919, next to container position 3R, exhibited severe heat and fire damage, along with melted fuselage frame flanges. The airplane's exterior paint was scorched and bubbled on the left side, next to the first two windows between FS 859 and 899, near the aft of container row 3 and the front of container row 4.

The fuselage crown was consumed by the fire between FS 939 and FS 1039, from approximately the middle of container row 4 to the middle of container row 5. The frame flanges on either side of this consumed area of the fuselage crown were burned and melted. The left side of the fuselage crown was also consumed by fire between FS 1179 and FS 1531, an area corresponding to approximately the middle of cargo container 6L to the middle of cargo container 9L.

Light soot deposits were found on the cusp holes under the cabin floor vents and on floor structural components on the right side of the cabin between FS 1039 and FS 1099, outboard of the 5R position (on the accident flight, position 5R was occupied by a loaded cargo pallet, not a cargo container). A floor vent panel at FS 1119 was melted. Intense heat and fire damage was observed in the area of container position 6R at the level of the cabin cargo deck floor on the right side of the fuselage. Three floor vent panels outboard of container 6R were melted or fire damaged, including a floor vent panel between FS 1199 and 1219, which was melted on the corner near FS 1199 and at FS 1139, where the baffle and floor vent grill were melted. The bottom surface of cargo container 6R was melted through the bottom of the container onto a seat track and through the cargo compartment floor into the lower cargo compartment. No other cargo container floors or bottom surfaces were breached.

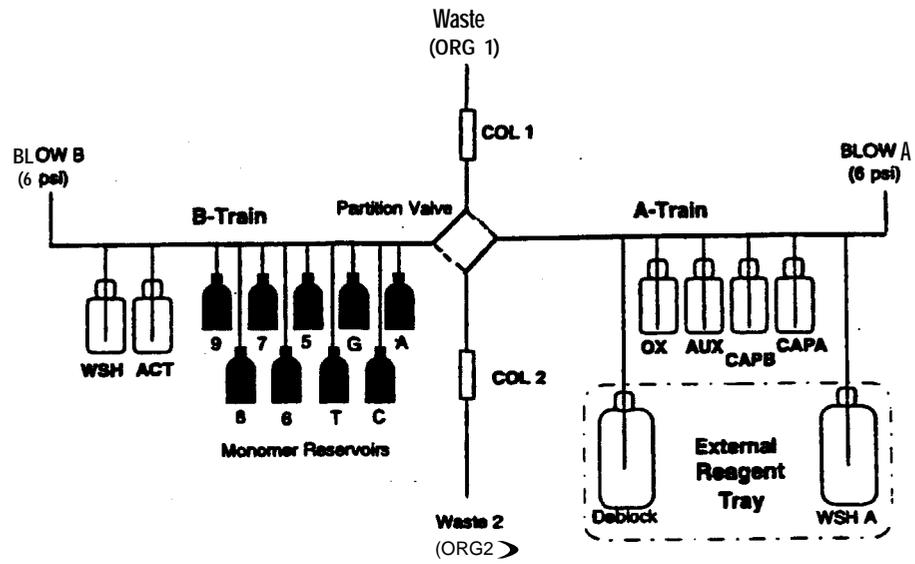
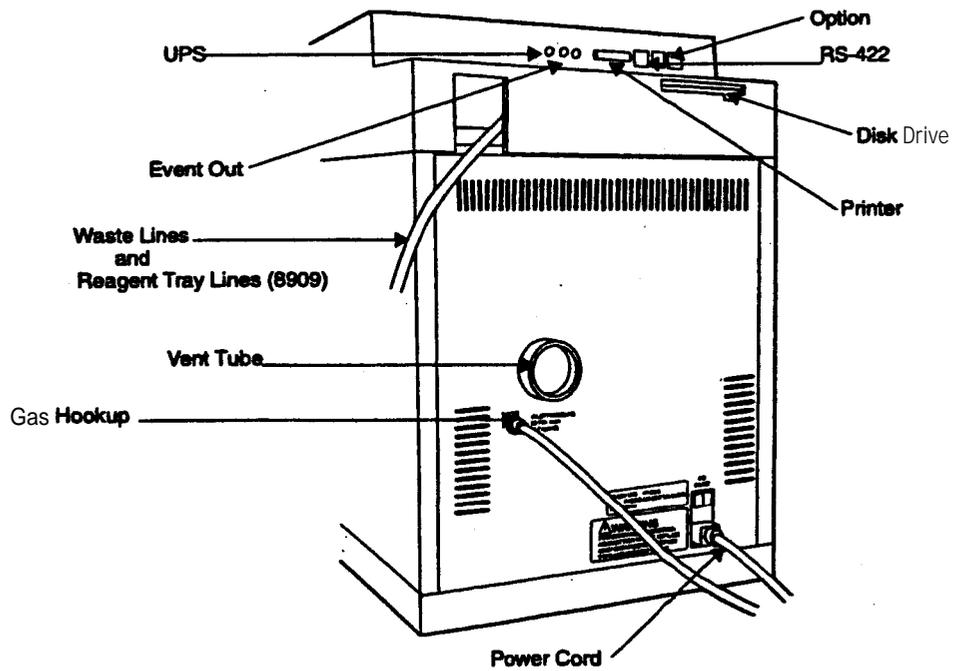
Figure A.—Expedite Model 8909 DNA synthesizer instrument diagram.

A paper diagram of the bottle locations and system schematic taped inside the front door of the synthesizer exhibited slight soot damage. The paint on the inside of the door below the window frame was undamaged but exhibited some sooting. The inside of the door exhibited heavier heat damage above the lower window frame than was observed below the window frame. The stainless steel bottle bracket was heavily sooted behind bottles 4, 5, and 6. The plastic dip tubes were cut off during the on-site accident phase. The upper third of the right side of the stainless steel bottle bracket exhibited some sooting and discoloration. The left side was sooted from the base to the top of the synthesizer. The polyethylene drip tray was melted along the right rear side and was heavily sooted along the left and forward walls. An 8½- by 9½- inch rectangular soot-free area was observed approximately 1 inch from the left side of the drip tray. Pieces of broken glass and a large amount of debris were found in the bottom of the drip tray. The floor of the synthesizer was heavily sooted and also contained pieces of debris. There was some blue discoloration along the right side of the stainless steel bracket where it intersected the mounting for bottles 1, 2, and 3.

Removal of the synthesizer controller top revealed that the controller top's interior exhibited extensive fire damage, and all of the electrical wire insulation was destroyed. The wire conductors were intact and brittle. The inside of the top was heavily sooted. Most of the paint was charred and missing under the controller PC board and around the floppy drive at the rear of the controller top. The resin binder for the controller PC board was destroyed by fire. The
