FLIGHT SAFETY FOUNDATION

JULY 2002

## Erroneous ILS Indications Pose Risk of Controlled Flight Into Terrain

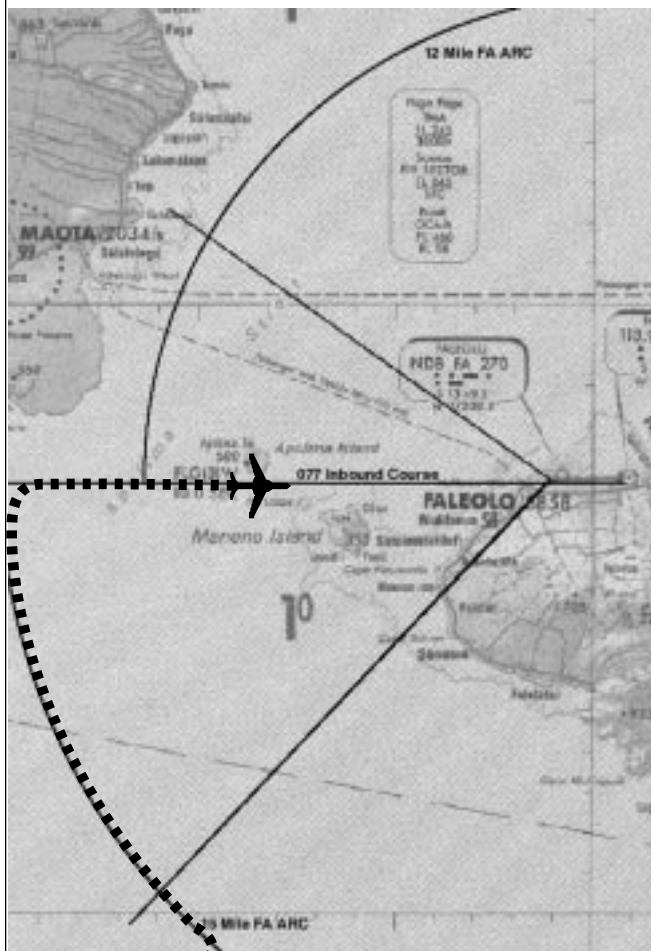
Figure 1

### Air New Zealand Flight NZ 60; Initial Instrument Landing System Approach; Faleola, Samoa; July 29, 2000

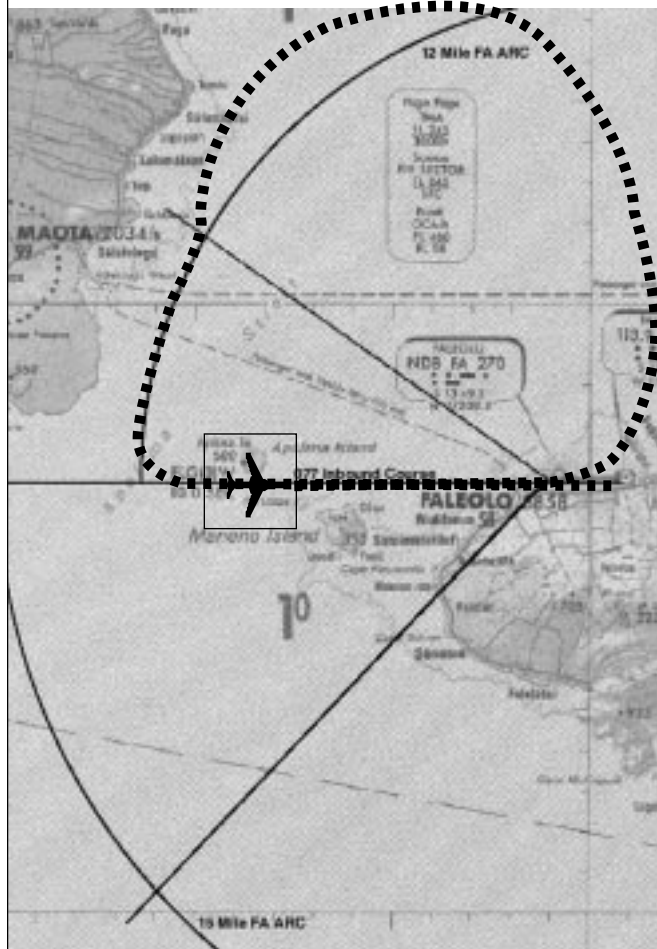
The aircraft was about 5.5 nautical miles (10.2 kilometers) from the runway threshold when the captain began the missed approach (see Figure 2, page 8). The report said that the

## Air New Zealand Flight NZ 60; Missed Approach, Localizer Approach and Landing; Faleola, Samoa; July 29, 2000

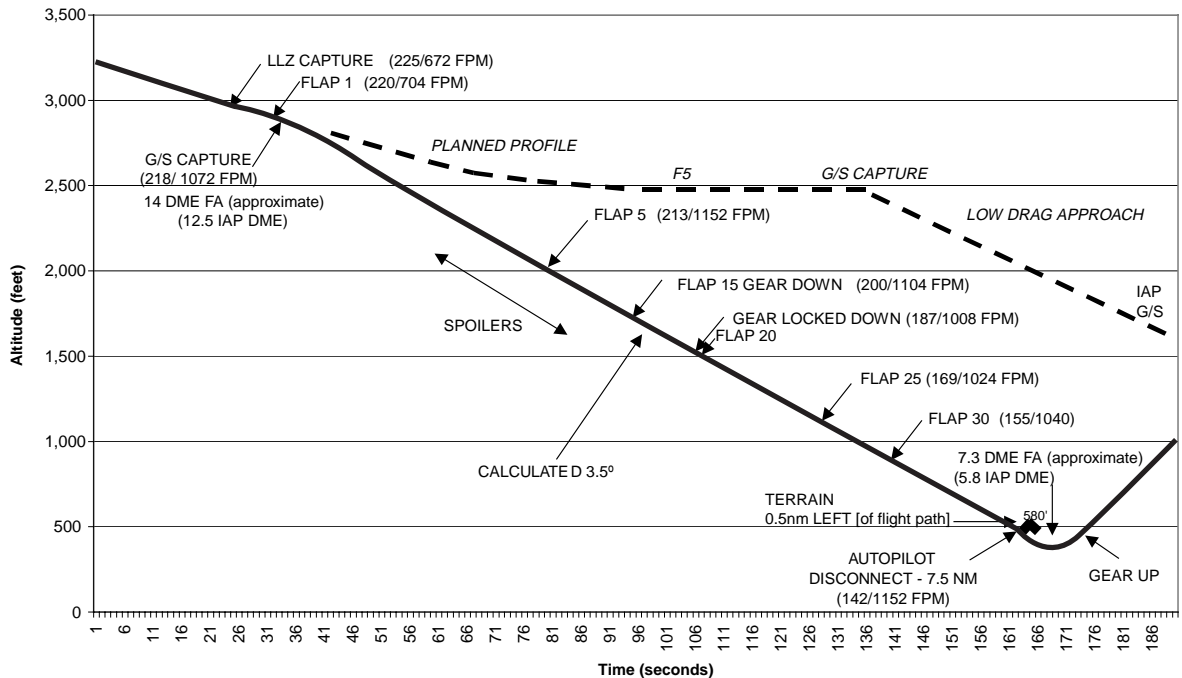
The presence of the CSB signals (which cause course deviation indicator [CDI] glideslope indicators/pointers to center and warning flags to retract or to not be displayed) without the SBO signals (which are required to provide steering information) caused the erroneous on-glideslope indications.

The Air New Zealand report said that the erroneous glideslope indications observed by the B-767 crew resulted from errors by a maintenance technician who returned the ILS system to service after repairs were performed on localizer power-supply cables that had been severed during construction at the Faleolo airport:

- The maintenance technician returned the ILS system to service with the malfunctioning standby glideslope transmitter selected as the operating transmitter; and,

## Flight Path of Air New Zealand Flight NZ 60; Faleolo, Samoa; July 29, 2000

Based on the investigation, Air New Zealand made several recommendations to the New Zealand Civil Aviation Authority (CAA). Among the recommendations was that current navaid maintenance-and-testing procedures be reviewed with respect to the following:

- “If maintenance is planned on the localizer [or glideslope] that has the potential to cause the radiation of erroneous information, then both the localizer [and glideslope] should be removed from service or, as a minimum, remove [the ident] or change the ident [e.g., to “TST” for test]; and,

- “Instituting an acceptable quality-assurance check that will, at a minimum, verify the [automatic] equipment monitor is in control prior to releasing the navigation aid back to service and note the importance of the tower ‘monitor’ [ILS status-indication system] in detecting systemic failure.”

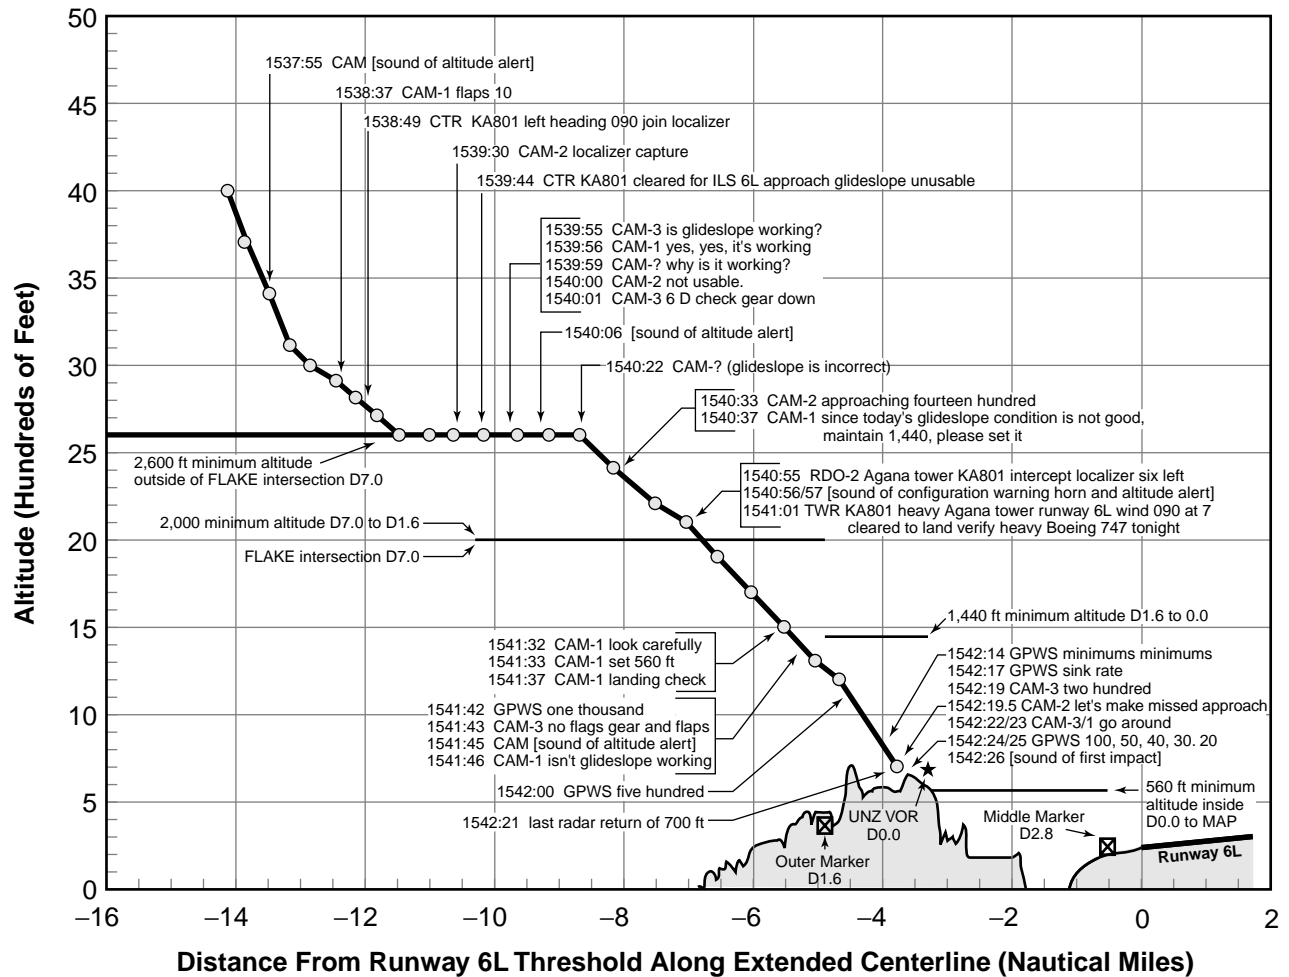
NTSB said that the probable cause of the accident was “the captain’s failure to adequately brief and execute the nonprecision approach and the first officer’s and [the] flight engineer’s failure[s] to effectively monitor and cross-check the captain’s execution of the approach.”

## Flight Path and Excerpts From Cockpit Voice Recorder Transcript; Korean Air Flight 801; Nimitz Hill, Guam; Aug. 6, 1997

The report said that spurious radio signals could have caused erratic movement of the glideslope needles and flags on the accident crew's ADIs and HSIs but that continuous activation of the needles and continuous retraction of the flags were unlikely. The report said that the absence of glideslope-capture indications on the FMAs "should have been sufficient to convince the ... flight crew to disregard the glideslope indications."

NTSB made several recommendations based on the findings of the Guam accident investigation. Among the recommendations was that FAA "disseminate information to pilots, through the *Aeronautical Information Manual* [AIM], about the possibility of momentary erroneous indications on cockpit displays when the primary signal generator for a ground-based navigational transmitter (for example, a glideslope, VOR or nondirectional beacon transmitter) is inoperative. Further, this information should reiterate to pilots that they should disregard any navigation indication, regardless of its apparent validity, if the particular transmitter was identified as unusable or inoperative."
