'Glideslope Unusable'

It took a moment, at a bad time, for the pilots to decipher an unexpected and unusual clearance.

BY MARK LACAGNINA

This article is based on AAIU Formal Report No. 2008-23, published Sept. 15, 2008.

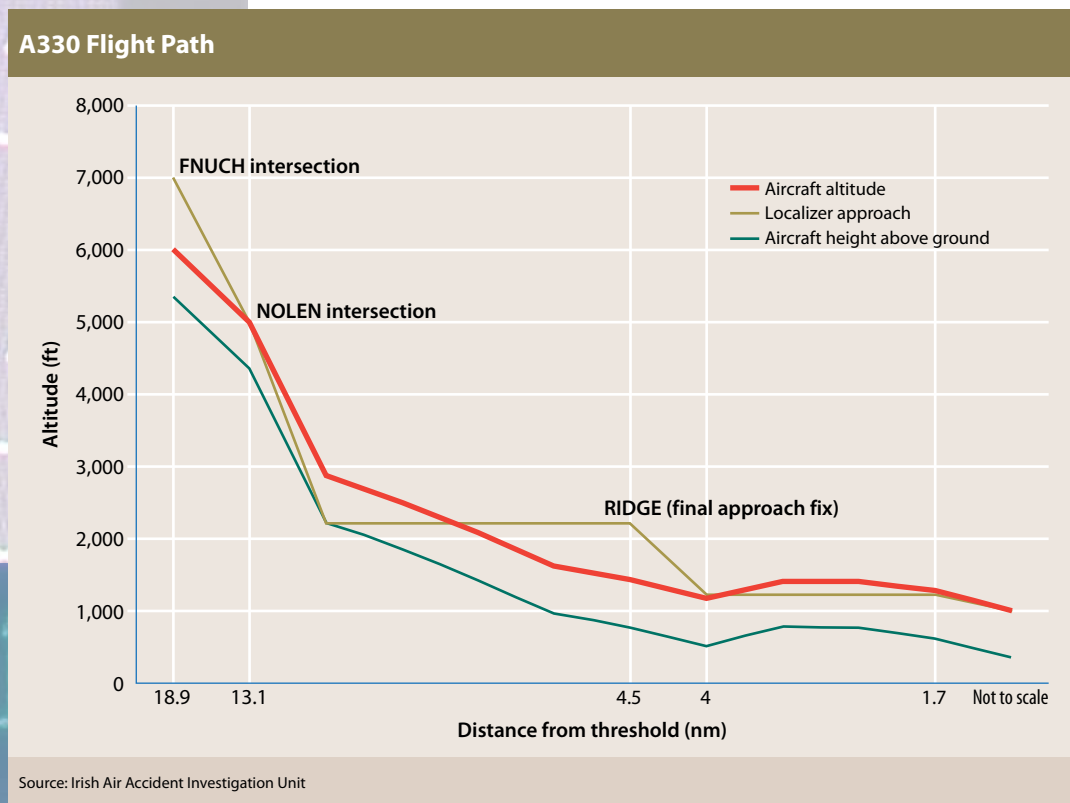
Figure 1

Visual meteorological conditions with good visibility and light winds prevailed at the airport. Due to an altitude assignment by ATC, the aircraft crossed the FNUCH intersection 1,000 ft below the published approach height (Figure 1, p. 27). It then crossed the NOLEN intersection at the published altitude.

Recorded flight data monitoring (FDM) data showed that the aircraft descended below the correct flight path after crossing NOLEN and was 774 ft too low when it crossed RIDGE, the final approach fix.
