Crash During Approach to Landing
Business Jet Services, Ltd.
Gulfstream G-1159A (G-III), N85VT
Houston, Texas
November 22, 2004

Aircraft Accident Brief

**NTSB/AAB-06/06
PB2007-100699
Notation 7828
Adopted November 2, 2006**

Accident Number:	DCA05MA011
Aircraft and Registration:	Gulfstream III, N85VT
Location:	Houston, Texas
Date:	November 22, 2004
Adopted On:	November 2, 2006

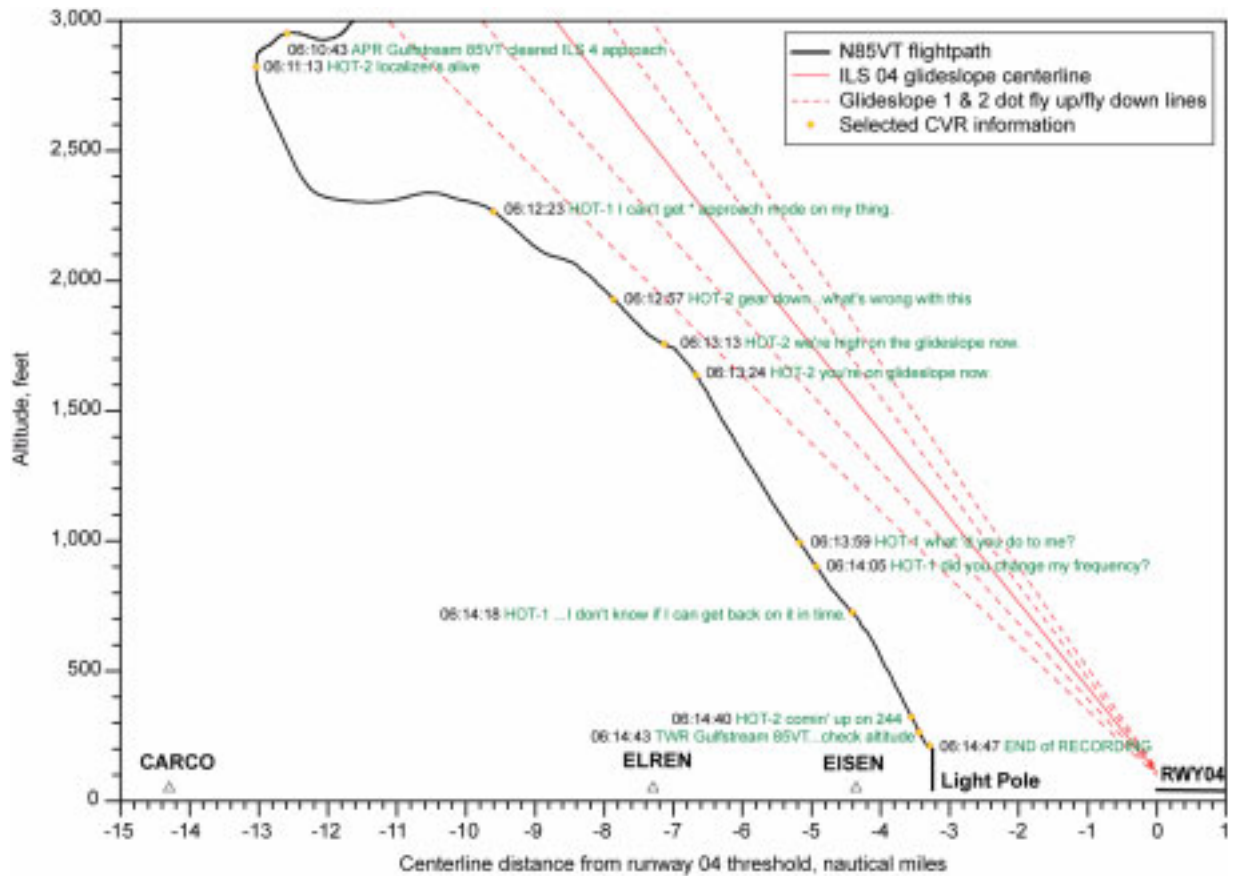
Figure 3. Accident airplane's altitude profile.

At 0612:31, the HOU ATCT controller reported to the first officer that the RVR was 1,600 feet.⁷ The first officer acknowledged the transmission. At 0612:40, the first officer stated, “gear down.” At 0612:57, the first officer asked, “what [is]...wrong with this?” The captain responded, “I don’t know.” At 0613:03, the first officer further asked, “what do we have set wrong? we have...long range [navigation or NAV] or something... that we shouldn’t have?” Five seconds later, the captain reported, “got NAV...VOR one.” The first officer stated, “okay, we’re high on the glideslope now,” and the captain replied, “just gonna have to do it this way.” At 0613:24, the first officer stated, “guess so. yeah you’re on [the] glideslope now.” However, the airplane performance study showed that, about the time that the first officer made the comments about the glideslope, the airplane was at an altitude of about 1,700 feet and was 700 feet below the glideslope. (See figure 3 for the accident airplane’s altitude profile.)

At 0613:44, the captain asked the first officer if they were going to descend to an altitude of 244 feet,⁸ and the first officer replied, “yeah.” The airplane performance study indicated that, about 0614, the airplane was at an altitude of about 1,000 feet. At 0614:05, the captain asked, “what happened? did you change my frequency?” The first officer responded, “yeah we were down there...the VOR frequency was on.” He then stated, “we’re all squared away now...you got it.” The captain responded, “yeah, but I, I don’t know if I can get back on it in time.” The first officer replied, “yeah you will...you’re squared away now.” The airplane performance study showed that, shortly after the captain’s question regarding the frequency, the airplane turned right and subsequently intersected the ILS runway 4 localizer centerline. As shown in figure 3, about this time, the airplane was at an altitude of about 900 feet and was 800 feet below the glideslope.
