## SAFETY

DAVID CARBAUGH  
CHIEF PILOT  
FLIGHT OPERATIONS SAFETY  
BOEING COMMERCIAL AIRPLANES

# HAZARDS of ERRONEOUS GLIDESLOPE INDICATIONS

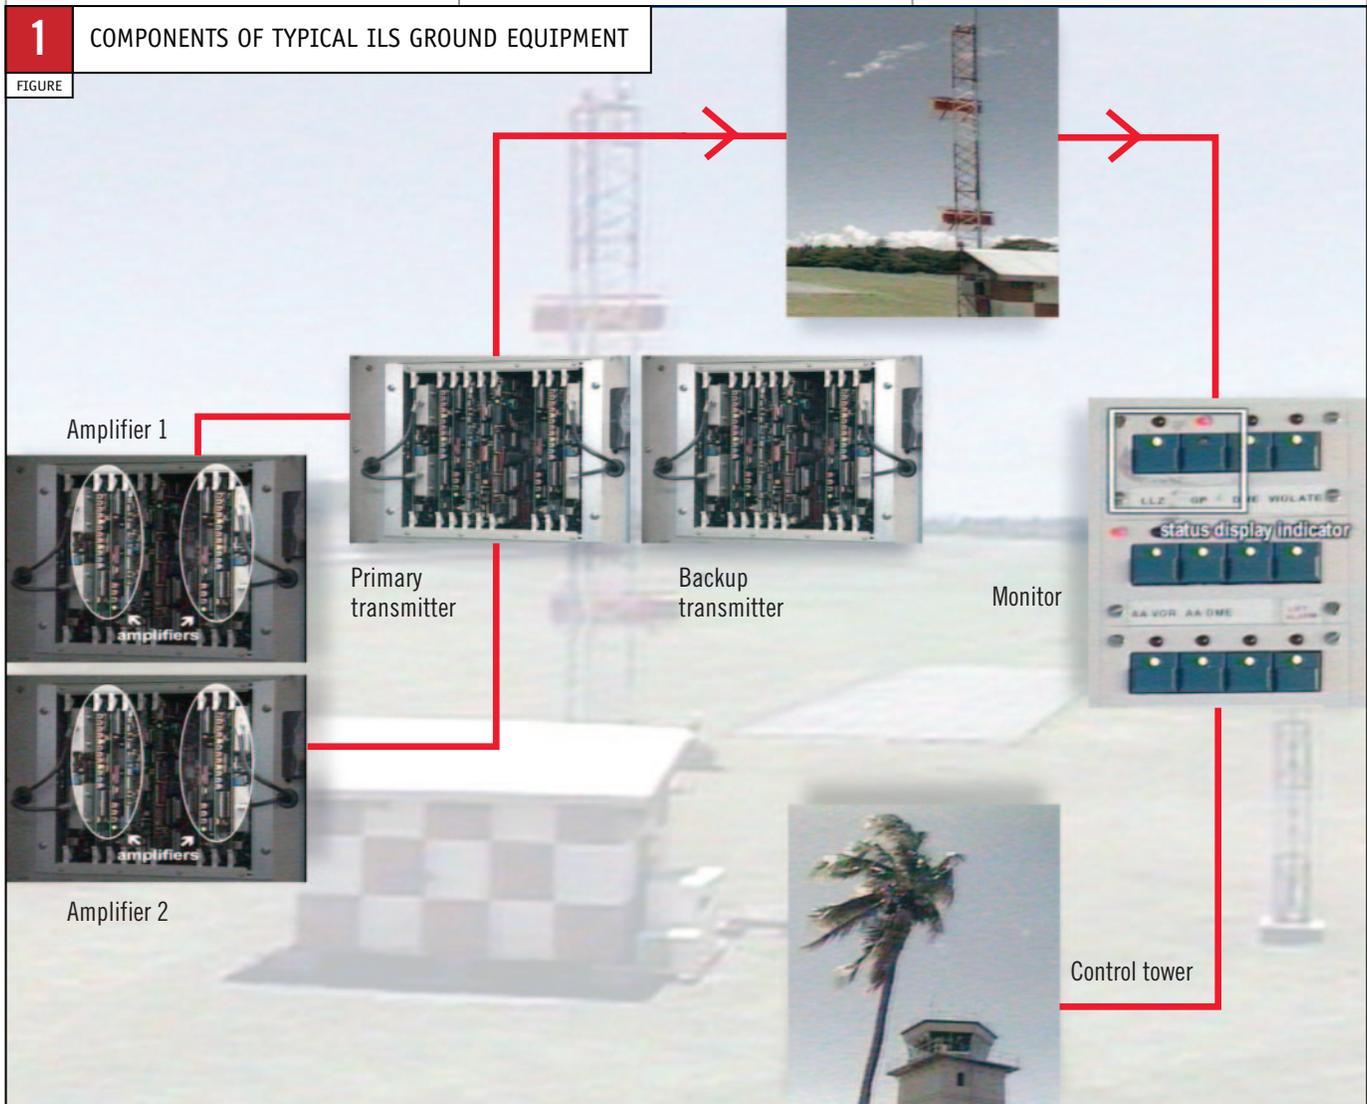
### COMPONENTS OF TYPICAL ILS GROUND EQUIPMENT

ILS ground equipment provides horizontal and vertical guidance information to airplane instrumentation. The equipment typically comprises five components: a localizer transmission system, a glideslope transmission system, a DME or marker system, a standby transmitter, and a remote control and indicator system (fig. 1).

On the night of July 29, 2000, the glideslope sidelobe

amplifier was not operating in Apia. In addition, the ILS ground equipment had been left in bypass mode following calibration maintenance. This prevented system transfer to the standby transmitter. No alarm sounded in the control tower because the cable that fed information to the tower navigation status displays had been cut during construction. As a result, the Air New Zealand flight received only the glideslope carrier wave transmission, which was interpreted by the instruments as being on glideslope, with no warning indications.

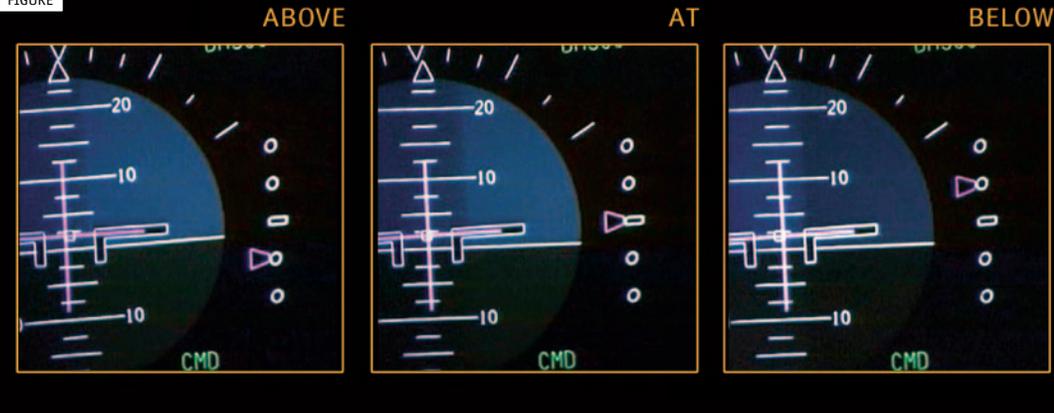
### ADI: INDICATING ABOVE, AT, AND BELOW GLIDEPATH

During normal ILS operation, the localizer and glideslope transmitters each radiate a carrier wave of 90- and 150-Hz signals of equal amplitude. These signals alone do not provide guidance but are compared with separate 90- and 150-Hz sidelobe signals radiated by the localizer and glideslope to create complex interference patterns. The patterns are designed so that when an airplane is below the desired glideslope, the instruments will sense a predominance of 150-Hz signals; when the airplane is above the desired glideslope, the instruments will sense a predominance of 90-Hz signals; and when the airplane is on the glideslope, the instruments will sense equal amounts of 90- and 150-Hz signals (fig. 2).

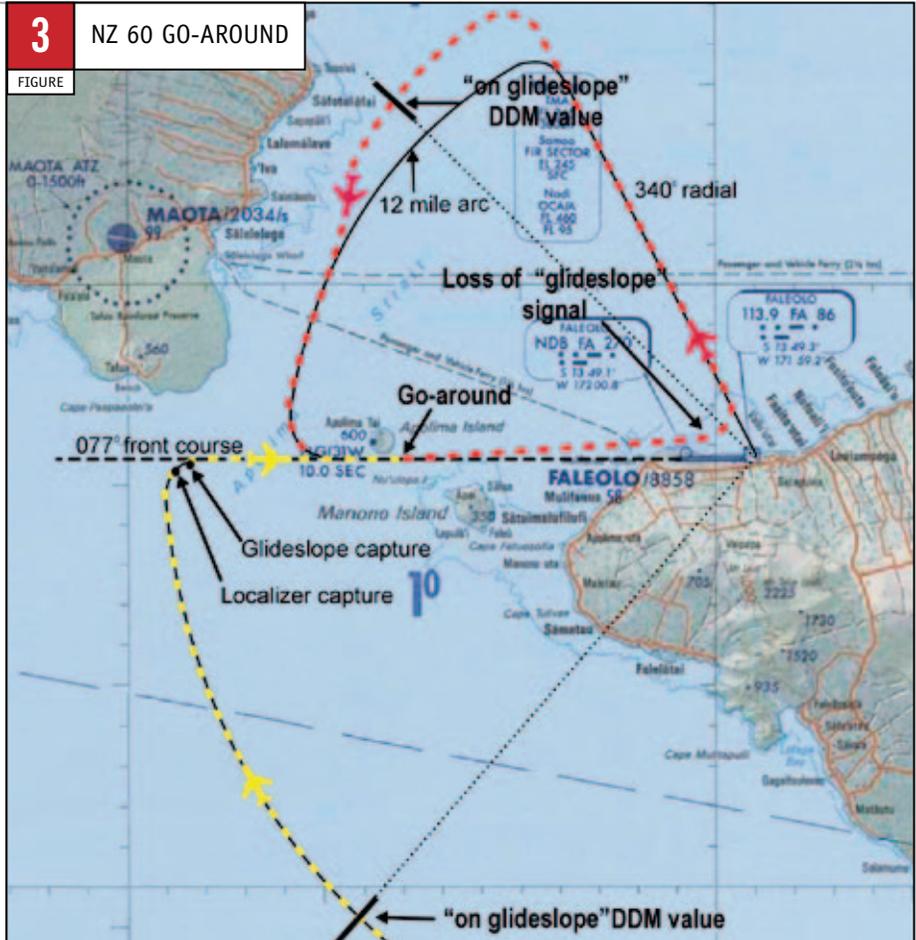
## 3 NZ 60 GO-AROUND

The captain executed a timely go-around 5.5 mi from the runway at an altitude of less than 400 ft. The crew successfully executed a second approach by using the localizer and ignoring the on-glidepath indications.

notice to airmen (NOTAM) bulletins had informed them that the ILS was unmonitored, and they discussed this during their approach briefings. They also paid attention to subtle cues that something might be wrong, even though the automatic flight system was indicating normally. Last, the crewmembers were willing to execute a go-around to give them more time to sort through the conflicting information (fig. 3).
