FINAL REPORT

AAIU Synoptic Report No: 2007-010

Aircraft Type and Registration:	Beech 65-A90 King Air, N712DB
No. and Type of Engines:	2 x PT6A-20
Aircraft Serial Number:	LJ311
Year of Manufacture:	1967
Date and Time (UTC):	22 August 2006 @ 15.39 hrs
Location:	Ireland West Airport Knock
Type of Flight:	Private
Persons on Board:	Crew - 2 Passengers - Nil
Injuries:	Crew - Nil Passengers - Nil
Nature of Damage:	Distortion of wings and tailplane
Commander's Licence:	See 1.4 Personnel Information
Commander's Details:	Male, aged 48 years
Commander's Flying Experience:	753 hours of which 95 were on type
Information Source:	AAIU Field Investigation

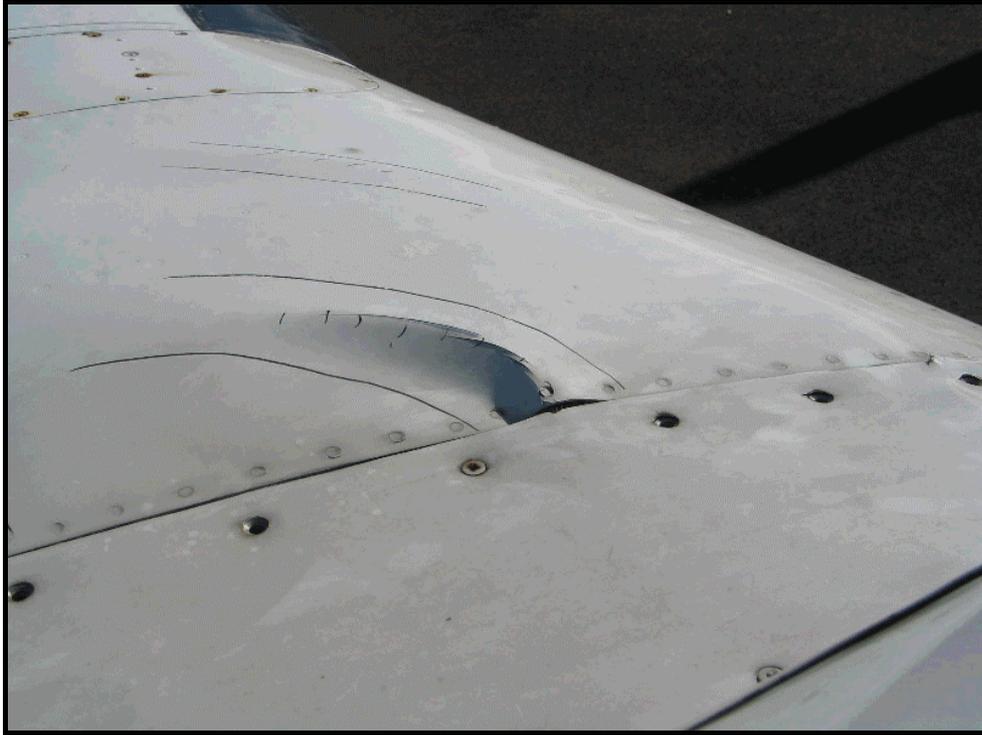
The skin on the top wing surface of both port and starboard wings was found buckled at the outer panel joint (**Photo 1**). The outer panel joint is a production joint, just outboard of the engines, where the outer section of the wing is bolted to the stub wing section. In addition ripples on the upper skin of both wings extend outboard from the joints (**Photo 2**).

The skin buckling at the outer panel joint on top wing surface is more significant on the port (**Photo 1**) than the starboard wing. This is consistent with concurrent application of right roll and high G. This buckling is termed “compression buckling” and is caused by wing overload.

In view of the age of the aircraft, the fact that both wings are buckled at the production joints and more critically with distortion in the stub wing, it is probable that the aircraft was damaged beyond economical repair.

Photo 1
Buckling on port wing at outer wing panel joint

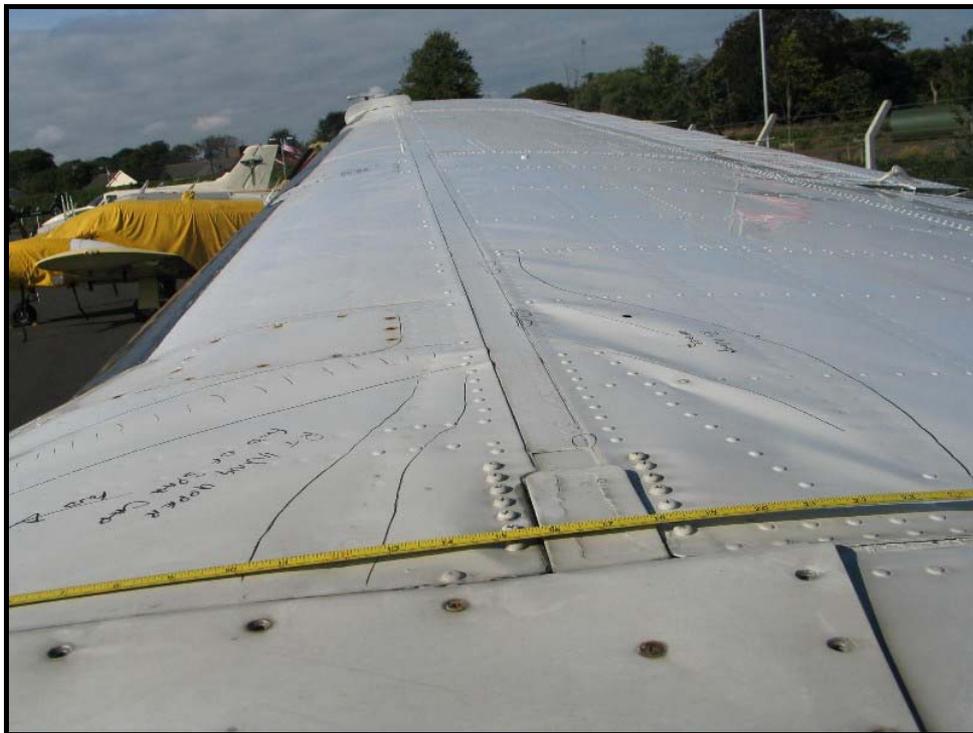
The upper skin ripples in **Photo 2** that extend outboard from the joint on both wings are symptomatic of gross over speed and occurs as aerodynamic forces push the wings up and aft. In this case drag would have been particularly high as the flaps were partially extended at the time of the occurrence. With a VFe of 174 knots and a possible speed reached between 280-300 kt this damage is not surprising as the exceedence could be in excess of 160% of VFE.

Photo 2
Upper skin rippling on starboard wing outside outer wing panel joint
