After a simple error wiped out much of their navigation information, the Polish pilots of a 737 were unable to adequately communicate their problem to British controllers.

BY LINDA WERFELMAN

Language Barrier

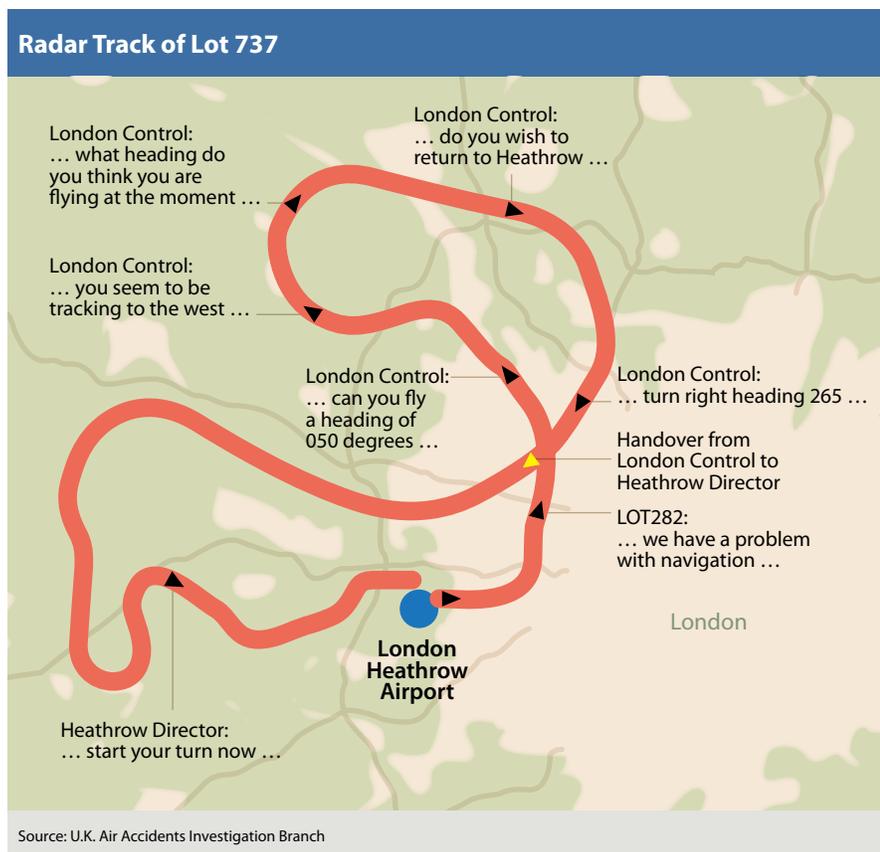
Figure 1

No one was injured and the airplane was not damaged in the late morning incident on June 4, 2007, which involved a circuitous 27-minute return flight to Heathrow, where the airplane was landed safely, a report by the U.K. Air Accidents Investigation Branch (AAIB) said (Figure 1, p. 42). While the commander worked to resolve the problem, the copilot flew the airplane by reference

At one point in the flight, as the airplane was flown north instead of north-northeast as directed, it came into conflict with another aircraft, whose crew was issued revised instructions to maintain separation, said the report.
