NATIONAL TRANSPORTATION SAFETY BOARD

AIRCRAFT ACCIDENT REPORT

**AIR CANADA FLIGHT 797
McDONNELL DOUGLAS DC-9-32, C-FTLL
GREATER CINCINNATI
INTERNATIONAL AIRPORT
COVINGTON, KENTUCKY
JUNE 2, 1983**

NTSB/AAR-86/02

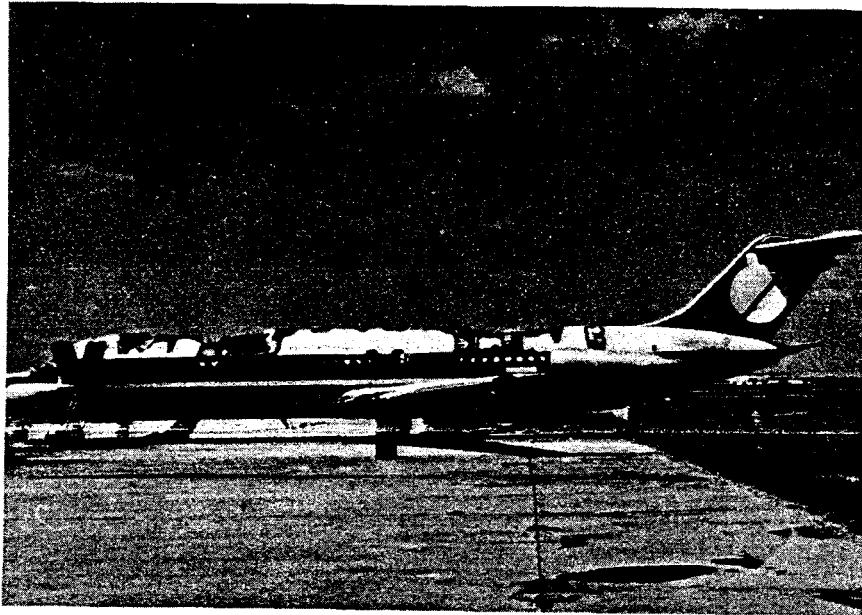
Figure S.-Left side of the airplane.

The cabin area of the upper fuselage down to below the level of the cabin windows was damaged heavily by fire; below that level the fuselage was relatively intact. The majority of the cabin windows were either missing or had partially melted out. (See figures 3 and 4.) Forward of the aft pressure bulkhead, the upper areas of the cabin windows were discolored and burned away in several locations. The fuselage skin above the left aft lavatory was intact, but a rectangular area corresponding closely to the shape of the lavatory had been discolored to dark brown and a large area of paint had been burned away. The rectangular area began above the engine pylon and extended to the top of the fuselage. (See figures 3 and 4.)

Forward of the aft lavatory, between fuselage station (**FS**) 929 and FS 758, the top of the fuselage was damaged heavily by heat and had been burned away down to the top of the cabin windows. Between FS 758 and FS 484, the fuselage upper skin was intact but was buckled and discolored by heat at the very top between the 11 o'clock and 2 o'clock positions (aft looking forward). Between FS 484 forward to the cabin entry door (**FS 200**), the upper skin of the fuselage had burned away partially. Except for some sooting around the edges of the left and right forward cabin entrance doors, the fuselage forward of FS 200 was intact with no apparent heat or fire damage.

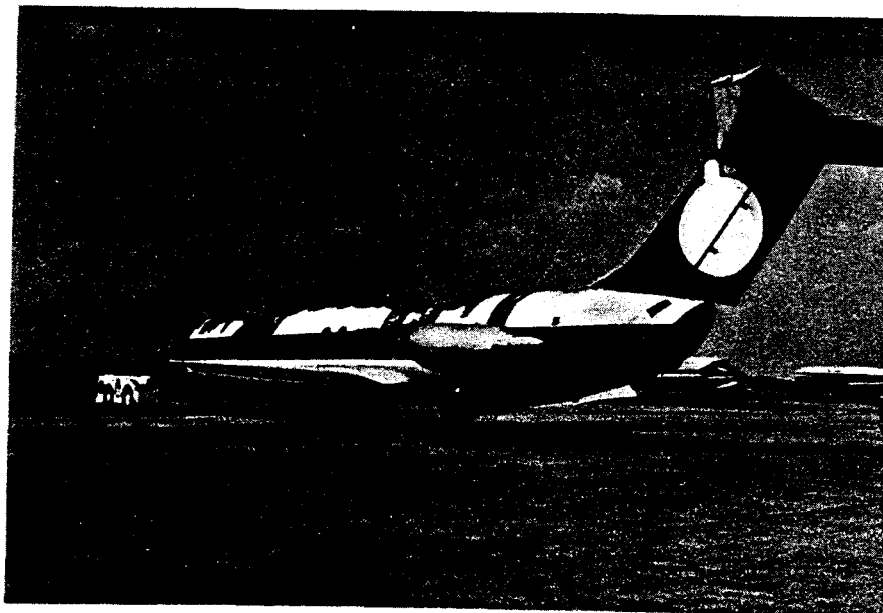
There were thick soot deposits along the lower side of the fuselage beginning at the cabin air outflow valve at FS 945 and from around the access **door** in the lavatory service panel at FS 965. The soot pattern trailed rearward along the airplane's side,

Figure 4.-Left side of the airplane, rear view, depicting rectangular burn pattern and Soot trail. .

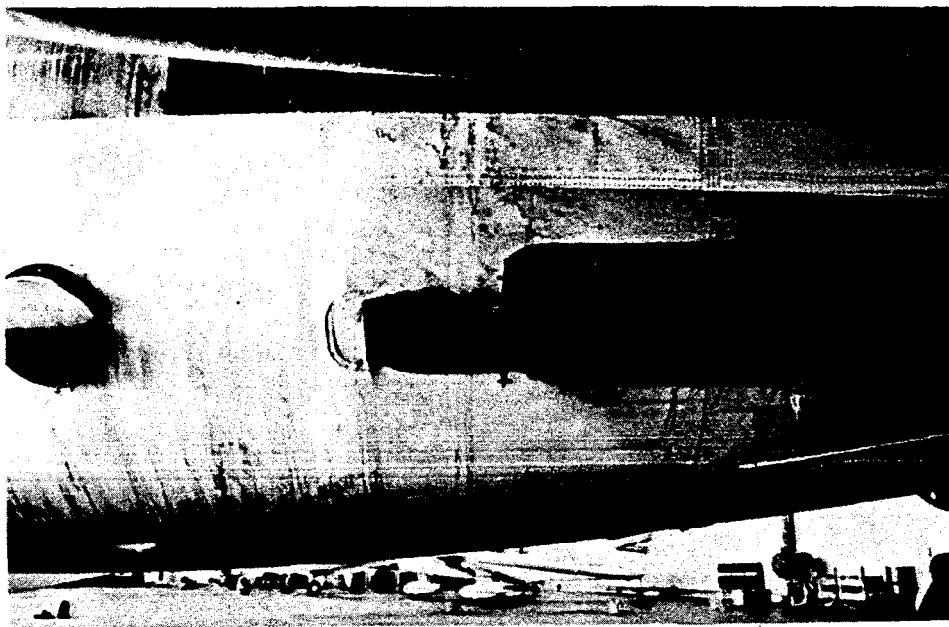
including the tailcone. The cabin air dump valve, at FS 920, was open, and light soot deposits trailed aft from around the edges of the valve. (See figure 5.)

Figure S.-Soot trail deposits on left side of fuselage at lavatory, service panel and outflow valve.

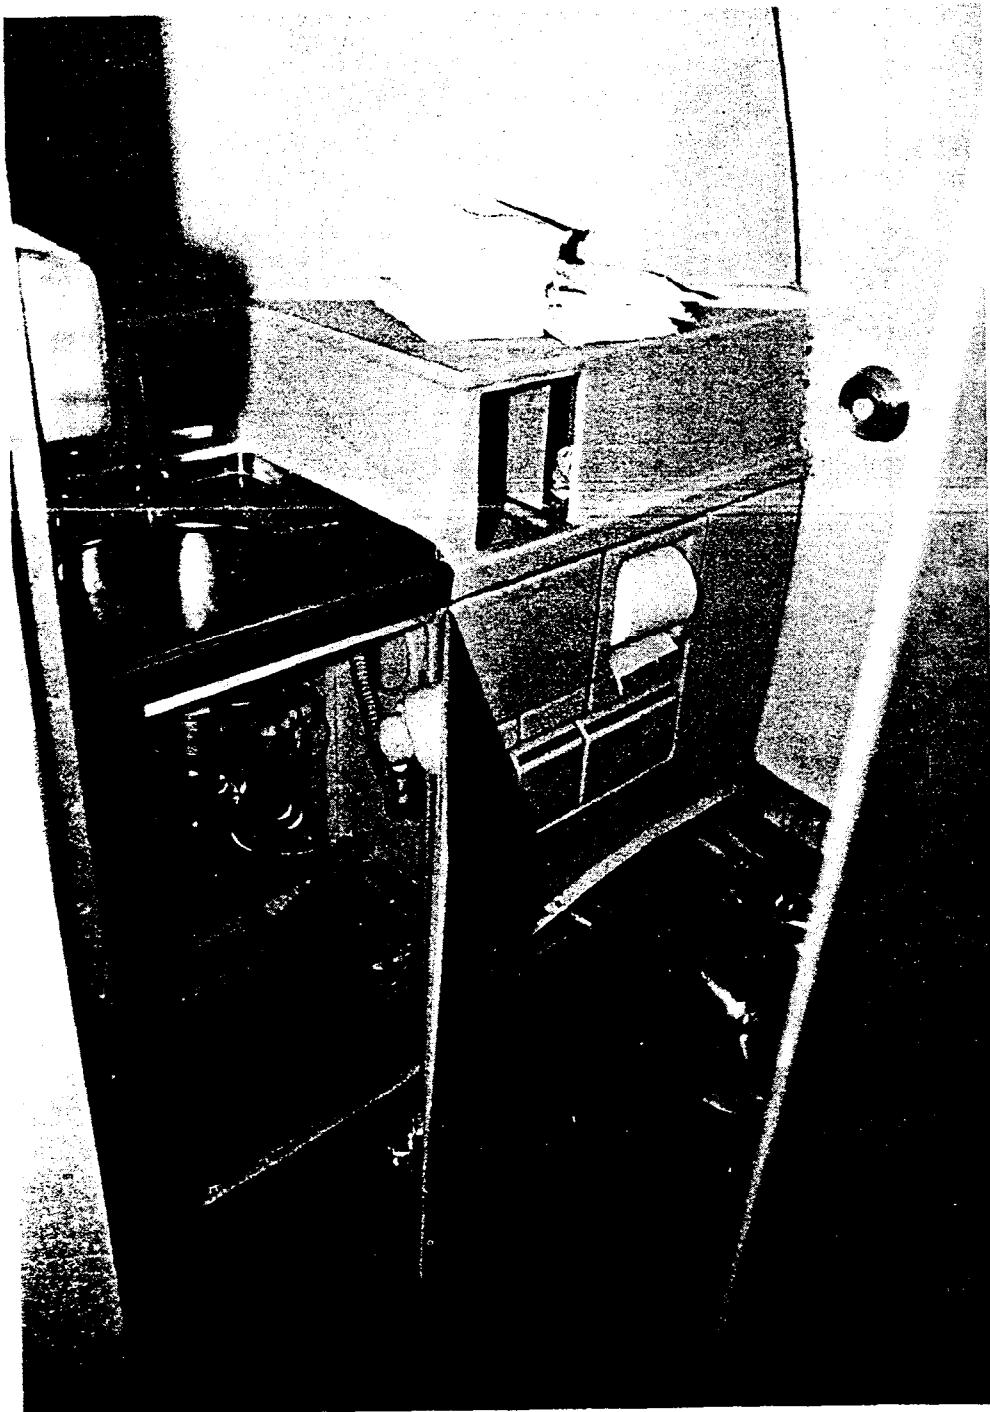
Figure 10.—Aft lavatory viewed toward aft and outboard wall.
Lavatory sink door is open exposing trash receptacle:
Toilet shroud has been removed showing the top of the
flush motor between the commode and forward wall of
the amenities section.

The aft lavatory was damaged extensively by fire and heat. Most of the lavatory's interior walls had been burned away. The entry door, which had been kept closed, was destroyed except within 16 inches of the floor. The aft pressure bulkhead and fuselage skin which comprised the outermost portion of the lavatory enclosure were intact, but were buckled and discolored to dark brown.

The stainless steel sink and the section of the vanity frame supporting the sink were intact against the aft lavatory wall. The plastic door on the front of the sink portion of the vanity was burned away. The cold air outlet nozzle mounted in the door was recovered in the debris and was in the closed position.

Except for the top of the trash chute, which had burned away at the point where it attached to the top of the sink at the waste disposal door, the trash chute and trash container behind and below the sink were intact. The aft side of the container was scorched, but not burned, and the paint on the inside surface of the container was blistered. Paper trash in the container was scorched but was not burned. The aluminum shelf below the container was intact; it was covered with debris, but exhibited little evidence of heat damage. The lavatory floor in this area was intact, but was covered with damp debris. Included in the debris were a plastic vial and a paper maintenance tag, neither of which was burned. These items were located on the floor under the sink area.

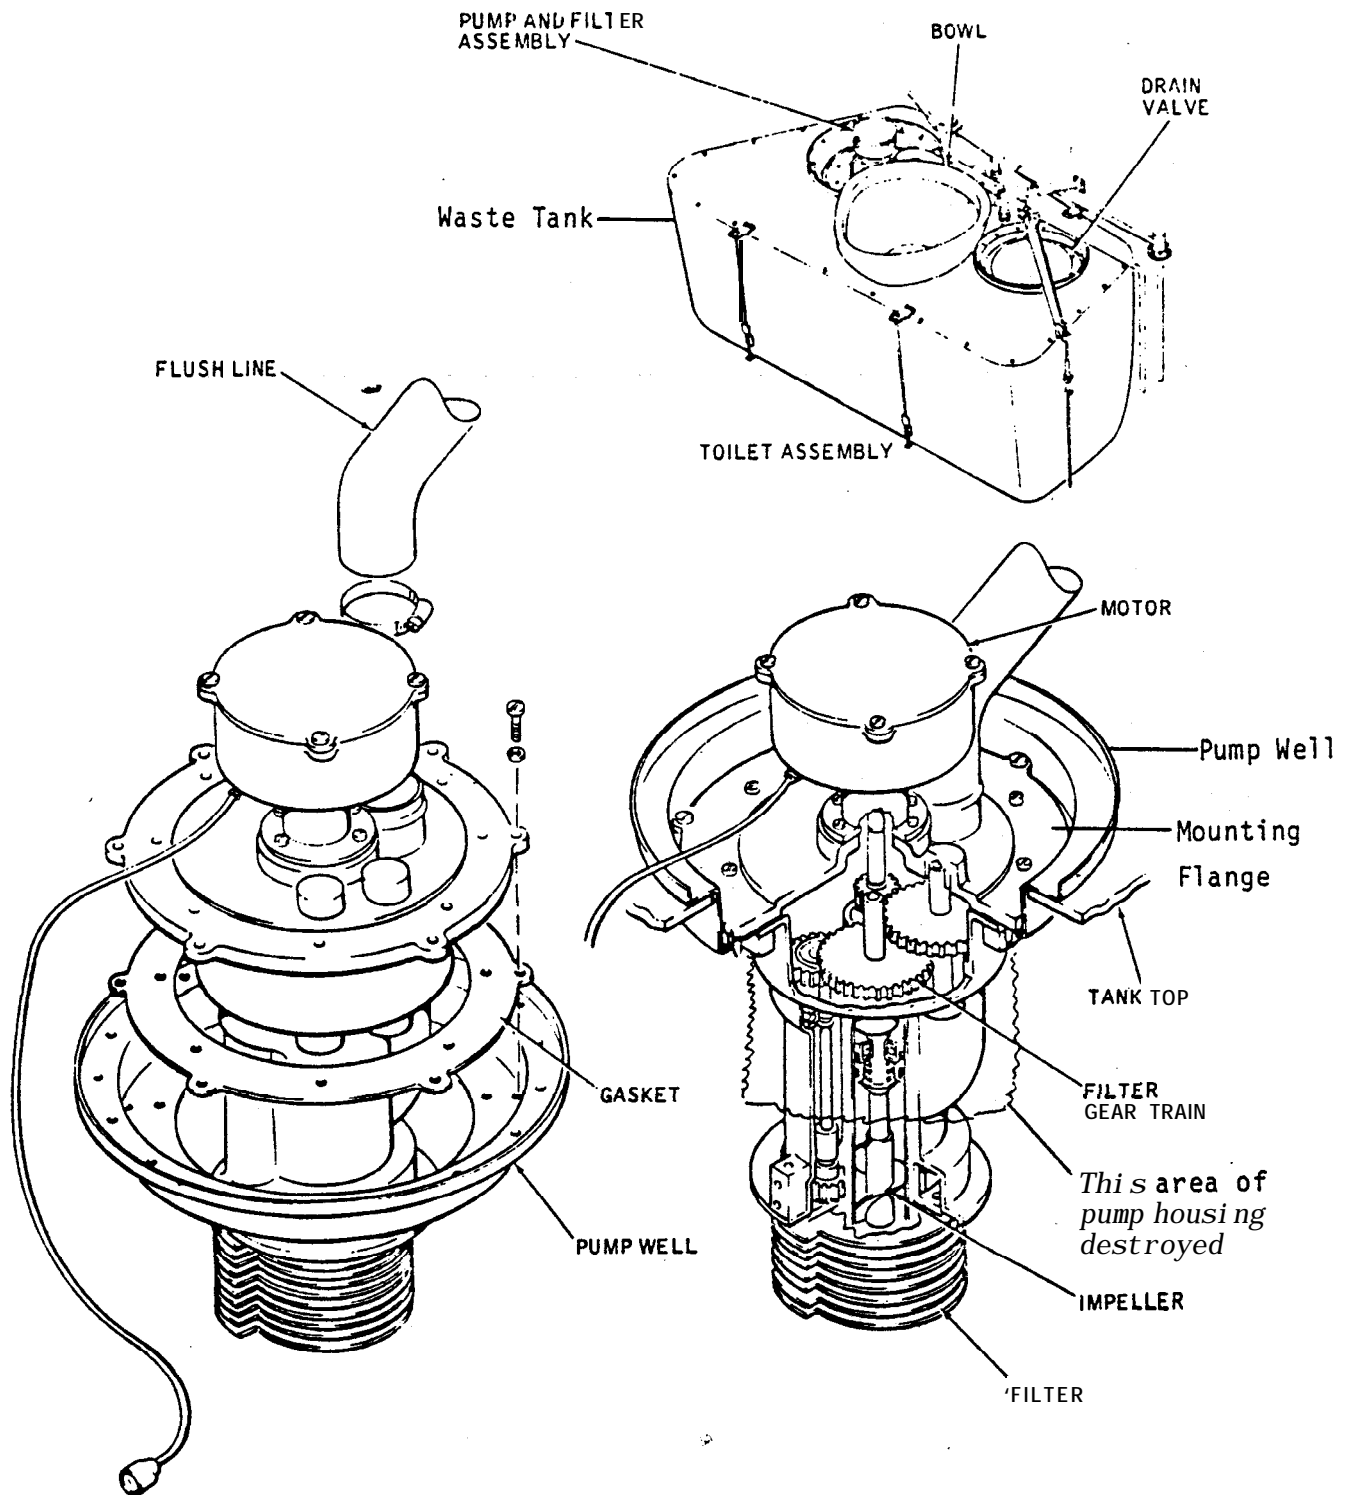
Figure 11.—Lavatory pump and filter system.

The flush motor was found attached to its mounting flange which was attached to the pump well. The flush motor assembly was found in approximately its normal position in the waste tank next to, but detached from, the flush pump and filter assembly. The motor housing was completely melted. Large concentrations of molten metal were found on the forward side of the mounting flange facing the toilet bowl, and on the aft side where the 3-phase electrical leads enter the motor housing. A portion of the wiring harness which supplies a.c. power to the flush timer, flush motor, and flush button was encased in the molten metal on the aft side of the motor. The rotor section of the flush motor was encased in molten metal above the field windings; however, the rotor did not appear to have been damaged extensively by heat. (See figure 11.)

The flush pump and filter assembly found in the waste tank was partially intact. The filter and pump mechanisms, which apparently had been located below the water line in the waste tank, were in good condition. Above the water line, the plastic housing for the pump and filter was melted away. This housing also encloses the filter gear train and is part of the assembly used to mount the pump and filter to the pump well. The exposed shaft and gears showed heat damage. The gears, which make up the filter gear train that connects the motor to the pump and filter, were found lying in the waste tank. The plastic mounting ring, which mates the pump and filter housing to the pump well, was found intact among the debris in the waste tank. There was some slight melting of the top surface of the mounting ring. All of the components of the flush motor and pump assembly were removed for further examination.
