Runway overrun Onur Air

Runway overrun after rejected take-off of the Onur Air MD-88, registration TC-ONP, at Groningen Airport Eelde on 17 June 2003

The Hague, 6 April 2006 (investigation number 2003071)

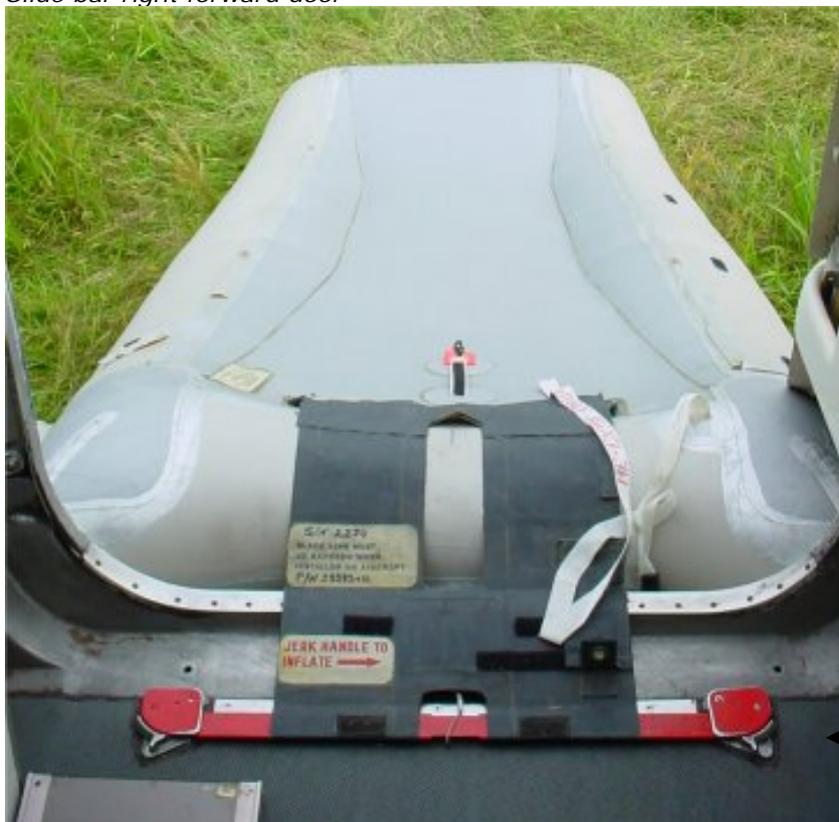
Slide bar left forward door

The left forward aircraft door was used during the evacuation. This door was fitted with an escape slide. The purser stated that she opened the door and activated the slide by pulling the inflation cord. The right forward aircraft door was not used during the evacuation. When a cabin crew member opened this door the slide fell out off its container and the package dropped on the ground next to the aircraft.

During the investigation it was noted that two different systems that hold the slide bar were used for the left and right forward aircraft doors. (See pictures below)

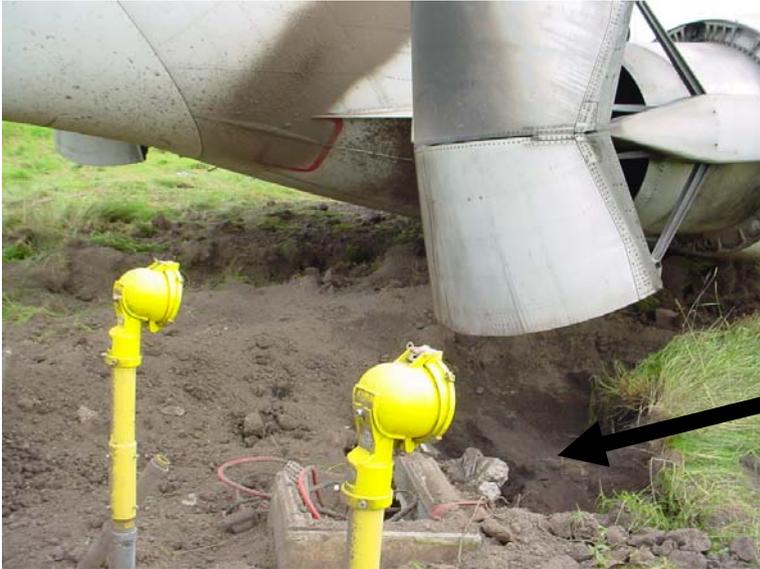
Investigation revealed that at the Groningen airport, in the area after the end of the runway, the so-called 'overrun area', there are underground concrete structures (transformation wells) in soft soil. The Dutch Safety Board holds the view that such a combination (underground structures and soft soil) entails a great fire hazard for the occupants in the event of a collision (the aircraft fuel, the risk of ignition of sparks and the engines which are hot). As Onur Air's MD-88 is a type of aircraft of which the engines are not located under the wing, but are mounted on the rear side of the fuselage, reducing the risk of contact with the ground.

At the day of the accident the soil in the overrun area was not strong enough to support the aircraft. During the overrun the main landing gear sank in the soft soil and damaged several of the approach light system embedded concrete structures and their contents. The centre and wing fuel tanks and engines did not encounter the concrete construction.

- It is recommended to the Minister of Transport, Public Works and Water Management to investigate to which extent the requirements concerning the underground infrastructure in the direct vicinity of start and landing runways has to be stepped up to prevent serious damage to aircraft that overrun the runway.

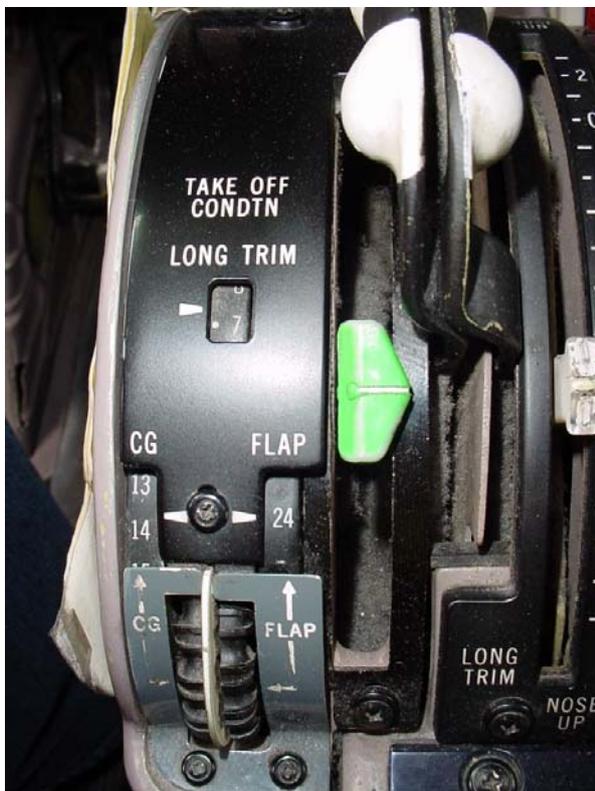
Figure 2: pedestal take-off condition computer.

The captain stated and the CVR recording confirmed that during the take-off a stabilizer warning sounded. After the accident DTSB investigators found the TO-CG input on the take-off condition computer set at approximately 13.5 % MAC (and flap input 24 degrees), which positioned the green band opposite to the stabilizer trim position indicator.

Functional checks were carried out in order to verify proper functioning of the stabilizer warning system. Stabilizer configuration warning tests in accordance with the Aircraft Maintenance Manual (AMM) showed no anomalies in the system. Additional tests were performed to verify what TO-CG (thumbwheel) inputs on the take-off condition computer would generate a stabilizer warning. It was found that 13.5 % MAC input could not produce a warning. When 11.1 % MAC was inserted the stabilizer warning sounded.
