## Challenger With Frost on Wings Enters Uncontrolled Roll on Takeoff

*The report said that the judgment and concentration of the flight crew, who were aware of the wing contamination but did not have the aircraft deiced before departure, might have been impaired by the combined effects of a nonprescription drug, jet lag and fatigue.*

[FSF editorial note: This article, except where specifically noted, is based on U.K. Air Accidents Investigation Branch Aircraft Accident Report No. 5/2004 (EW/C2002/1/2). The 74-page report contains illustrations and appendixes.]

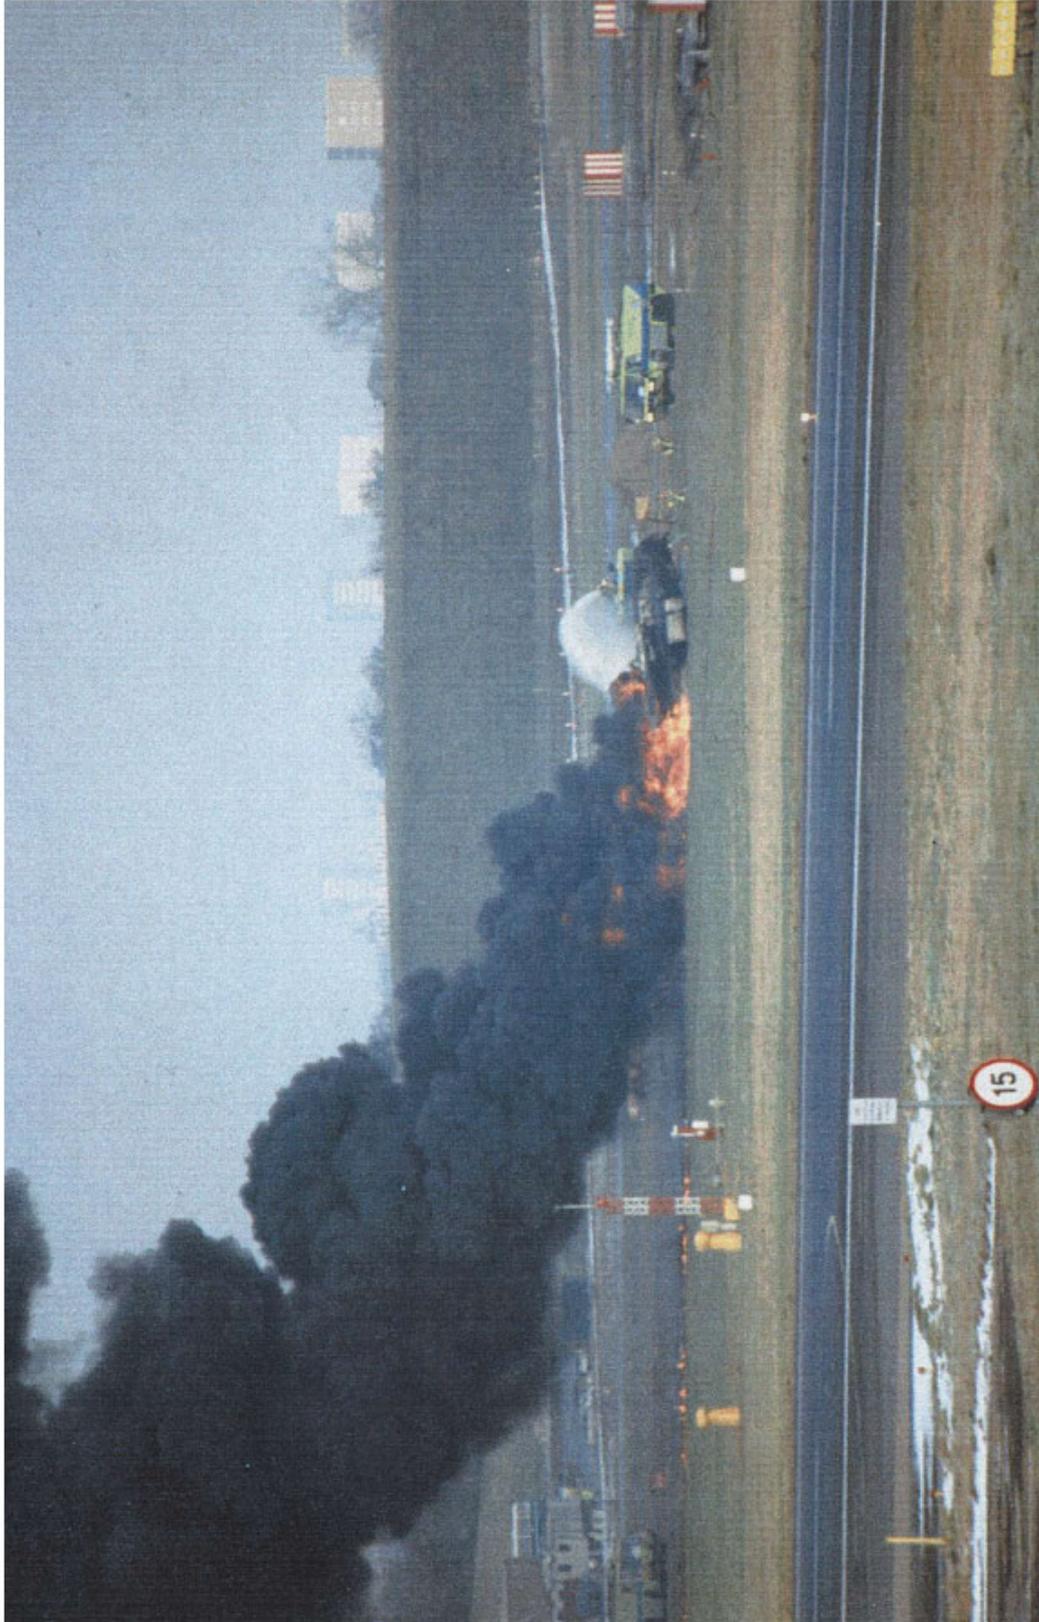
**Figure 2**

The aircraft was largely destroyed by impact and fire damage (Figure 2).

**N90AG Accident Site**
