Reduced Visibility, Mountainous Terrain Cited in Gulfstream III CFIT at Aspen

Darkness increased and weather conditions deteriorated as the pilots continued a nonprecision instrument approach below minimums without adequate visual references at the Aspen (Colorado, U.S.) airport. A delayed departure, a nighttime landing curfew and pressure from the charter customer to land were factors cited in the controlled-flight-into-terrain (CFIT) accident.

—
FSF Editorial Staff

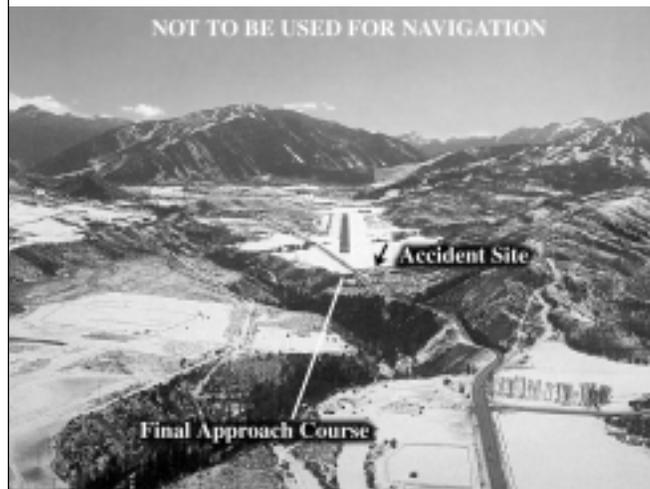
Figure 1

The Aspen airport, also known as Sardy Field, is at an elevation of 7,815 feet and is surrounded by higher terrain (see Figure 1). The VOR/DME-C approach procedure includes only circling approach minimums; straight-in approach minimums are not included because a straight-in approach would require a descent gradient of 700 feet per nautical mile between the final approach fix (FAF) and the runway threshold crossing height (see Figure 2, page 4). Among FAA's requirements for straight-in approach procedures is a maximum descent gradient of 400 feet per nautical mile between the FAF and the threshold crossing height.

Airborne View of Final Approach to Runway 15, Aspen–Pitkin County (Colorado, U.S.) Airport, March 29, 2001

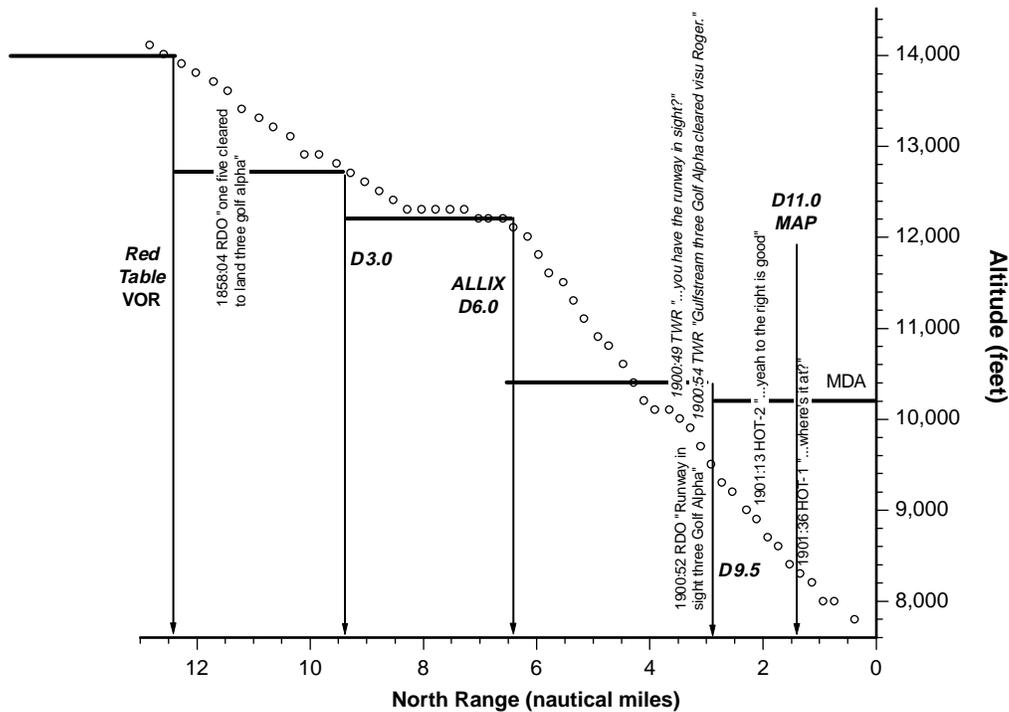
Gulfstream III Flight Path, Aspen–Pitkin County (Colorado, U.S.) Airport, March 29, 2001

The report said that the cloud tops were at about 16,000 feet and that “after descending through this altitude, the airplane was in and out of the clouds.”

The controller told investigators that she had observed the aircraft descend below 10,400 feet before reaching the 9.5-DME step-down fix.
