Improvised GPS Approach Procedure And Low Visibility Set Stage for CFIT

—
FSF Editorial Staff

[FSF editorial note: This article, except where specifically noted, is based on Australian Transport Safety Bureau *Aircraft Accident Report: Controlled Flight Into Terrain; Ilyushin IL-76TD, RDPL-34141; Baucau, Timor-Leste; 31 January, 2003*. The 144-page report contains illustrations and appendixes.]

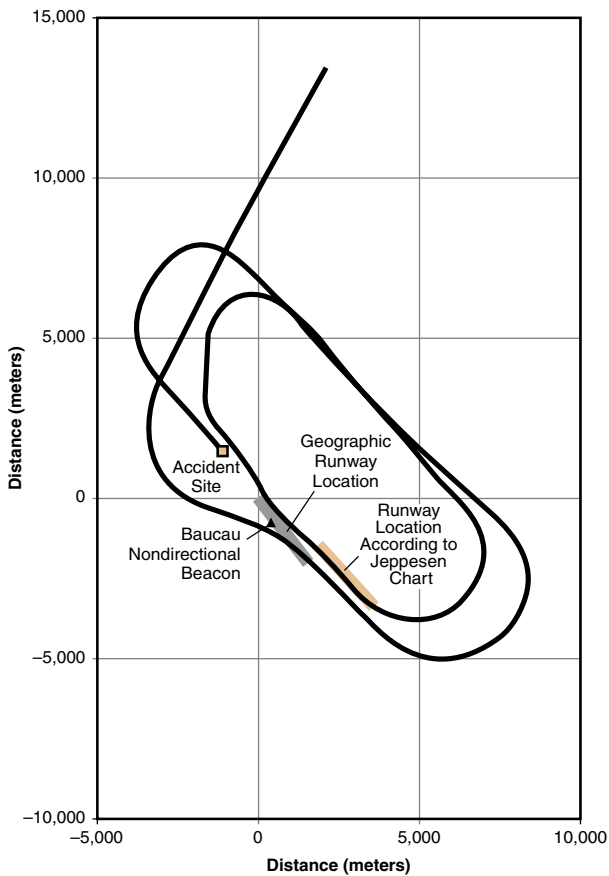
Figure 1

The airplane was on a southwesterly heading as it neared the airport (Figure 1, page 4). The navigator recommended that the captain conduct an overflight of the airport before conducting an approach. The captain agreed and said that he would conduct the overflight on a heading of 135 degrees (the magnetic heading for Runway 14 published on the Jeppesen airport chart). The 135-degree heading did not coincide with the published NDB Runway 14 final approach course, which was 146 degrees. The captain did not brief the other flight crewmembers on how low he would fly the airplane during the overflight or during the approach.

The waypoint coordinates were derived from information published on the Jeppesen airport chart and NDB Runway 14 approach chart. The report said that the charts inaccurately depicted the NDB as being located northwest of Runway 14; the NDB actually was located off the right side of Runway 14. As a

Flight Path of Ilyushin IL-76; Baucau, Timor-Leste; Jan. 31, 2003

result, the waypoint entered into the GPS navigation equipment was about 2.5 kilometers (1.4 nautical miles) southeast of the runway threshold.
