Sabreliner Strikes Mountain Ridge During Night Visual Approach

—
FSF Editorial Staff

Accident Prevention

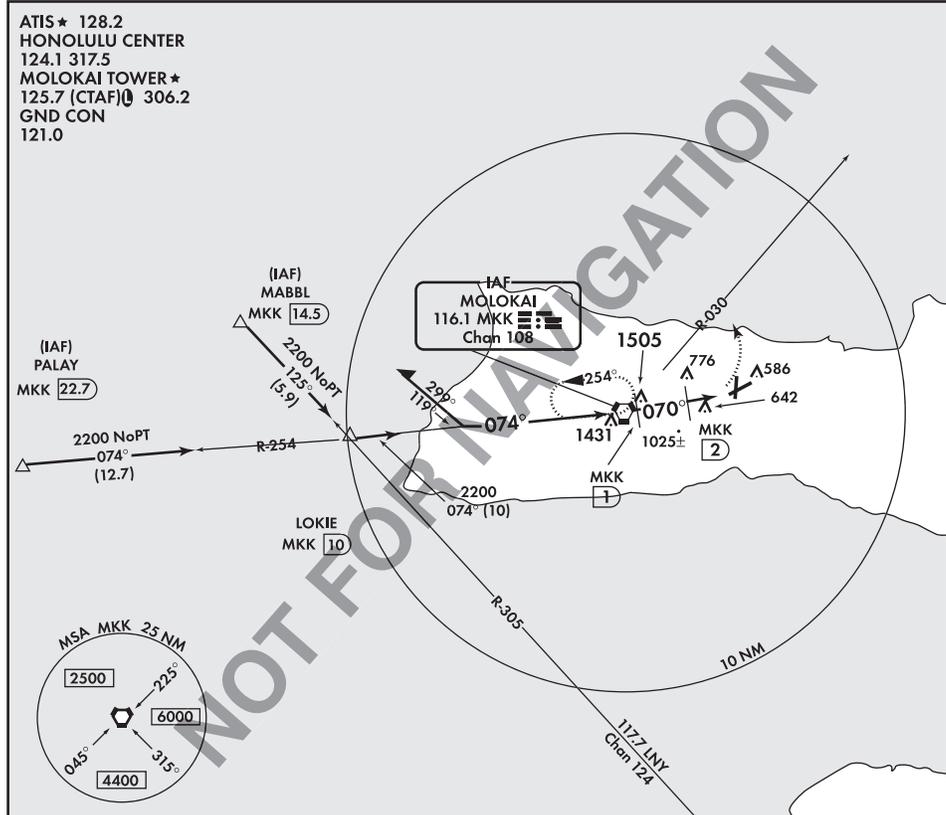
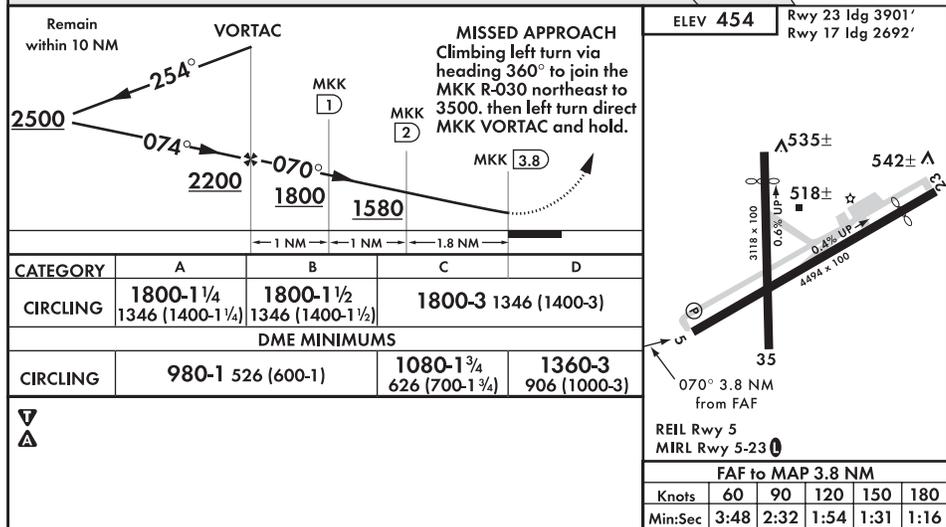
Figure 1

[The copilot referred to a requirement of the VOR/GPS (global positioning system) approach procedure that, after passing over the VOR from the northeast, an aircraft should be flown on an outbound course of 254 degrees for one minute before beginning the procedure turn, which comprises a right turn to a heading of 299 degrees, followed after a specific time by a left turn to a heading of 119 degrees; the minimum altitude for this segment is 2,500 feet (Figure 1, page 4). After intercepting the 074-degree inbound course to the VOR, the aircraft can be flown to 2,200 feet. After passing over the VOR inbound, a descent to 1,800 feet should be conducted after establishing the aircraft on the inbound course, 070 degrees. After passing the first step-down fix, which is 1.0 nautical mile (1.8 kilometers) from the VOR, a descent to 1,580 feet should be conducted. After passing the second step-down fix, which is 2.0 nautical miles (3.7 kilometers) from the VOR, a descent should be conducted to 1,080 feet, the published minimum descent altitude (MDA) for the Sabreliner, which was equipped with distance-measuring equipment (DME) and is a Category C aircraft. The missed approach point is 3.8 nautical miles from the VOR. The VOR/GPS approach is designated "Alpha" because landing requires a circling maneuver either to Runway 5-23, which is 4,494 feet (1,371 meters) long, or to Runway 17-35, which is 3,118 feet (951 meters) long.]

VOR-A Approach Procedure, Molokai (Hawaii, U.S.) Airport, May 10, 2000

At 2029, the copilot said, "Missed approach is climbing left turn via three-sixty heading."
