**Aviation Safety Council  
Taipei, Taiwan**

# **GE 791 Occurrence Investigation Report**

**IN-FLIGHT ICING ENCOUNTER AND CRASH INTO THE SEA  
TRANSASIA AIRWAYS FLIGHT 791  
ATR72-200, B-22708  
17 KILOMETERS SOUTHWEST OF MAKUNG CITY,  
PENGHU ISLANDS, TAIWAN  
DECEMBER 21, 2002**

**ASC-AOR-05-04-001**

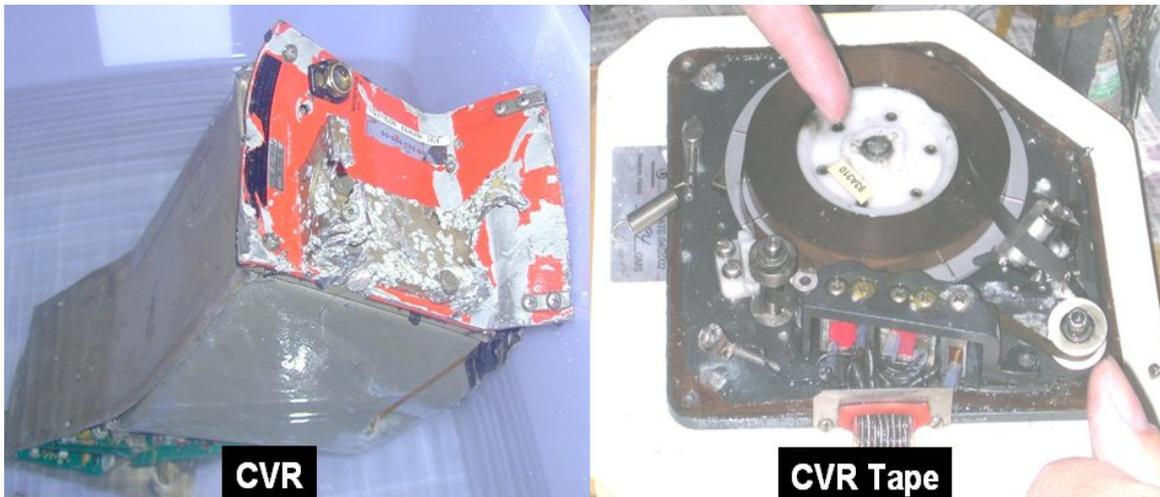
Figure 1.11-1 CVR physical damage and the CVR tape

The exterior of the CVR unit was seriously damaged when it was found. The protective dust cover was separated from the unit. The front panel, without the underwater locator beacon (ULB) and nameplate, was seriously distorted but still attached to the chassis. It arrived ASC lab in a container filled with fresh water. There were several dents and scratches on the interior crash enclosure. The recording assembly appeared to be in good condition except several damages on the plastic reel. The magnetic tape was wet and remained in its original positions without damage. Discoloration and dirt were found on the tape.(refer to figure 1.11-1)

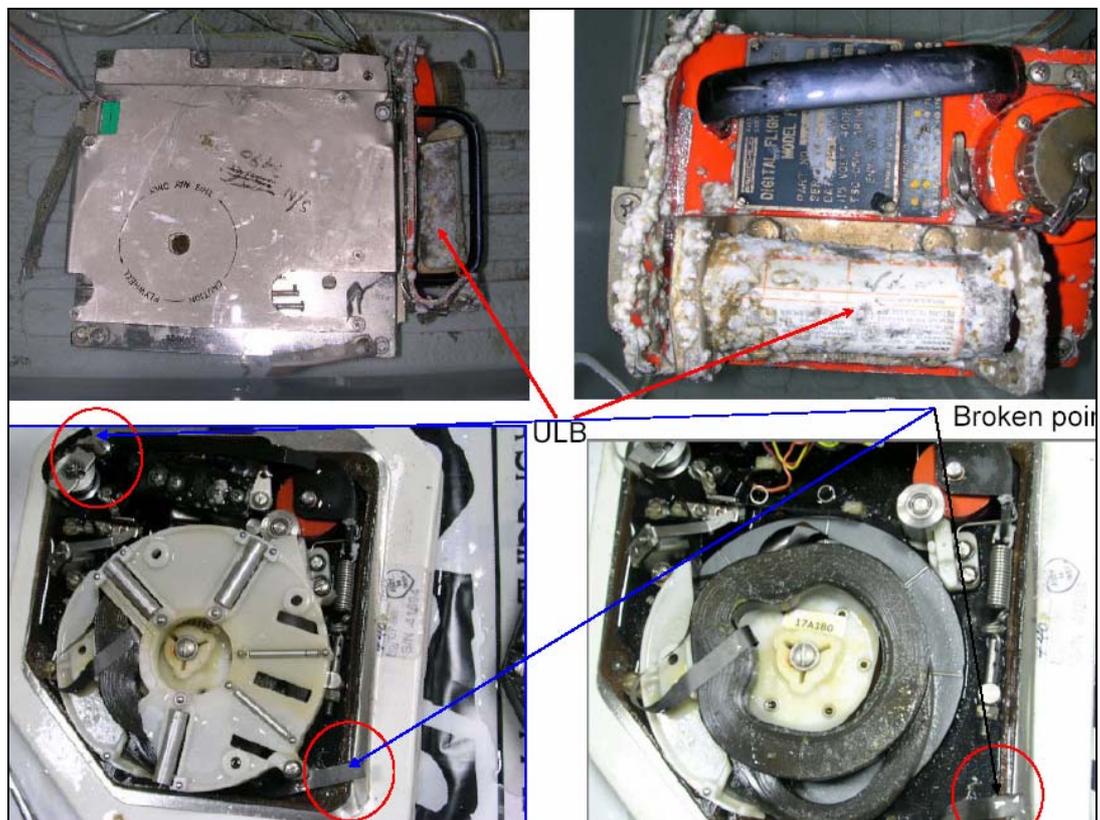
Figure 1.11-2 FDR physical damage and FDR tape

The damaged Loral model F800 FDR, part number 17M800-261, serial number 3490, was brought to the lab in a container filled with water. The protective dust cover and circuit board assemblies were lost while the front panel with the ULB and nameplate was still attached to the unit. The magnetic tape was stained and wet with the inside half squeezed out of the reel. There was a cutting break on the tape between the corner guide roller and the write heads. After it was cleaned and re-reeled, a detail examination showed some discoloration and wrinkle on it, especially the portions exposed to the outside or contacting with the mechanism. Several serious wrinkles were found near the cutting end. (refer to figure 1.11-2)

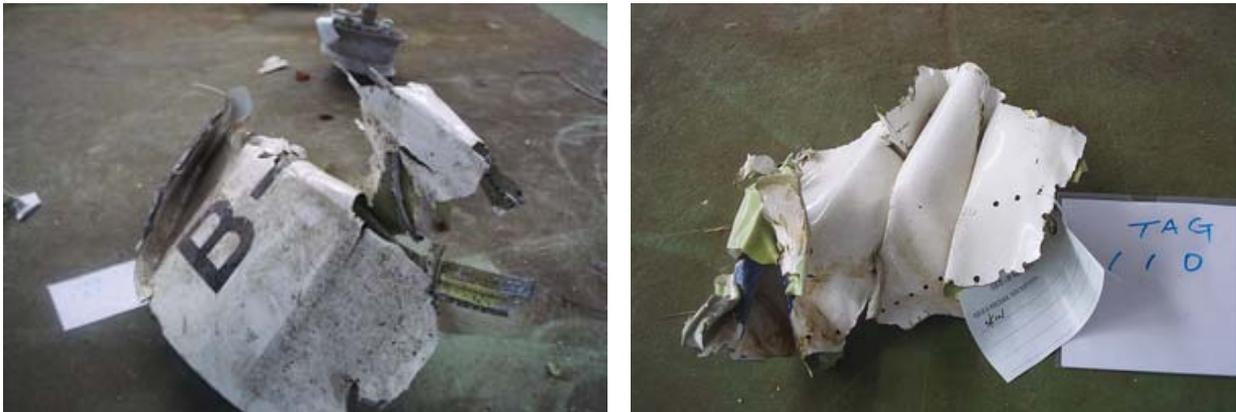
Figure 1.12-1 Fuselage skin

- Fuselage skin: They were seriously wrinkled. The fracture edges were irregular. The painting surface has no any fire phenomenon. The fracture surfaces have no fatigue and corrosion phenomenon(refer to figure1.12-1).

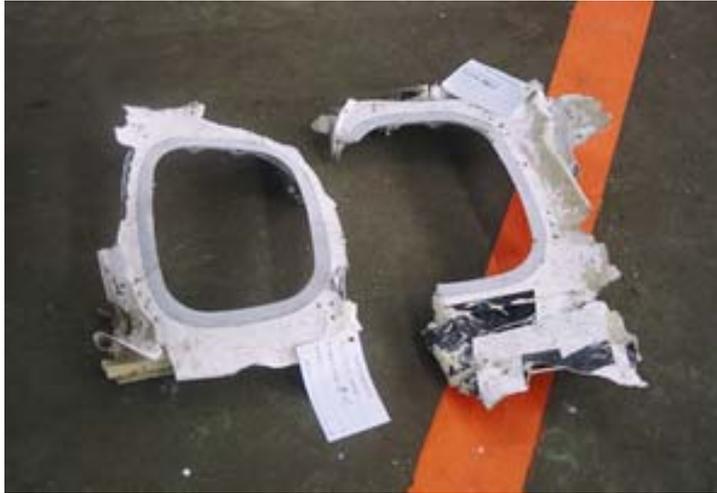
Figure 1.12-2 Window frame

- Window frame were separated from skin. The fracture surface was particular to longitudinal (refer to Figure 1.12-2).

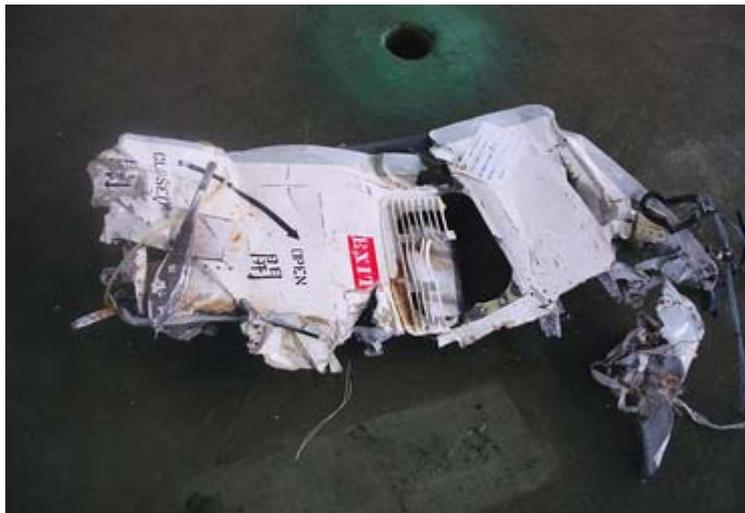
Figure 1.12-3 Right after door

- Right after door : The door handle was at close position. The front was seriously compressed and perpendicular to longitudinal ( refer to figure1.12-3 ) .

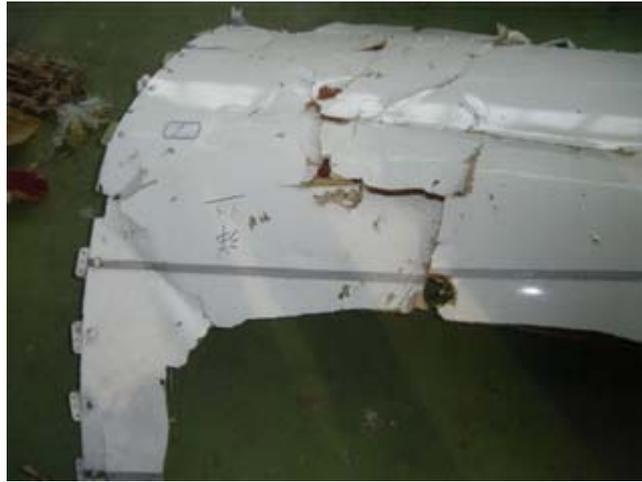
Figure 1.12-4 Tail cone

- Tail cone was seriously broken. The fracture edge was irregular. The lines of front wrinkle were perpendicular to longitudinal (refer to figure1.12-4).

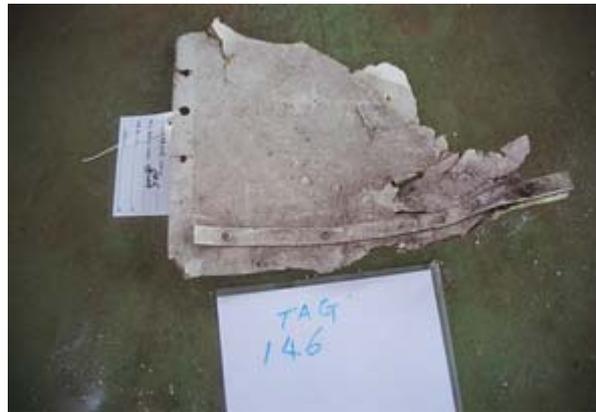
Figure 1.12-5 Cargo compartment partition

Cabin partition was seriously broken. Metal bar was bent and perpendicular to the longitudinal axis. (Figure 1.12-5) ◦

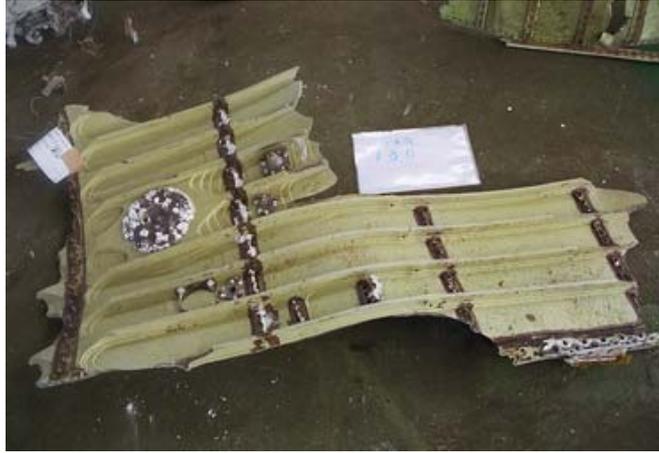
Figure 1.12-6 Wing root skin (bottom of fuel tank)

- Front spar: It's seriously broken and bended. The fracture edge was irregular. Wing root were bent downward and perpendicular to the longitudinal axis. Wing tip bent downward and 45 degree perpendicular to the longitudinal axis. Trailing edge structure broken and bent afterward. (Figure 1.12-6~8) ◦

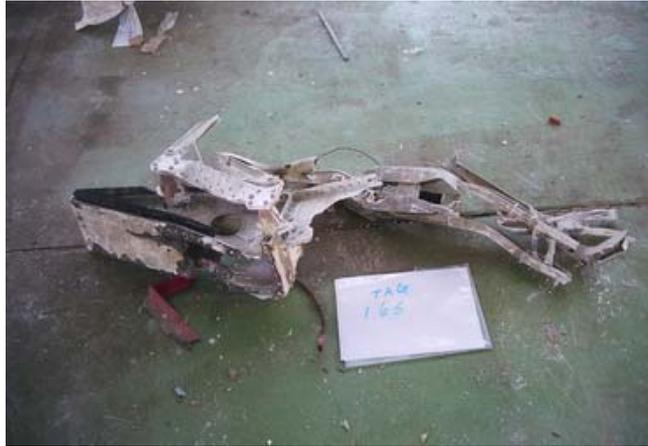
Figure 1.12-9 Flap driven mechanism

- Flap structure : Driven mechanism was broken. Honeycomb structure was seriously broken. The surface layer was separated from core structure. There was no impact marks found on surface. The leading edge was broken. The skin at front part was broken. The fracture surface was perpendicular to longitudinal (refer to figure 1.12-9~11).

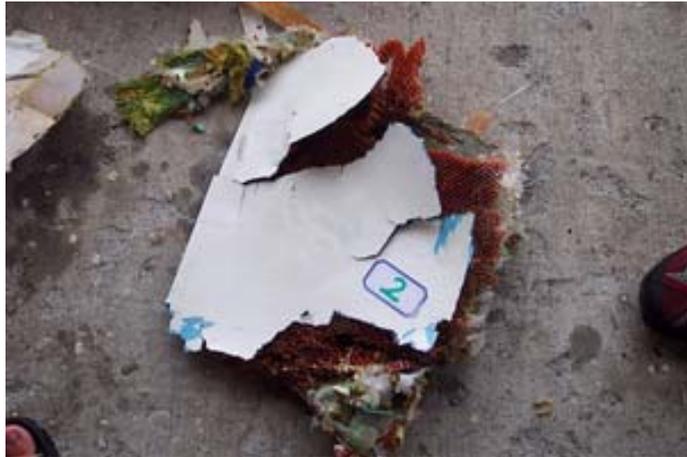
Figure 1.12-12 Vertical stabilizer honeycomb structure

- Tail structure : The honeycomb structure of vertical stabilizer , rudder and elevator was seriously broken and delaminated. Fracture surface was irregular. The paint was peel off. Some dents and scratch found on surface. Separated window frame protruded into the honeycomb structure of rudder (refer to figure 1.12-12~16)

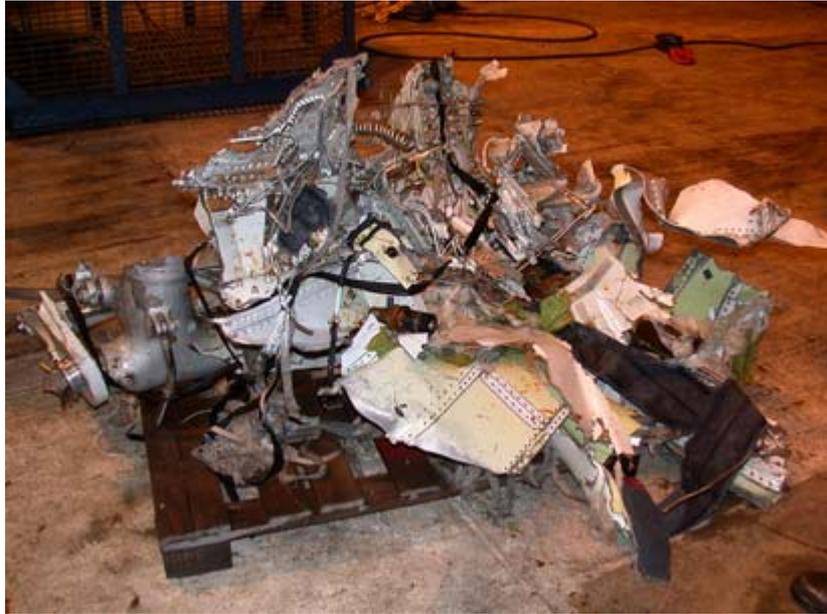
Figure 1.12-17 Landing gear structure and vicinity skin

3. Body landing gear: The damage around the body landing gear including supporting structure broken, vicinity skin wrinkled, landing gear strut bended, wheel separated and broken, and tire broken (figure 1.12-17~21).

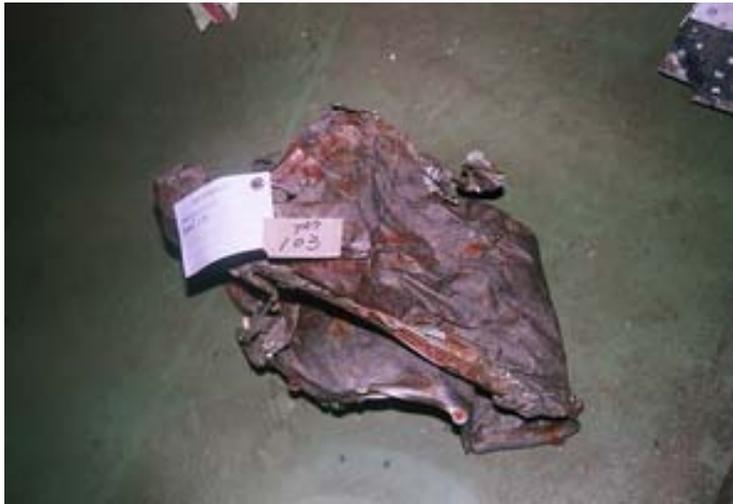
Figure 1.12-22 Exhaust pipe

- Power plant: The damage found on recovered power plant included exhaust pipe squeezed, tail cone separated but not broken, propellers broken, bended and separated (refer to figure 1.12-22~24)

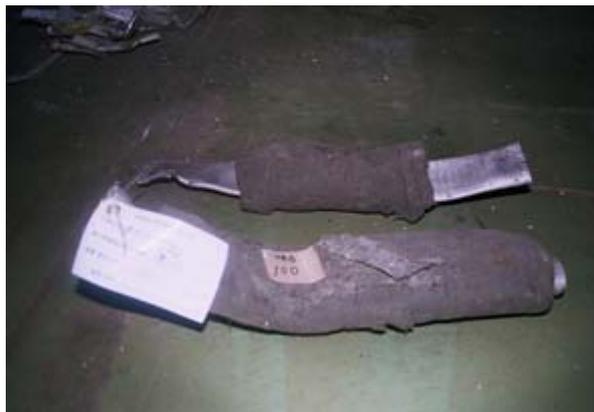
Figure 1.12-26 Pipes

- Pipes: The recovered pipes were small segments and flat (refer to figure 1.12-26).

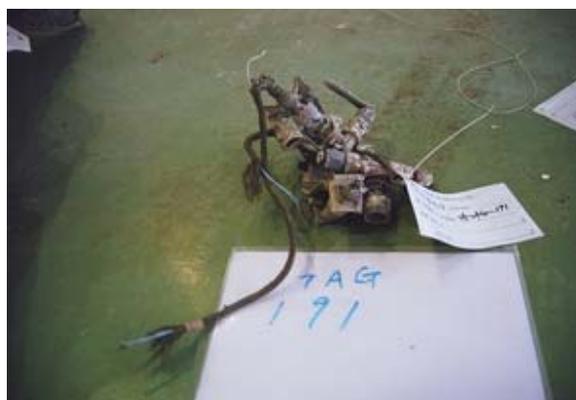
Figure 1.12-27 Wing de-icing regulator

- Wing de-icing regulator valve: The adjacent pipes were broken, but shape is still conserved (refer to figure 1.12-27).

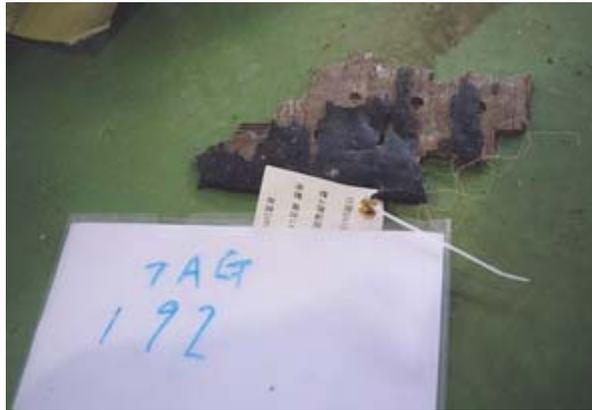
Figure 1.12-28 Wing de-icing boot

- Wing de-icing boot: It was broken into small pieces (refer to figure 1.12-28).

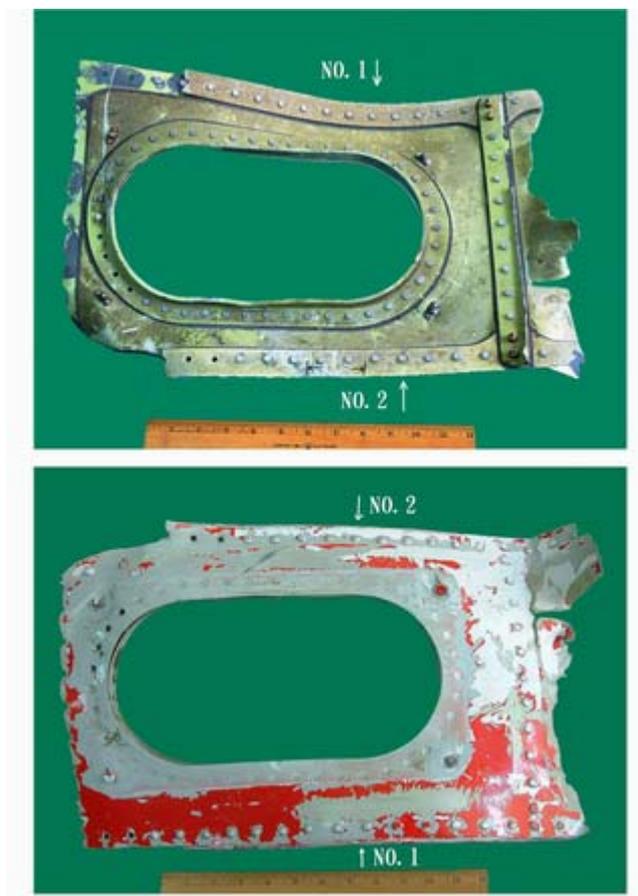
Figure 1.16-4 Wreckage with suspected fatigue crack

One window frame with fracture surface (refer to figure 1.16-4) was sent to CSIST for fatigue examination. (Refer to Appendix 14)

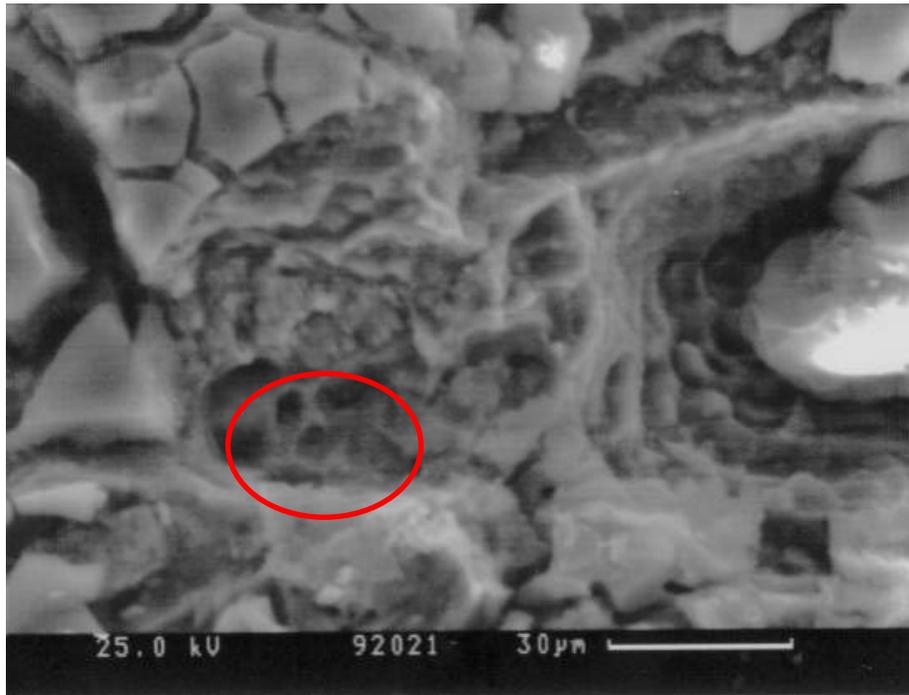
The surface of this sample was covered a layer of oxide which is adverse for SEM examination. This examination found dimple structure on fracture surface which due to overload damage (refer to figure 1.16-5).

Figure 1.16-5 SEM examination showing the dimple structure (790X) ◦

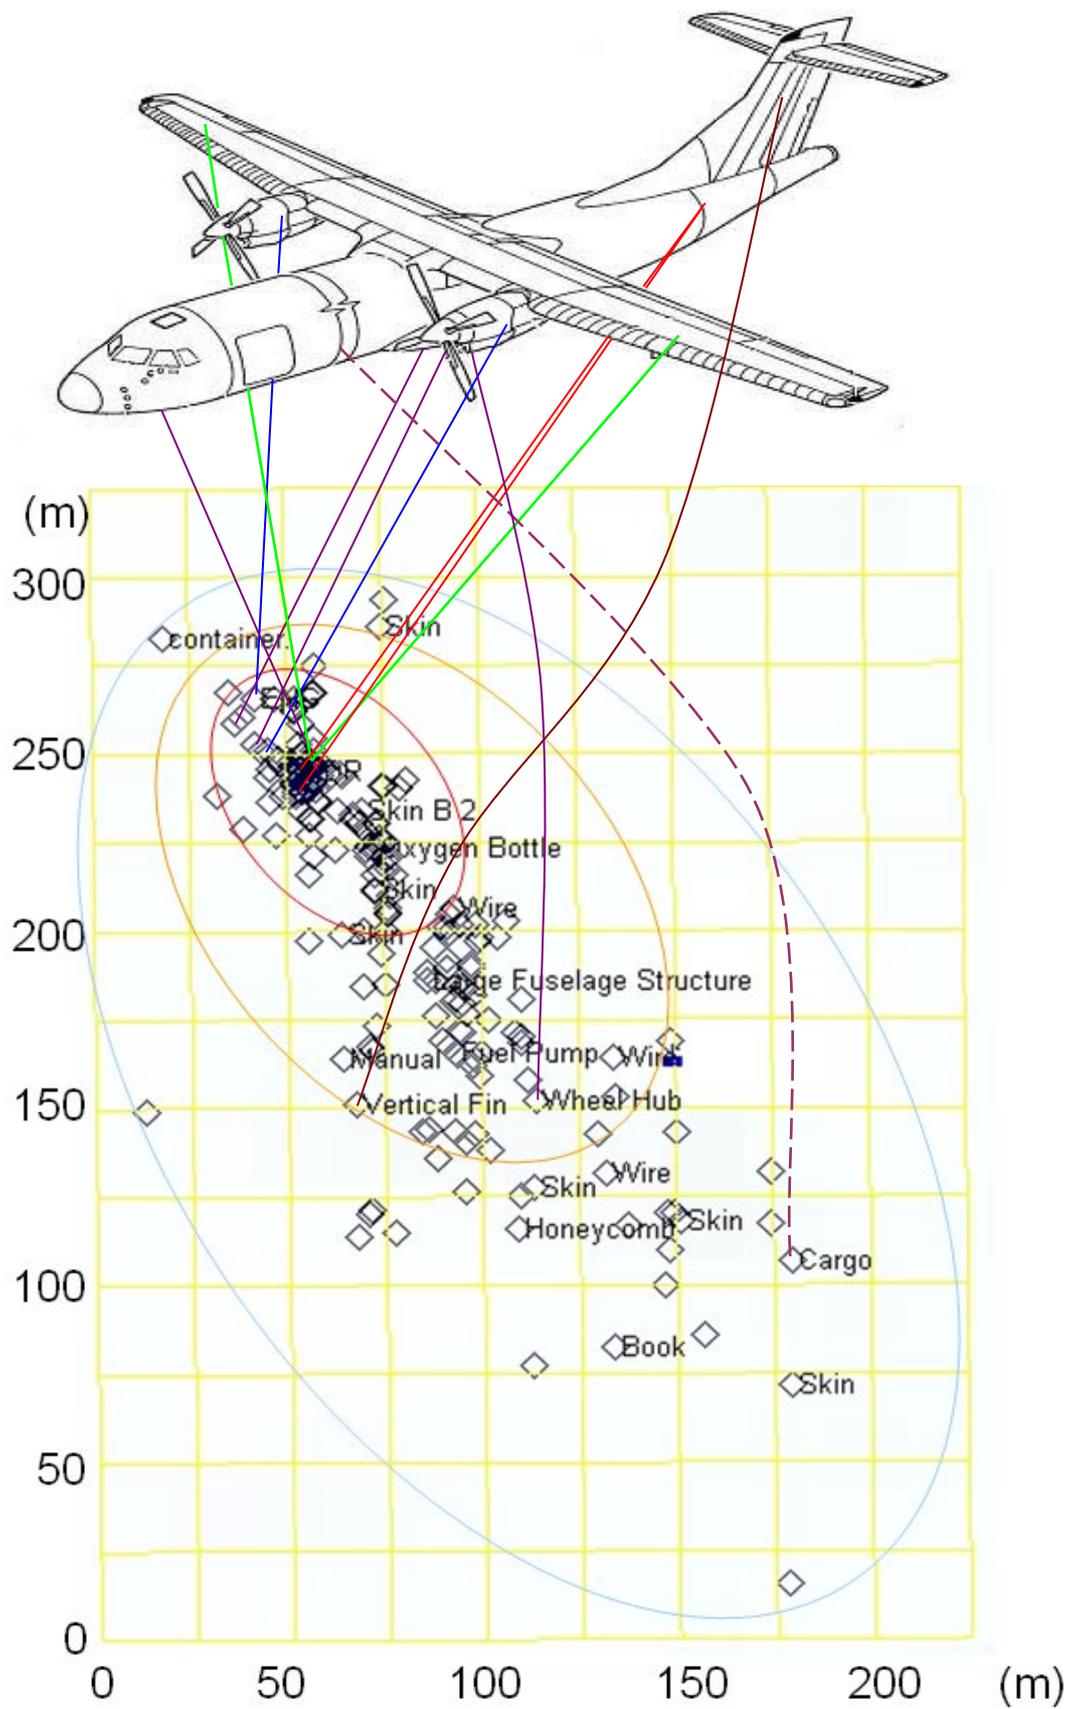
Figure 2.6-1 Wreckage scattering observed from ROV

Total 199 pieces of wreckage were examined. There were no evidence of slow growth damage, i.e., no structure fatigue damage was found. All the structure failure was cause by over load damage and occurred during water impact.

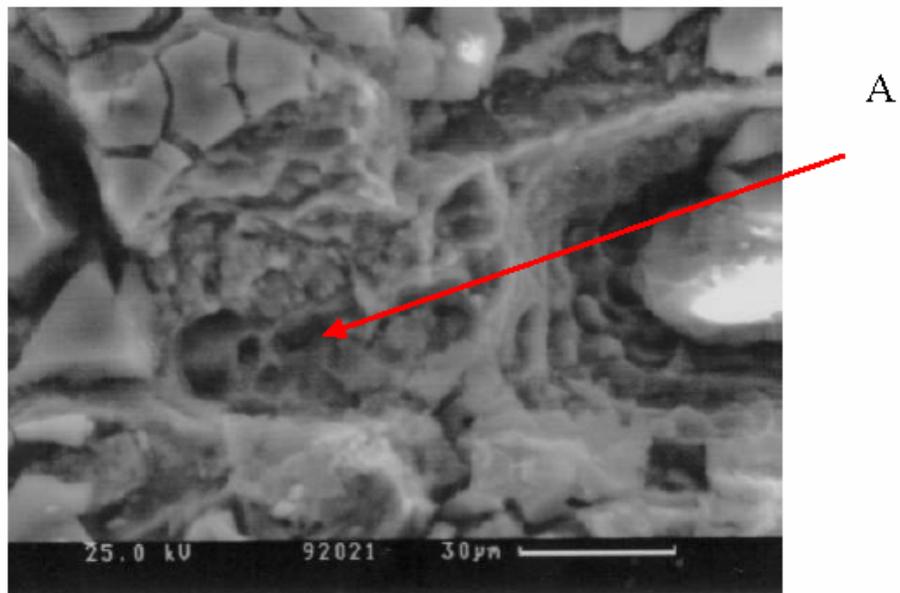
1. 客艙窗戶結構破損件的破壞模式為過負荷斷裂。

圖 15. 圖 14 上 A 點的 SEM 觀察，凹渦組織明顯可見。(790X)
