ATR 42 Strikes Mountain on Approach In Poor Visibility to Pristina, Kosovo

Deficiencies in the performance of the flight crew and the air traffic controller were among the causes cited by the report on the controlled-flight-into-terrain (CFIT) accident. Crew fatigue and an inoperative ground-proximity warning system were factors.

Accident Prevention

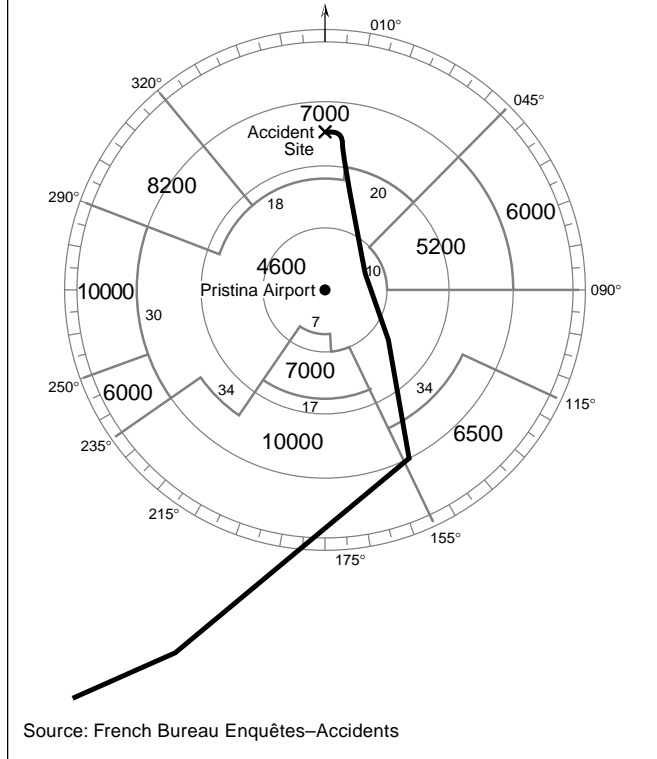
Aircraft Ground Track in Relation to Air Traffic Control Radar Vector Chart, ATR 42, Pristina, Kosovo, Nov. 12, 1999

Figure 1 shows the aircraft’s ground track in relation to the ATC radar vector chart.

About this time, the accident aircraft flew from an area where the minimum radar vectoring altitude was 4,600 feet to an area where the minimum radar vectoring altitude was 7,000 feet.

“Having changed [the accident aircraft’s] position to number two for the approach, [the controller] had to extend its track away to the north a little more than he had planned,” the report said. “This maneuver probably led to the loss [of the ATR’s radar signal] or clutter of the ATR’s radar signal because of poor detection in this mountainous region.

“This loss, along with the fact that the controller was probably focused on the track of the aircraft which was now number one, apparently caused him to forget Flight KSV 3275.”
