Commuter Aircraft Strikes Terrain During Unstabilized, Homemade Approach

The crew of a Raytheon Beech 1900D used self-programmed global positioning system (GPS) waypoints for navigation during a night approach to a Canadian airport with weather conditions below minimums for the published nonprecision instrument approach.

—
FSF Editorial Staff

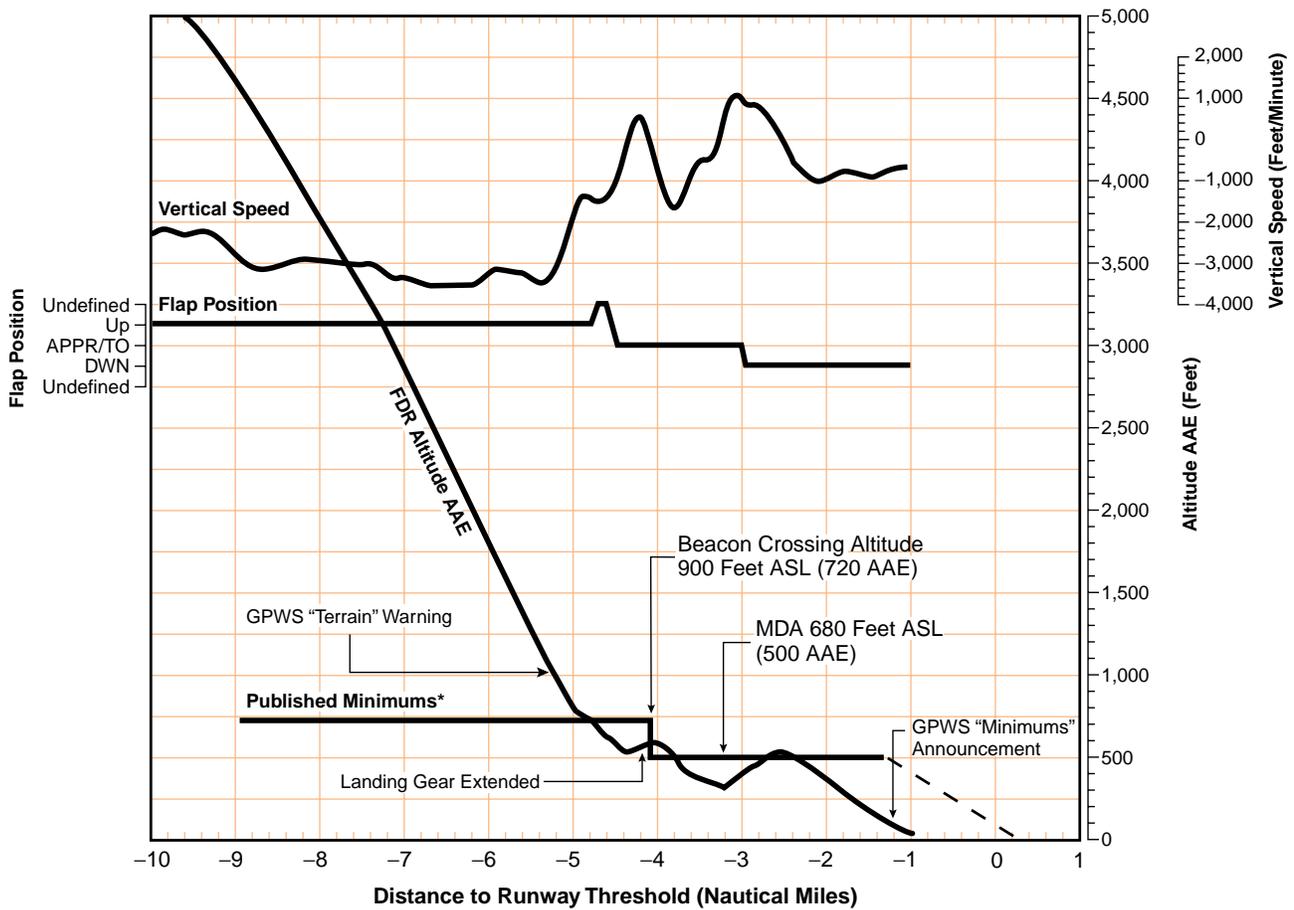
Figure 1

The crew began the descent from cruise altitude, 10,000 feet, when the aircraft was nine nautical miles (17 kilometers) from the NDB. The rate of descent exceeded 3,000 feet per minute (fpm) until the aircraft was about 1,200 feet above sea level (ASL; see Figure 1, page 4).

“For the last 30 seconds of flight and from approximately three [nautical miles] from the threshold, the aircraft descended steadily at approximately 850 fpm, at 140 [knots] to 150 knots indicated airspeed, with full flaps extended,” the report said. “The captain coached the first officer throughout the descent and called out altitudes and distances.”

Eight seconds before impact, the GPWS announced “minimums” at 100 feet AGL, the decision height selected on the radar altimeter. The captain told the first officer to continue flying a slow descent.

**Flight Data Recorder (FDR) Data; Raytheon Beech 1900D;
Sept-Îles, Quebec, Canada; Aug. 12, 1999**
