Landing Aircraft Collides During Rollout with Aircraft Taking Off on Intersecting Runway

—
FSF Editorial Staff

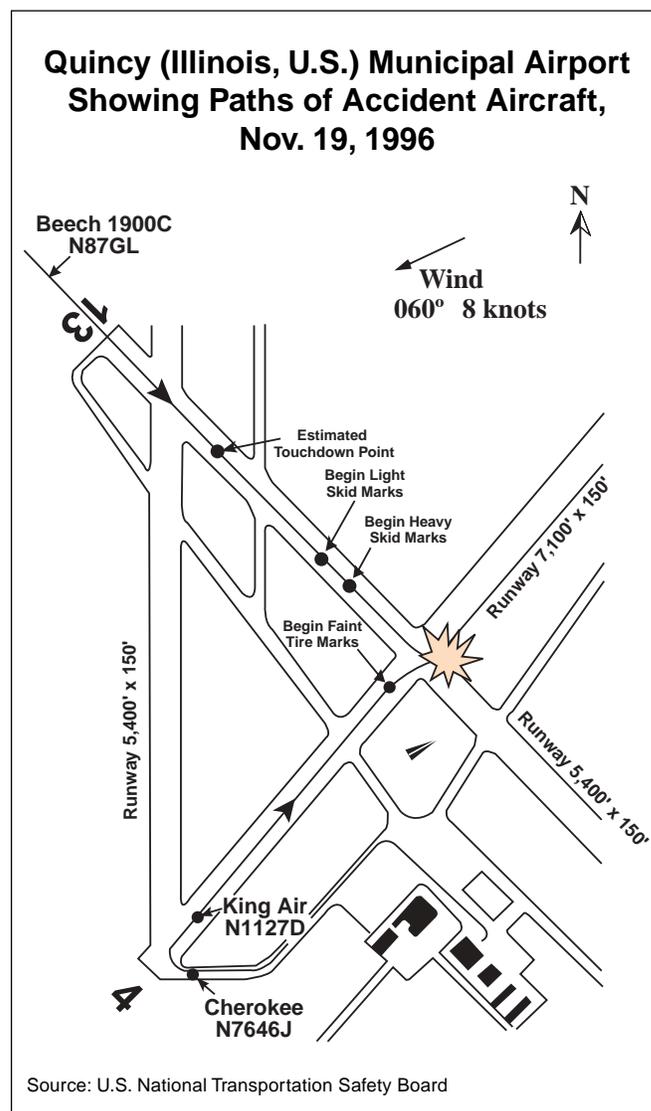
Figure 1

The report said, “At 1701, during Flight 5925’s landing rollout, the airplane collided with the King Air at the intersection of Runways 13 and 04 [Figure 1].”
