Improper Loading of Cargo Causes Loss of Aircraft Control on Approach

The Fokker F27 pitched nose-up when the flight crew extended full flaps on final approach. The crew did not regain control, and the aircraft stalled and struck the ground. The accident report said that the aircraft's center of gravity was "significantly aft" of the approved limit.

At 1706 local time Jan. 12, 1999, a Fokker F27-600 operated on a cargo flight by Channel Express struck the ground after the flight crew lost control of the aircraft on approach to Guernsey Airport, Channel Islands, United Kingdom. Both pilots were killed, and the aircraft was destroyed.

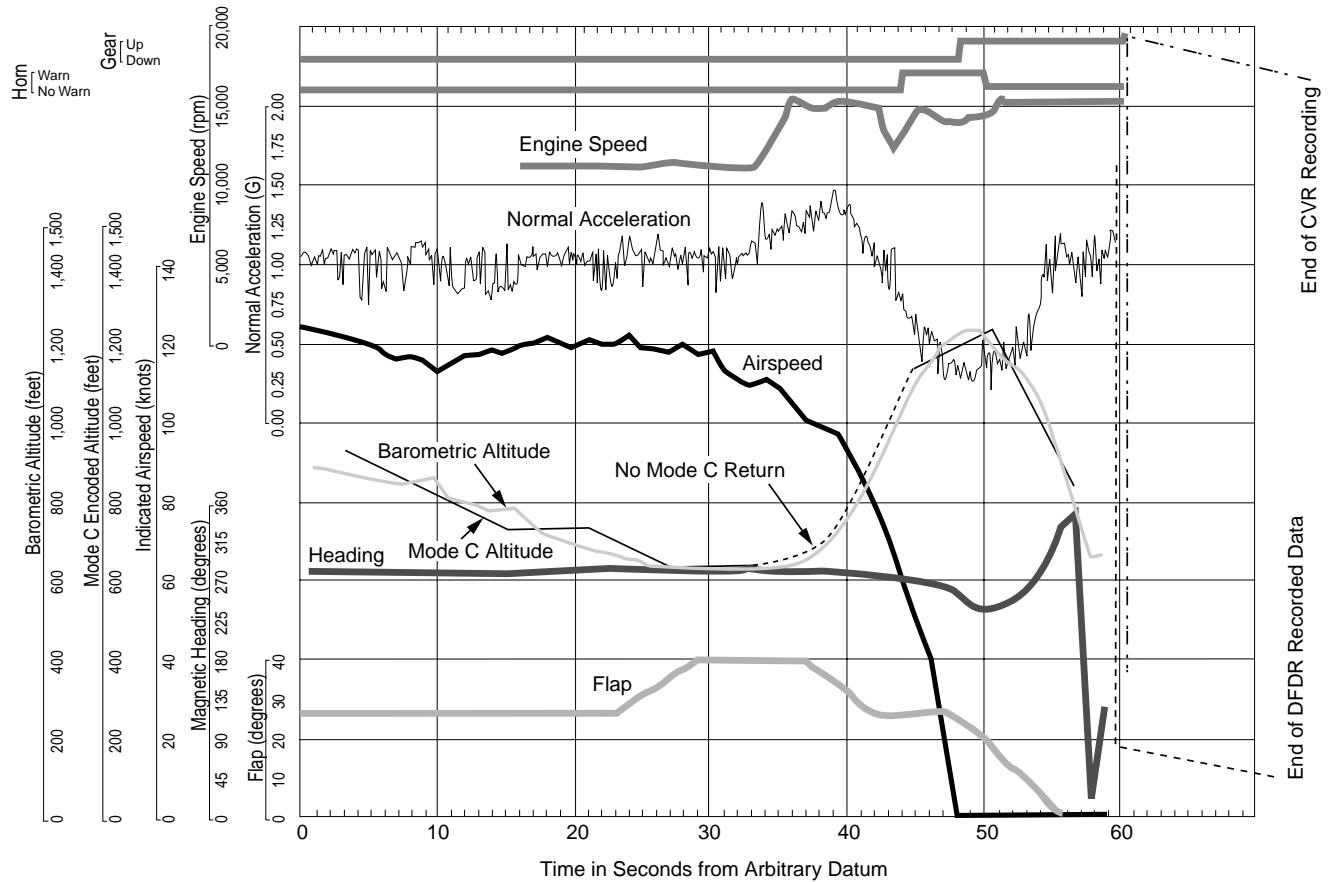
Figure 1 shows aircraft parameters correlated from the aircraft’s digital flight data recorder (DFDR) and cockpit voice recorder (CVR) for the last 60 seconds of the flight.

Correlated Flight Data Recorder Data and Cockpit Voice Recorder Data, Fokker F27-600, Near Guernsey Airport, Channel Islands, U.K., Jan. 12, 1999
