Descent Below Minimum Altitude Results in Tree Strike During Night, Nonprecision Approach

After descending below the published minimum descent altitude for the nondirectional beacon (NDB) approach, the commander began a missed approach as the aircraft struck trees. A three-foot section of the right wing was torn away; the crew diverted the aircraft to another airport, where they landed safely.

Accident Prevention

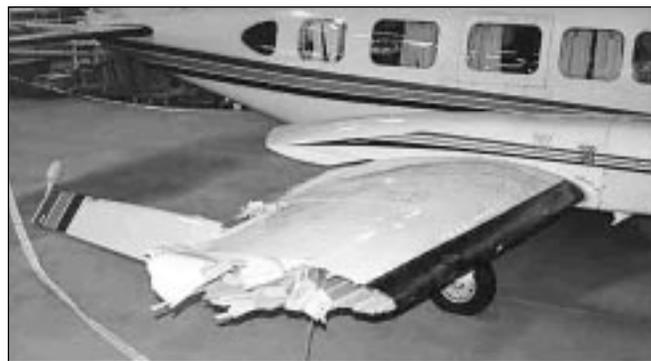
About one meter (three feet) of the Piper Chieftain's right wing separated during the tree strike. The aileron was torn from its hinges but remained attached to the wing by its actuating rod.
(Photo: Swedish Board of Accident Investigation)

“Pieces of the wing tip were recovered at the site, but the majority of the wing section that was torn off was found about ... 20 kilometers [11 nautical miles] south of the impact site,” the report said. “Signs of impact on spruce [trees] and pine trees, at a height of about 20 meters [66 feet] above the ground, were found at the accident site.”

About one meter (three feet) of the right wing separated from the airplane. The aileron separated from its hinges but remained attached to the wing by an actuating rod.

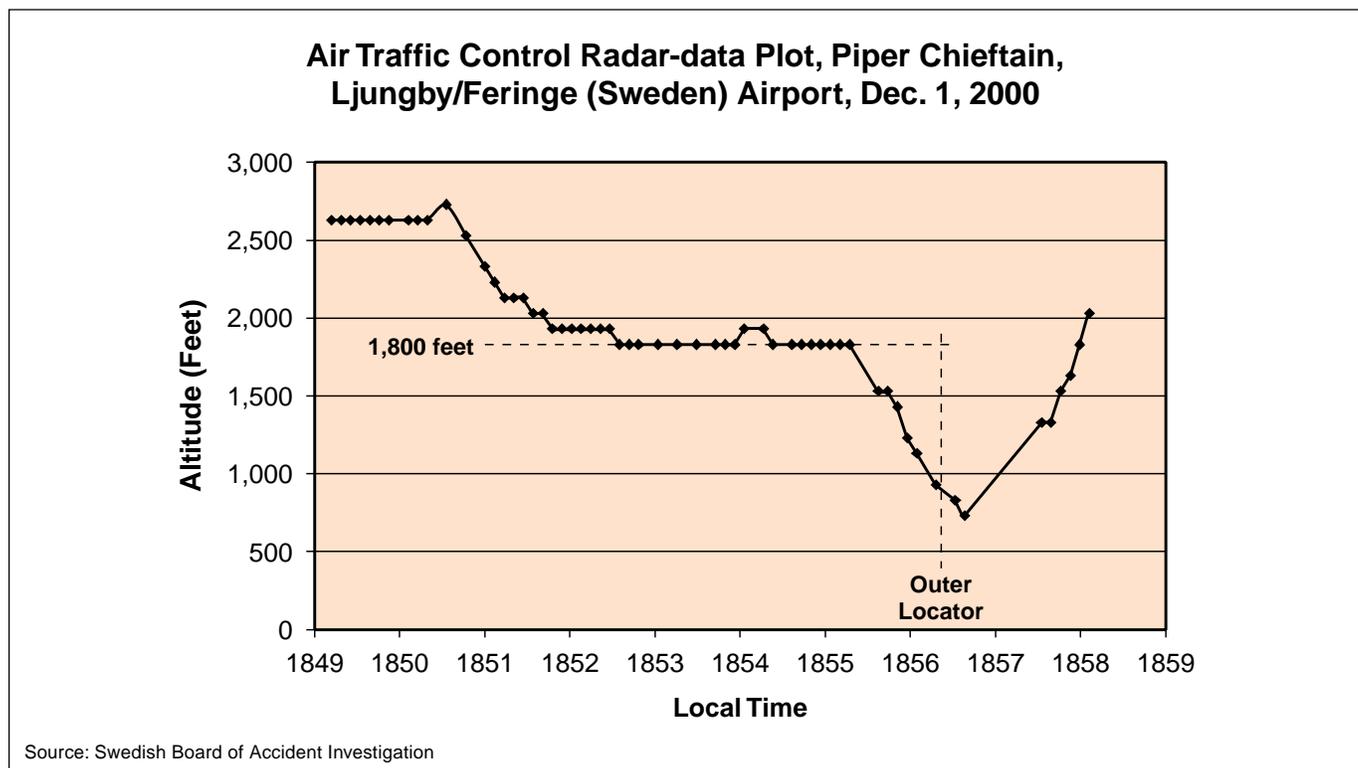
Figure 1

ATC radar data indicated that the airplane began to descend from 1,800 feet about 2.5 kilometers (1.4 nautical miles) from the outer locator (see Figure 1).
