Preventing HARD Nosegear Touchdowns

JEFF BLAND
MANAGER
DYNAMIC LOADS
BOEING COMMERCIAL AIRPLANES

DAVID CARBAUGH
CHIEF PILOT
FLIGHT OPERATIONS SAFETY
BOEING COMMERCIAL AIRPLANES

FLIGHT OPERATIONS

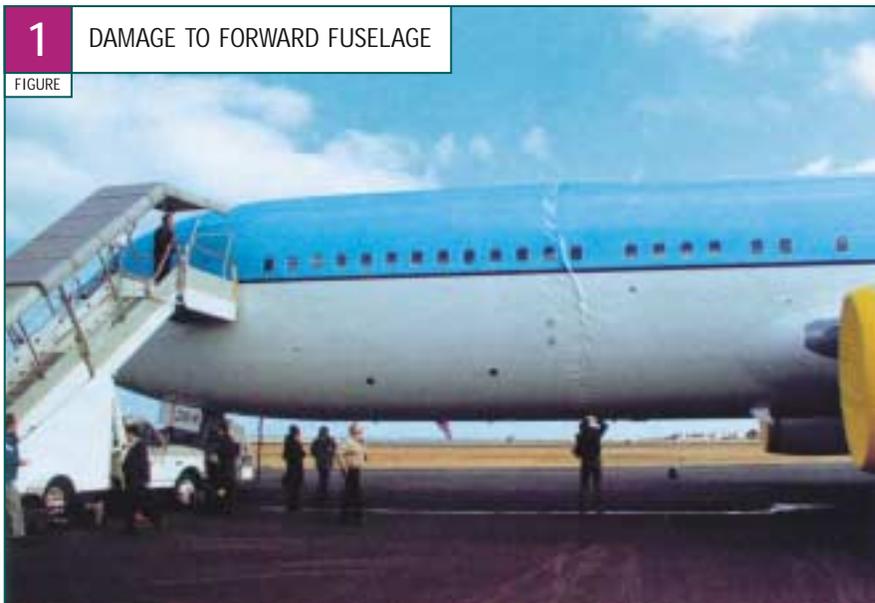
1 DAMAGE TO FORWARD FUSELAGE

An airplane was on approach to a relatively short runway in gusty conditions. The airplane experienced a normal main gear touchdown, but the full forward column movement applied by the flight crew caused very hard nosegear contact with the runway. Resulting damage included displaced nosegear, bent axles, and a buckled and cracked fuselage structure (fig. 1). In addition, the cockpit door, forward lavatory doors, and forward passenger doors were jammed closed.

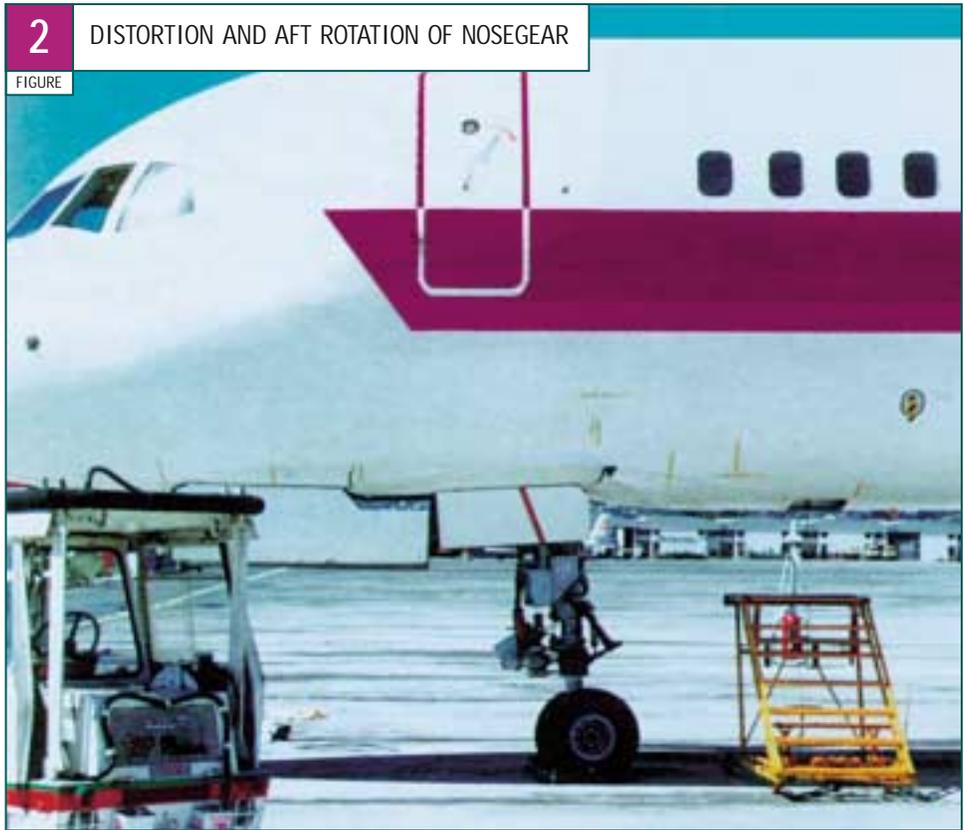
2 DISTORTION AND AFT ROTATION OF NOSEGEAR

An airplane returned to the departure airport following an in-flight engine shutdown. The airplane landed firmly on the main gear. Recordings

by the digital flight data recorder ended abruptly because of damage from the nosegear contact; however, the last data point showed that considerable forward control column movement had been applied. The nosegear was rotated aft and to the left of its normal position, resulting in damage to the lower fuselage and nosegear wheel well area (fig. 2).

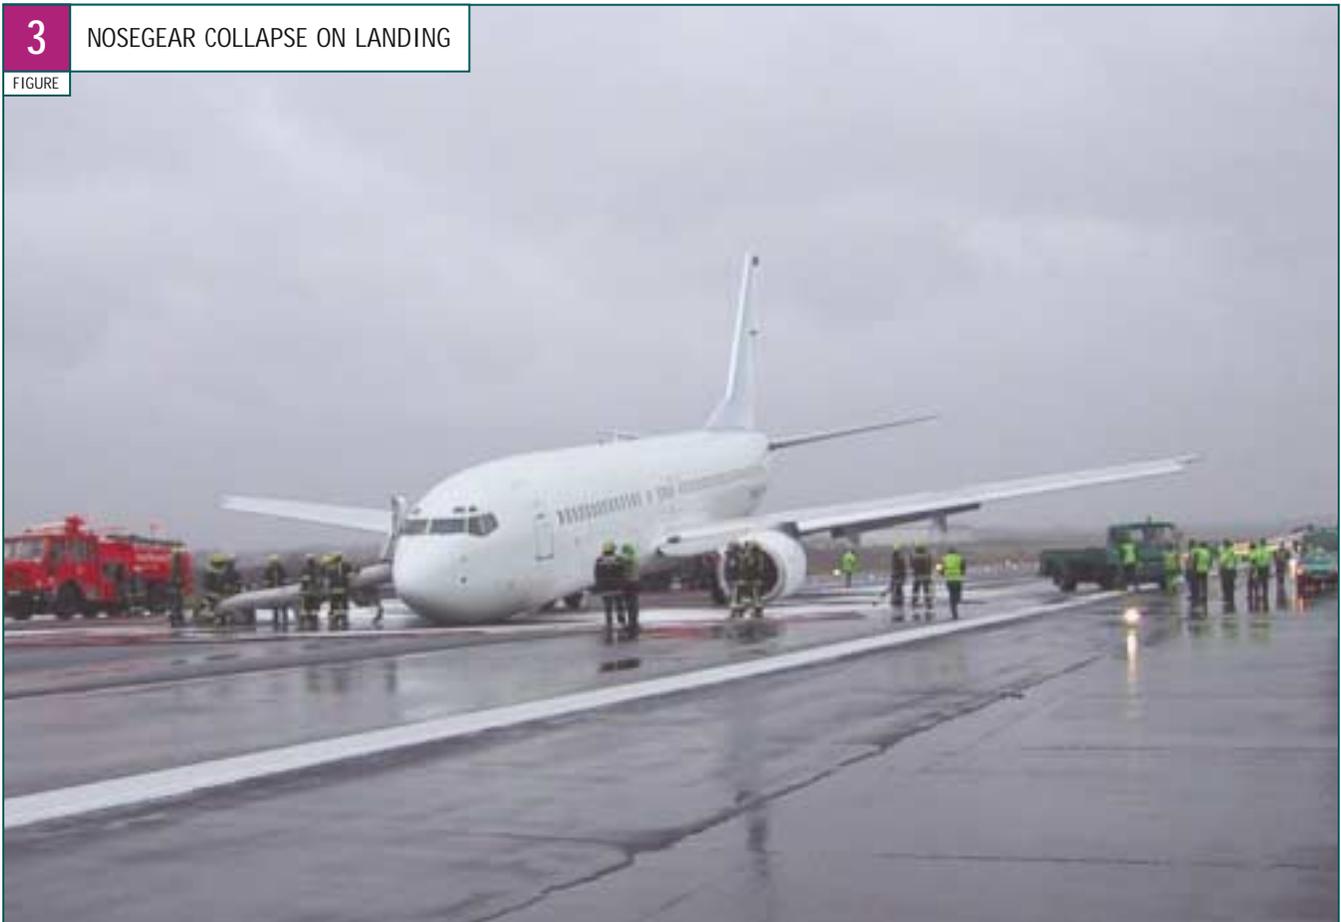
3 NOSEGEAR COLLAPSE ON LANDING

An airplane landing in strong crosswinds and turbulent conditions touched down on the main gear firmly, but not abnormally for the conditions. The airplane bounced, full forward column movement was applied, and the nosegear contacted the runway very hard, causing the nosegear to fail and rotate upward in the aft direction. The nosegear wheel assembly penetrated the electronics bay and caused considerable damage (fig. 3).

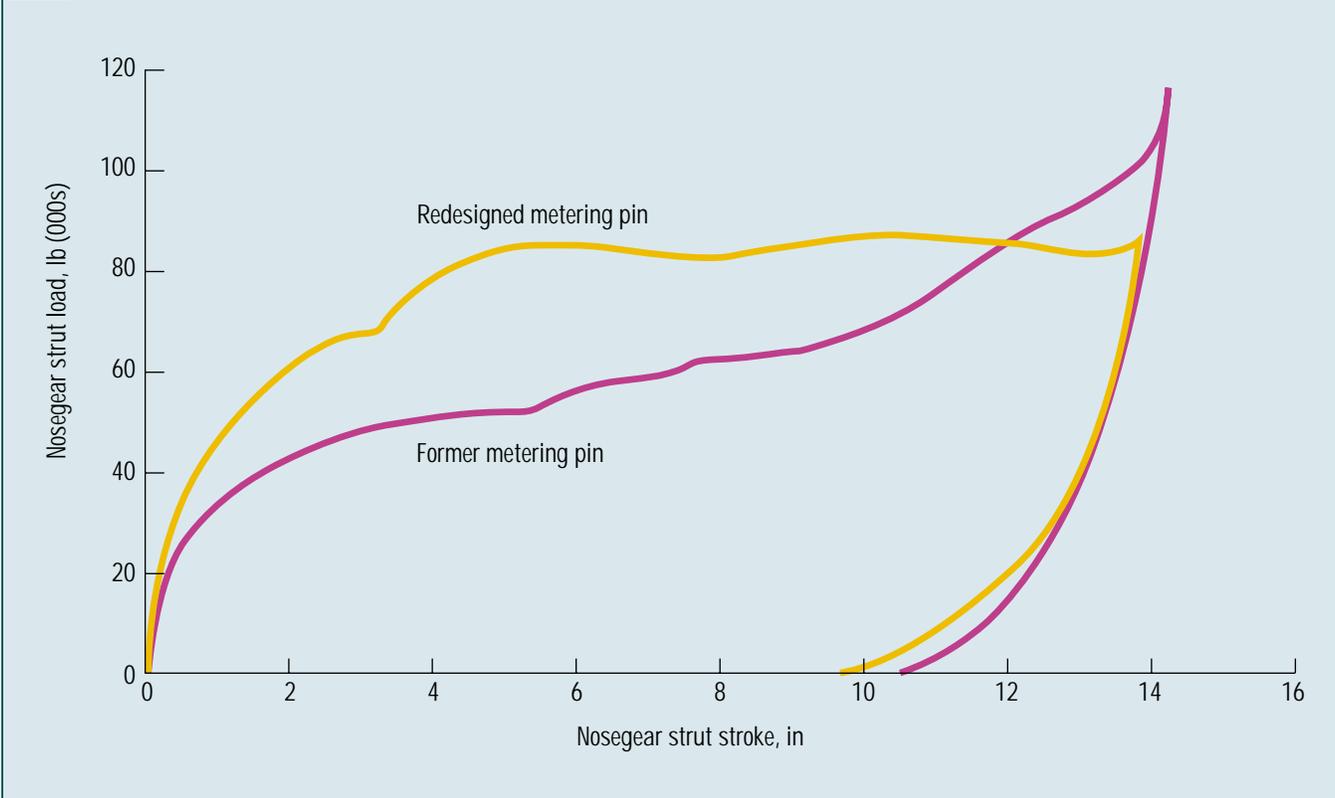
4 NOSEGEAR LOAD VERSUS STROKE FOR PITCHOVER

The most recent design enhancements involve the 767. The 767-300 nosegear metering pin has been further optimized to absorb the energy produced during overderotation events, thereby lowering the load on the nosegear (fig. 4). The metering pin device controls the flow of hydraulic fluid within the nosegear oleo strut. The design enhancement was incorporated into production airplanes in August 1994 and is available for retrofit on earlier 767-300s.

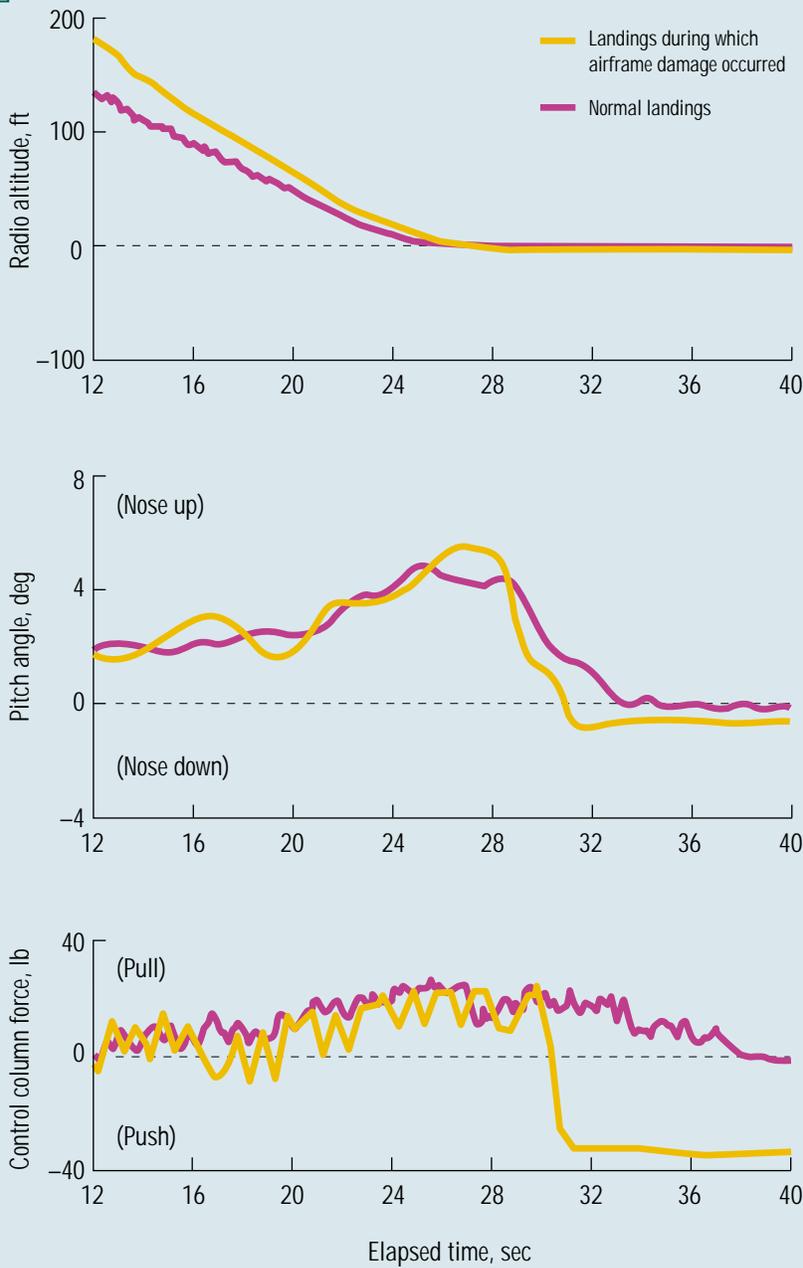
6 RADIO ALTITUDE, PITCH ANGLE, AND CONTROL COLUMN FORCES—NORMAL AND HARD LANDINGS

relaxing aft column pressure. When heavy brake applications are needed, with and without autobrakes, increased aft column pressure may be required to slow the derotation rate. Flight crews should not hold the nose up in the touchdown attitude or allow the nose to rise because either could result in a tail strike. Control column movement forward of the neutral position should not be needed. Figure 6 illustrates this smooth relaxation of column force as the nose is lowered. The figure compares the radio altitude, pitch angle, and control column forces for both normal landings and landings during which airframe damage occurred.

Flight crews can reduce the chances of airplane damage from hard nosegear contact by avoiding high derotation rates and excessive forward column inputs. In the event of a hard landing, the flight crew should report the event to the engineering and maintenance departments so that the airplane can be inspected for potential structural damage.
