PUSHBACK HAZARDS

ANALYSIS OF A MAJOR PUSHBACK ACCIDENT

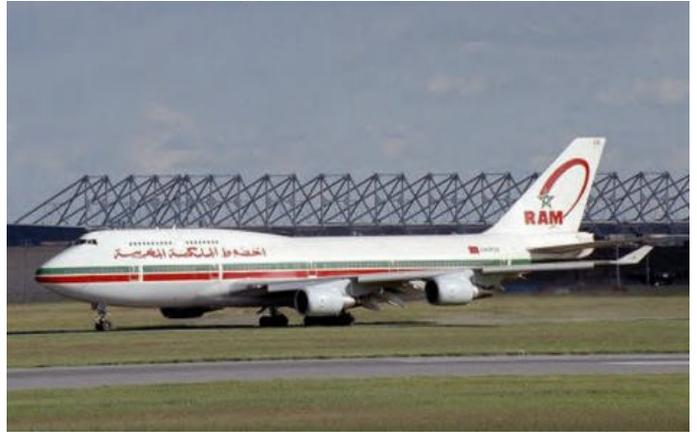
After making an external visual check from the cockpit, the captain released the brakes. Unknown to the B-747 flight crew, two de-icing vehicles were still positioned on opposite sides of the fuselage forward of the horizontal stabilizers, with five deicing personnel who were continuing the de-icing operation. As the aircraft moved forward, its horizontal stabilizers struck the telescoping booms of the de-icing vehicles, overturning the vehicles. The three occupants of the two buckets (cherry pickers) were killed when they struck the ground, and the two vehicle drivers received minor injuries.

The cause of the accident, as cited in the official Transportation Safety Board of Canada (TSB) accident investigation report, was that "flight crew started to taxi the aircraft before its perimeter was clear, following confusion in the radio communications.

Contributing to the accident, the report said, were a lack of de-icing procedures within Royal Air Maroc; noncompliance with procedures on the part of the CAIL (Canadian Airlines International Ltd.) de-icing crew; inadequate or inappropriate communications equipment; incomplete training of Snowman 1 (the chief de-icing truck driver, who was in charge of communications with the flight crew); a regulatory framework less demanding of foreign air carriers than of Canadian carriers, a lack of operational supervision; and a lack of adherence to radio protocol".

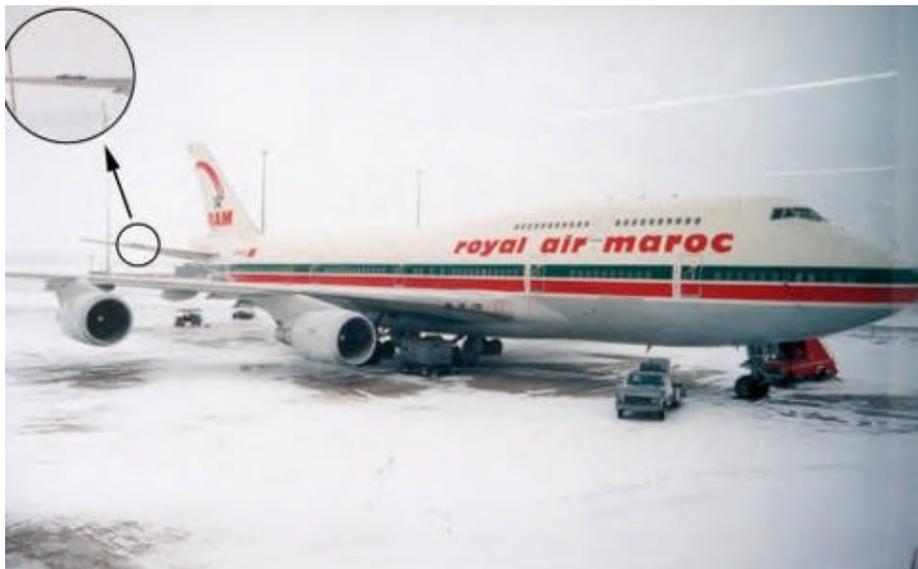
The captain of the B-747, after making an external visual check from the cockpit, advanced the throttles and the aircraft began to move forward. At that moment, the two de-icing trucks were still positioned on either side of the fuselage, forward of the empennage, and three de-icing personnel (two regular employees and one trainee) were in the cherry-picker buckets on the end of extended booms, spraying de-icing fluid onto the horizontal stabilizers. The

report said, "After he had taxied (29 meter (95 feet), the captain stopped the aircraft suddenly when he heard a radio message directing him to shut down the engines. The horizontal stabilizers of the aircraft had struck the telescopic booms of the de-icing vehicles, causing the occupants of the cherry-pickers to fall and knocking the de-icing vehicles over on their sides.

"The two vehicle drivers sustained minor injuries. The three occupants of the cherry pickers (who were not wearing their protective equipment) sustained fatal injuries when they struck the ground" after falling 15 meters (49 feet). The deicing trucks were heavily damaged, and the aircraft sustained substantial damage.
