## Captain Rejects Takeoff as Boeing 747 Veers off Slippery Runway

*The airline's flight attendant procedures did not provide adequate guidance to flight attendants on how to coordinate their actions during and after the impact sequence, the official U.S. report said.*

The final report of the U.S. National Transportation Safety Board (NTSB) said that the probable cause of the accident to Tower Air Flight 41 "was the captain's failure to reject the takeoff in a timely manner when excessive nosewheel steering tiller inputs resulted in a loss of directional control on a slippery runway."

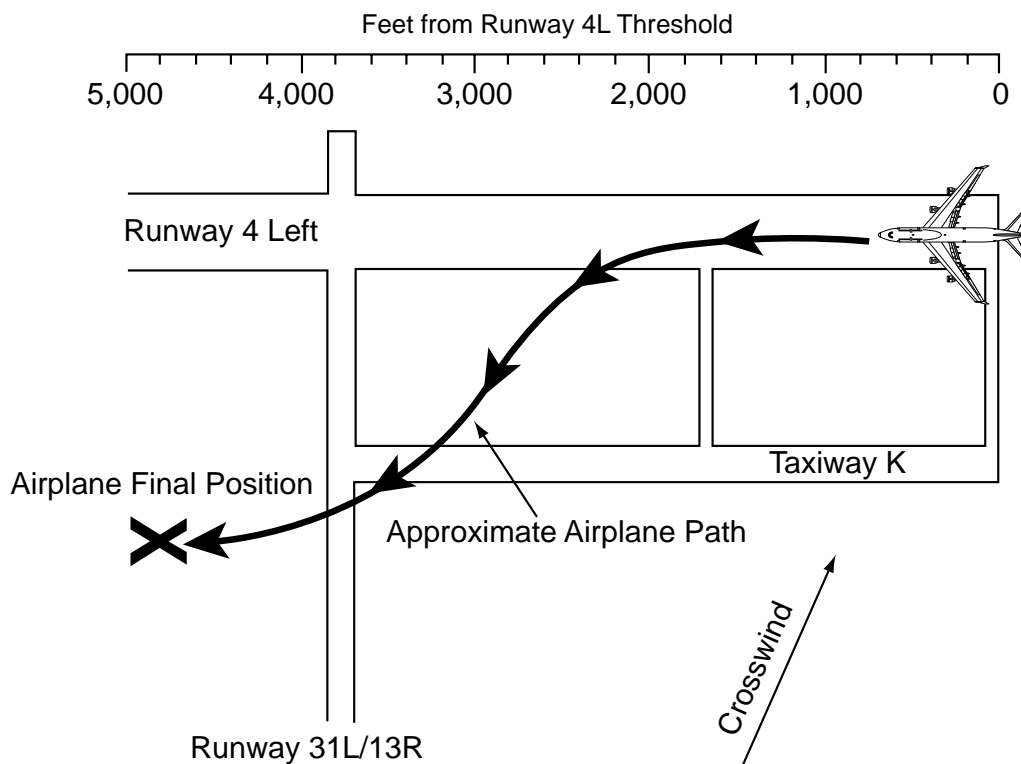
Figure 1

The captain rejected the takeoff, and the airplane went off the left side of the runway and continued for a short distance. The airplane came to rest approximately 1,464 meters (4,800 feet) from the runway threshold and 183 meters (600 feet) left of the runway centerline (Figure 1, page 3). One cabin crew member was seriously injured, and 24 passengers received minor injuries in the Dec. 20, 1995, accident. The airplane sustained substantial damage and was declared a total loss.

The captain said that he knew where the runway centerline was, “but he was unable to control the direction of movement,” the report said. “The captain said that while the airplane was still on the runway with the veer and drift to the left increasing, he applied full right rudder and nosewheel steering tiller. He said that he then retarded the power levers to idle and applied maximum braking. He said that he intentionally did not use reverse thrust because of the airplane’s slow speed at the time of the abort, the long runway and the possibility that reverse thrust could have worsened directional control. The airplane then departed the left side of the runway.”

### Path of Tower Air Boeing 747 Following Rejected Takeoff, Dec. 20, 1995

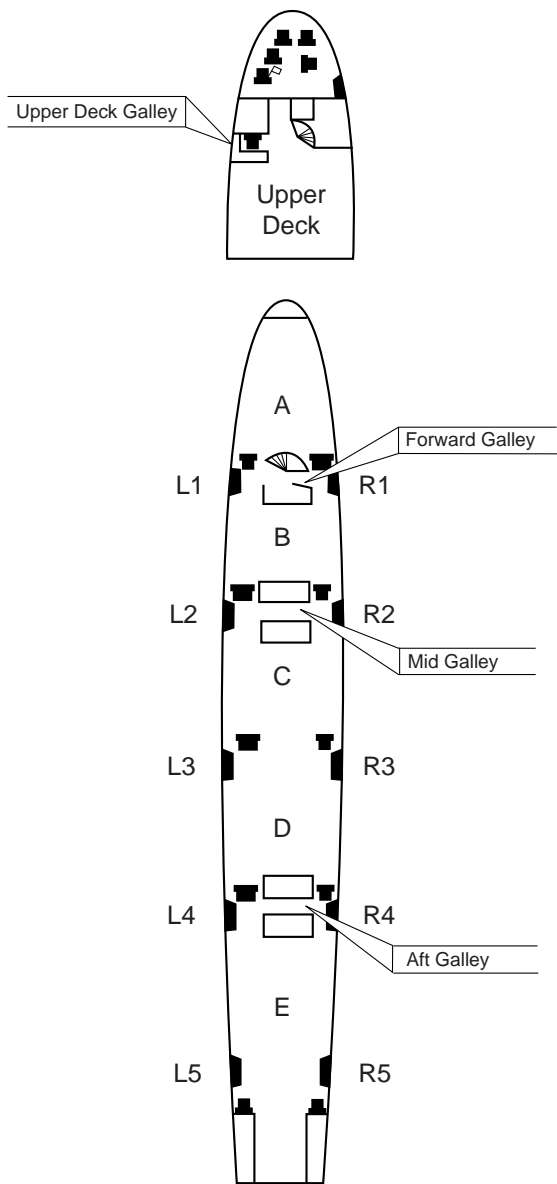
**Figure 2**

A flight attendant who was seated in the aft-facing jumpseat at door R4 (Figure 2, page 4) sensed, at the beginning of the takeoff and during the ensuing accident sequence, “movement toward the right side of the runway with a skidding sensation,” the report said. “Later, she heard ‘crunching, tearing’ noises, and saw the no. 4 engine skidding down the runway before the airplane stopped. She recalled that while the airplane was still moving, many overhead bins opened and spilled their contents. The larger side bins in the cabin nearby also opened and spilled even more debris.”

## Cabin Layout, Boeing 747, Tower Air Flight 41, Dec. 20, 1995

saw an ice cart and a beverage cart come loose,” the report said. “The ice cart hit her right shoulder, and she suffered a broken right shoulder. The ice cart continued to move forward and stopped upright in front of the empty passenger seats across from her jumpseat. The loose beverage cart hit the ice cart and then came to rest tilted against the seats, blocking the R4 exit.”

Investigators reviewed the security of service carts, galley containers, drawers and other galley items that were not contained during the accident sequence. “The most serious breach of galley security occurred in the aft galley complex, between the R4 and L4 exits [Figure 2, page 4],” the report said. “The two carts that came loose injured the R4 flight attendant and blocked the R4 exit.”

The NTSB recommended that the FAA “develop certification standards for the installation of secondary galley latches ... on all transport-category aircraft,” the report said. “Further, the FAA should require changes to existing installations as necessary to ensure that the strength of secondary latches and their installation are sufficient to adequately restrain carts.”
