Final Report

of AFRIQIYAH Airways Aircraft
Airbus A330-202, 5A-ONG Crash
Occurred at Tripoli (LIBYA)
on 12/05/2010

Published February 2013

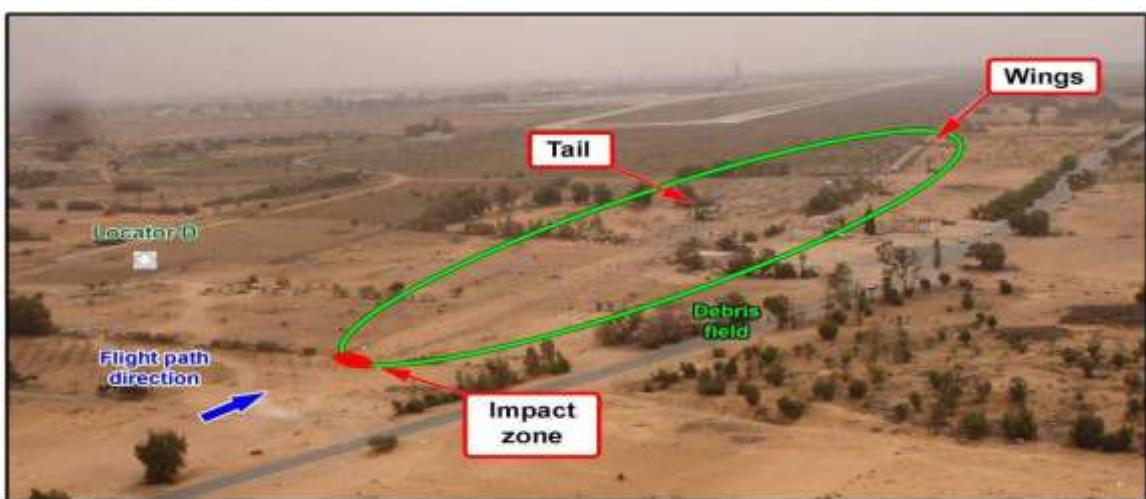
Aerial view of the debris field

Many small fragments belonging mainly to the mid and aft sections of the fuselage were distributed eastwards from the impact zone; pieces from the front section of the fuselage were found 180 m from the impact zone.

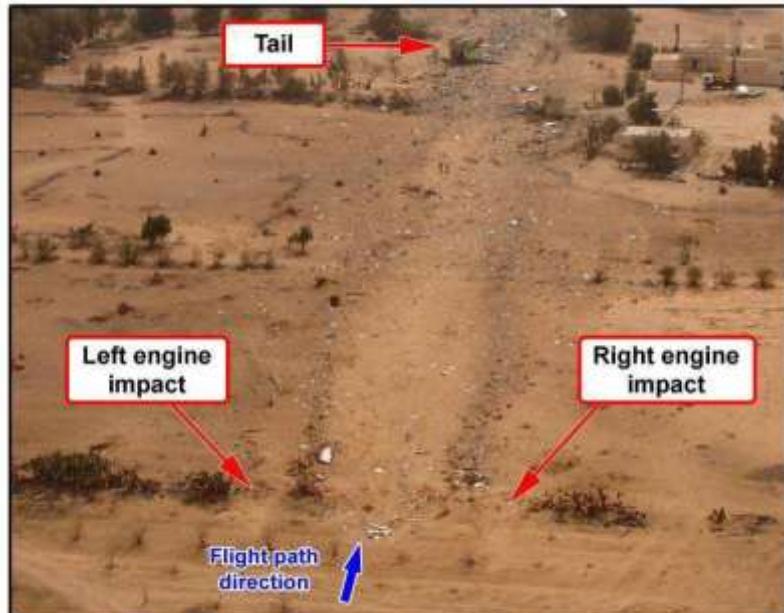
Aircraft ground impact

Initial observations show that the aircraft struck the ground with high energy and high longitudinal velocity.

Tree-tops were broken over an area located a few meters before the impact zone; elements of the aircraft broke away as a result of these contacts.

The first debris found in the impact zone comes from the soft underbelly of the aircraft, the landing gear doors and the nacelles of the two engines. It should be noted that debris from these parts of the aircraft were scattered over several hundred meters from the point of impact. No trace of the landing gear was observed at this location.

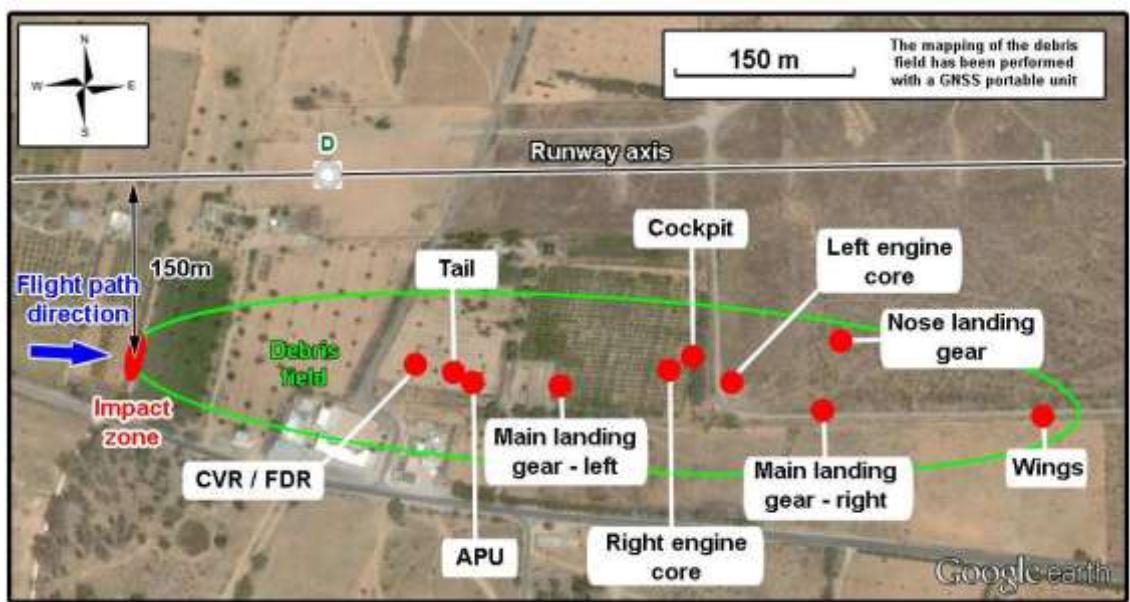
Distribution of the debris field

The first large items from the wreckage were distributed 270 m from the impact zone: the vertical stabilizer, the left Main Landing Gear (MLG), engine #1, the cockpit, engine #2, the right MLG, the nose gear, and finally the wings in the eastern part of the debris field. The latter bore significant fire marks.

The rear structure of the aircraft was located at about 275 m from the impact zone, comprising the tail section and the vertical stabilizer, with the main shaft of the Auxiliary Power Unit (APU) nearby. The adjusting screw of the Trimmable Horizontal Stabilizer (THS) was found broken. The nut was at a distance of 20.0 cm from the output bearing of the actuator.

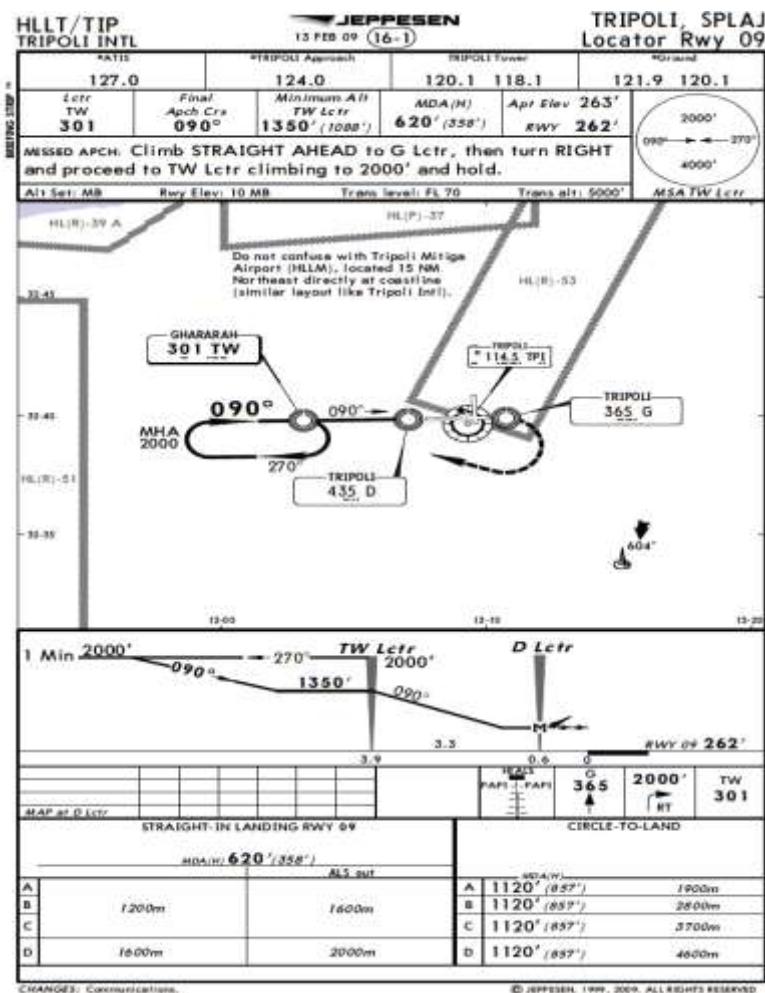
The Jeppesen chart did not provide any glide path after the FAF and did not include the table in the official map identifying crossing altitudes in relation the distance to the runway threshold 09 and rates of descent in relation the speed of the aircraft.
