Investigation Report

Type of Occurrence:	Serious incident
Date:	15 August 2011
Location:	Düsseldorf
Aircraft:	Airplane
Manufacturer / Model:	Airbus Industrie / A330-322
Injuries to Persons:	None
Damage:	Minor damage to aircraft
Other Damage:	None
Information Source:	Investigation by BFU
State File Number:	BFU 5X007-11

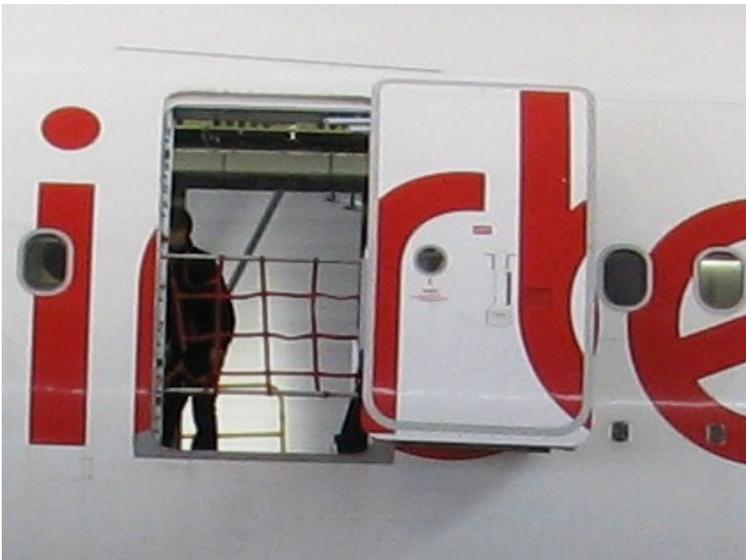
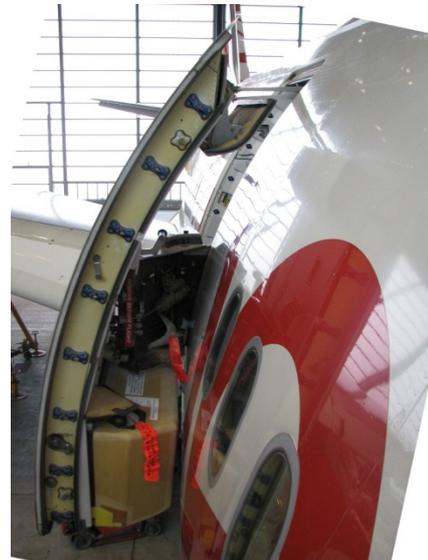
Door R2, in which the work light was installed, is opened almost always whenever the airplane is on the ground since it is used as a service door. The door is pushed outward when it is opened and all sides are exposed to the weather. The examination of an aircraft of the same type showed that the upper side of the door has openings through which water can flow unhindered into the door. Between the door structure and the inner lining there are no seals which would prevent the water from penetrating. When the door panel of this airplane was removed it was determined that the insulation mats had partially collected substantial amounts of water.

Open door R2

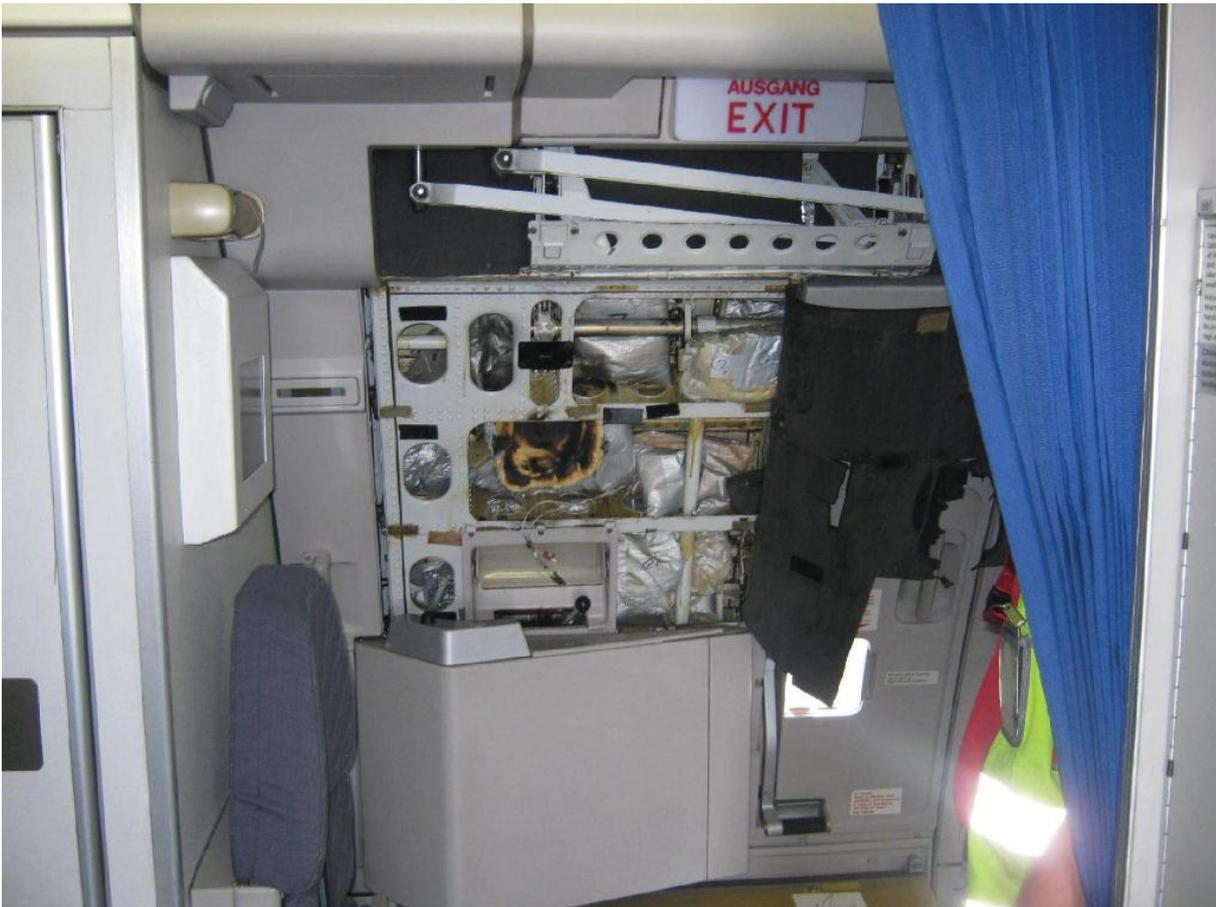
After the landing the interior panel of door 2R showed slight scorch marks in the area of the work light. After the lamp unit (P/N F925-90046-012-00-C) was removed it was determined that especially in the area of the power unit (P/N 8ES004692-10) heavy fire and heat traces were visible. The interior of the door showed fire and scorch marks on the insulation and the structure once the panel was removed.

Fire area on door R2 after the panelling was removed

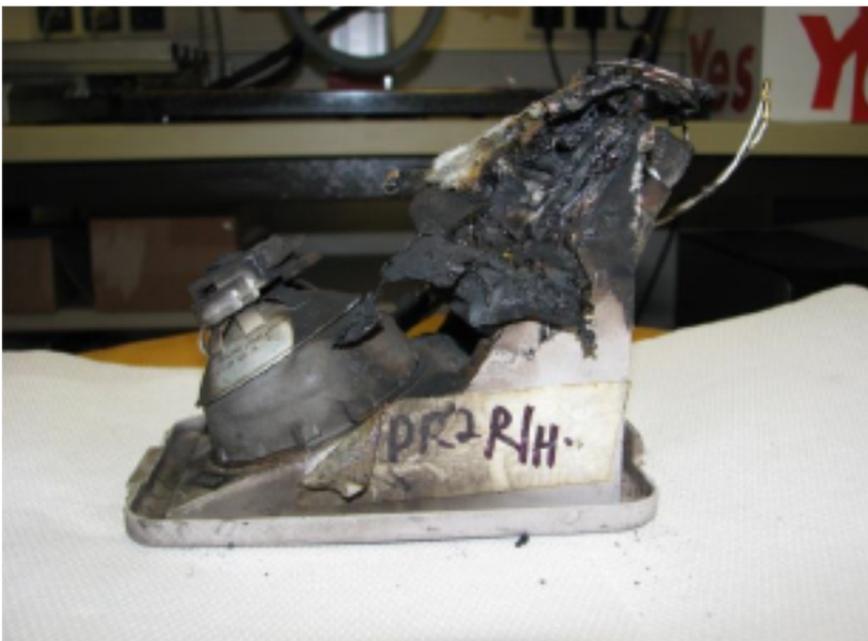
Lamp unit with fire and heat traces

The lamp unit was examined in the BFU laboratory. The circuit board of the power unit showed signs of high current flow along two circuit paths. These circuit paths were directly connected with 115 VAC/400 Hz and AC Return/GND.

The traces of high current flow on the circuit board of the power unit, the heat and fire traces on the lamp unit and on the insulation and the door panelling allow the conclusion that the short circuit in the power unit caused a fire which spread to the surrounding area. The fire was limited to a few square decimetres. The BFU is of the opinion that it cannot be determined conclusively if this was owed to the properties of the material used or the immediate use of the fire extinguisher. It is doubtful, however, that enough extinguishing agent could penetrate through the available openings to extinguish the fire. This is even more important because the fire extinguisher was

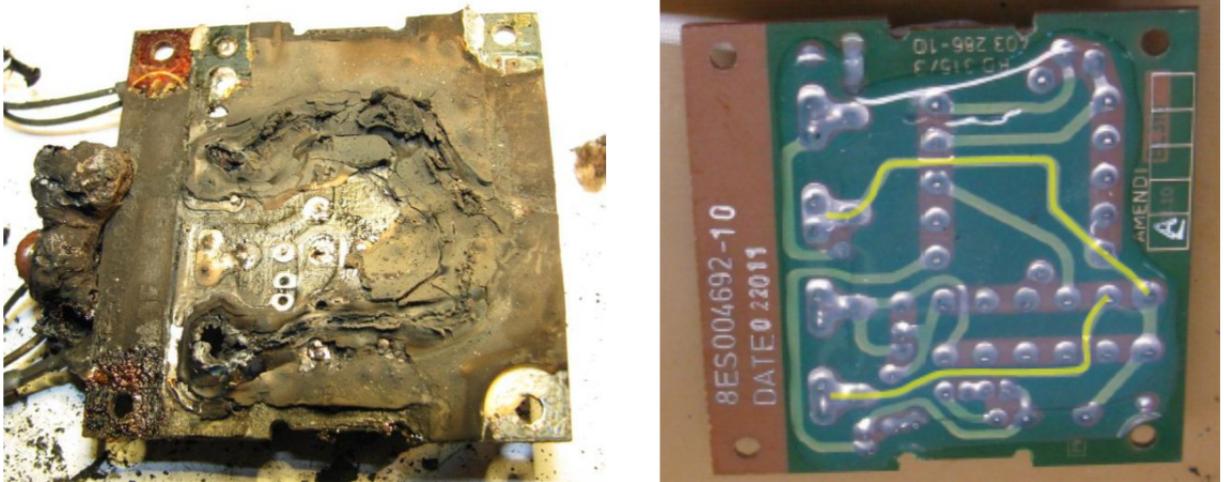
Comparison of damaged and new power unit

The BFU is of the opinion that the short circuit was definitely caused by water ingress in combination with a power unit coating insufficient for this particular environment since

On 26 September 2000 the power unit manufacturer published the Service Information Letter (SIL) No 8ES004692-33-001. It stated that water could reduce the insulation resistance on the circuit board. To prevent this, the production process had been improved. The replacement of affected parts was offered free of charge.

On 8 February 2005 a revision of the SIL was published. It advised of the once again modified production process and recommended replacement of all units produced before July 2002.

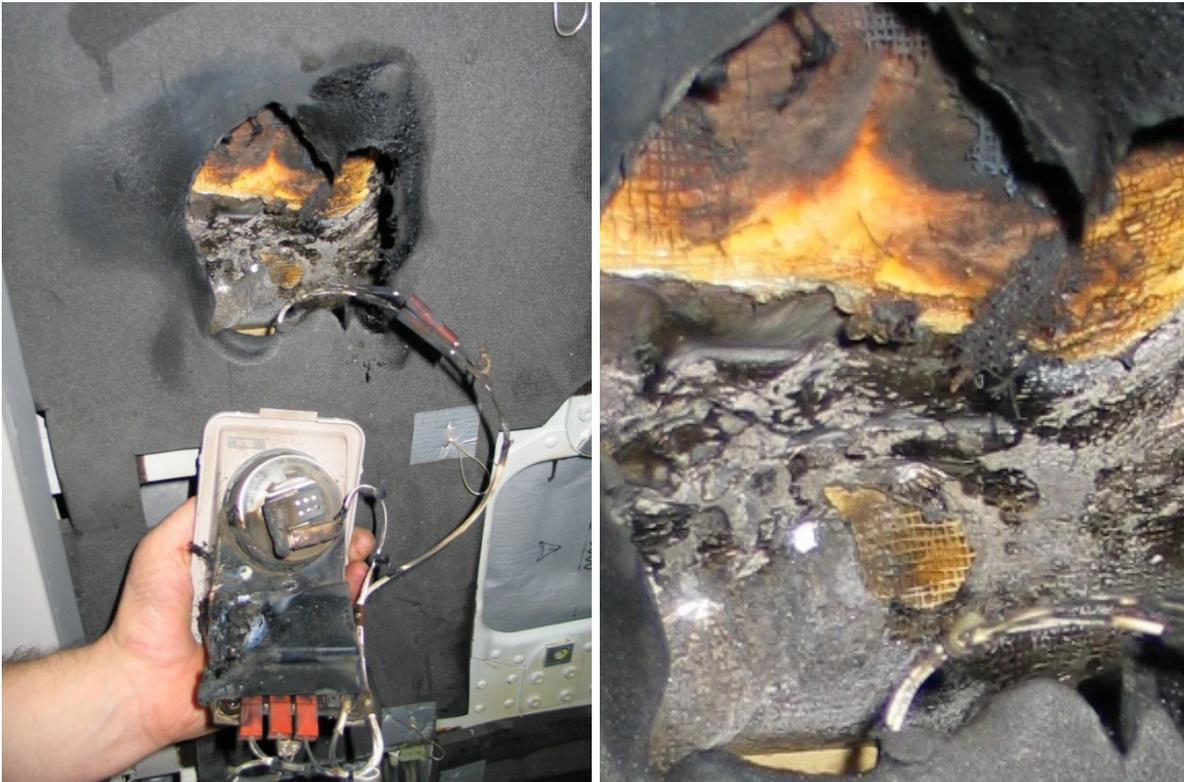
In January 2005 there was smoke development aboard an Airbus A340 in the area of the work light which was installed in a door. The smoke development ended after five minutes. The airplane returned and landed safely. The investigation on the ground conducted by technicians determined that the insulation mats in the vicinity of the lamp were very wet. The photo below shows that the insulation material of the door was partially pyrolyzed.

Traces behind the door panelling (overview and detail)
