Report

Serious incident on **22 July 2011**
in cruise at FL350, north Atlantic Ocean
to the **Airbus A340-313**
registered **F-GLZU**
operated by **Air France**

BEA

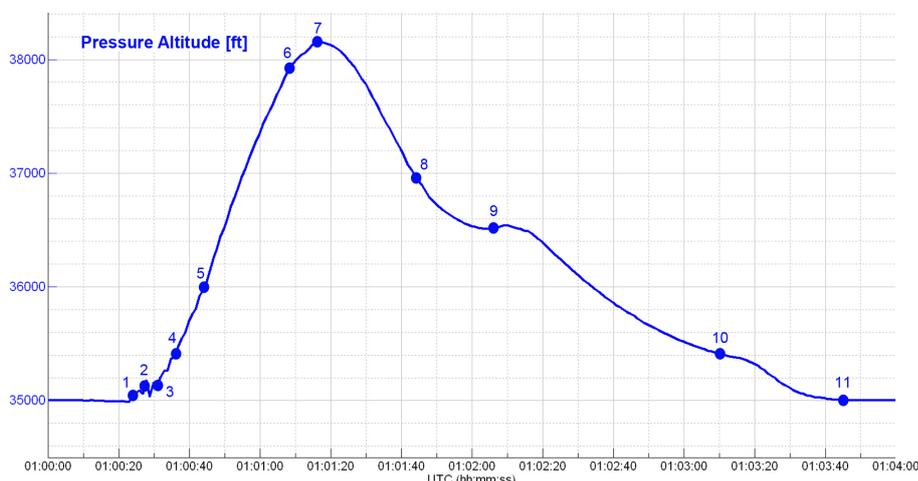
Figure 1 - Vertical flight path

At 1 h 00 min 24 (point n°1 on Figure 1), about 2 NM after passing coordinates 18N 60W, the aeroplane entered a zone of moderate turbulence. The overspeed warning ("OVERSPEED") was triggered⁽³⁾ and the "Master Warning" warning light came on. The crew stated that they were very surprised by this warning. Mach reached 0.87.

At 1 h 00 min 27 (point n°2), the PNF manually disengaged the AP by pressing the takeover pushbutton on the side-stick. A pitch-up input on the PNF's side-stick going as far as $\frac{3}{4}$ to stop was recorded for 6 seconds. This input was accompanied by an input to bank to the right then left. The PNF stated that he did not remember these inputs.

At 1 h 00 min 31 (point n°3), the PF extended the speedbrakes. Mach was 0.84 and started to decrease 2 seconds later.

At 1 h 00 min 44 (point n°5), the aeroplane was at FL360. The speedbrakes were retracted. Pitch attitude increased to about 12° in 2 seconds. The aeroplane continued to climb and Mach decreased.

At 1 h 01 min 08 (point n°6), while the aeroplane was at 37,950 ft in climb, the PF disengaged the A/THR and moved thrust levers forward to the TO/GA detent.

At 1 h 01 min 17 (point n°7), altitude reached maximum: 38,150 ft. Mach was 0.66.

At 1 h 02 min 06 (point n°9), the aeroplane descended past 36,520 ft. The PF then became aware of the disengagement of the AP and made a pitch-down input on his sidestick. Pitch attitude began to decrease 2 seconds later.

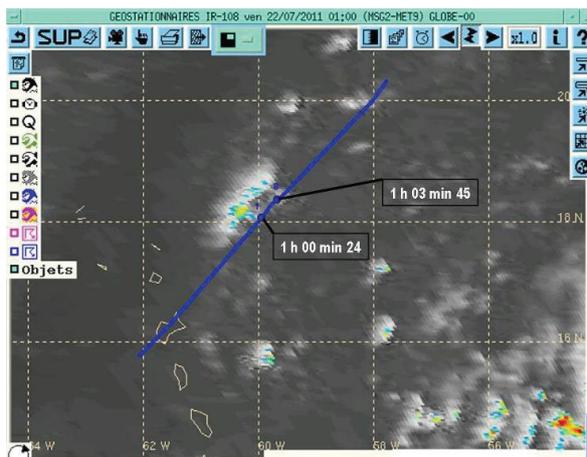
Figure 2 – Trajectory on IR image at 1 h 00

However, infra-red satellite images obtained by the BEA from Météo-France showed the presence of isolated cumulonimbus of moderate intensity between 0 h 30 and 1 h 30 in the area around point 18N 60W, with the top situated at FL380⁽⁷⁾. The recorded trajectory showed that the aeroplane flew close by these clouds during the event.

It should be noted that this type of isolated cloud in an inter-tropical zone is beyond forecasting abilities other than immediate or very short term forecasts.

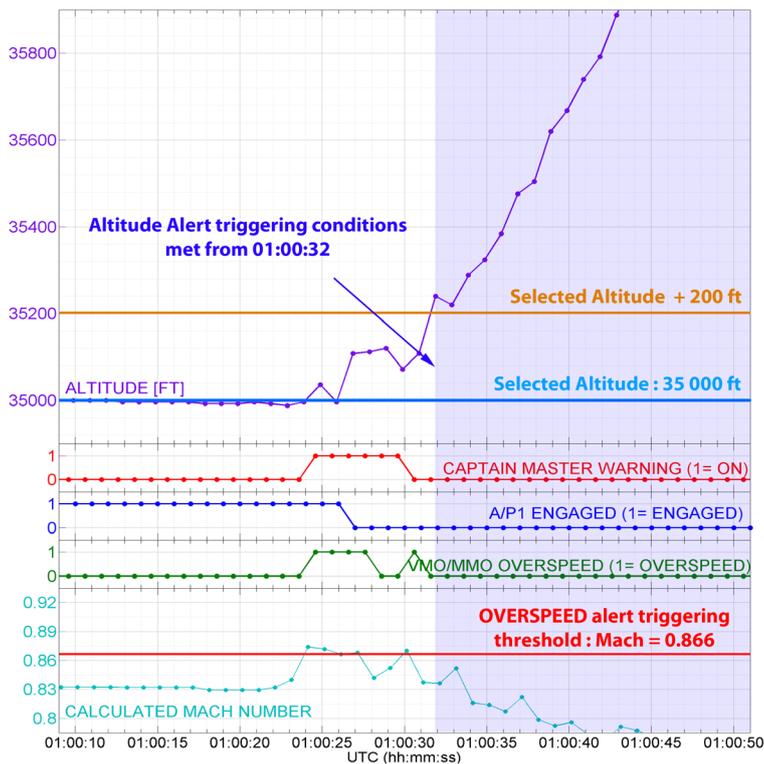
Figure 5 - Warnings recorded

The recorded data showed that there was initially an OVERSPEED warning, which generated a CRC aural warning. This warning was active as long as the Mach was greater than 0.866.

Three seconds later, the AP was disengaged, but as the CRC was still active, the “Cavalry Charge” aural warning was not generated, as it was masked by the CRC. While it was not generated, it could not be cancelled by a possible 2nd press on the sidestick takeover pushbutton.

The moment the 1st OVERSPEED stopped corresponded to the end of the 1.5 second maximum sounding of the “Cavalry Charge”, which was therefore not activated. The “Master Warning” continued to be active between the 1st and the 2nd OVERSPEED as the disengagement of the AP generates a “Master Warning” of 3 seconds if it is not cut off.

The moment of theoretical triggering of the “C-chord” warning, at 35,200 ft, was one second after the end of the 2nd OVERSPEED. Pressing the “Master Warning” warning light, at 36,900 ft, the PNF cancelled the “Altitude alert” about 20 seconds after it appeared. In the absence of a CVR recording, it was not possible to confirm what the real duration of the “C-chord” warning was.

- **EASA evaluate the possibility of requiring that the autopilot disengagement aural warning for all aeroplanes of a maximum mass on take-off of more than 5.7 t be triggered in compliance with paragraphs AMC 25.1322 and AMC 25.1329(j) of the CS-25. [Recommendation FRAN-2012-022]**

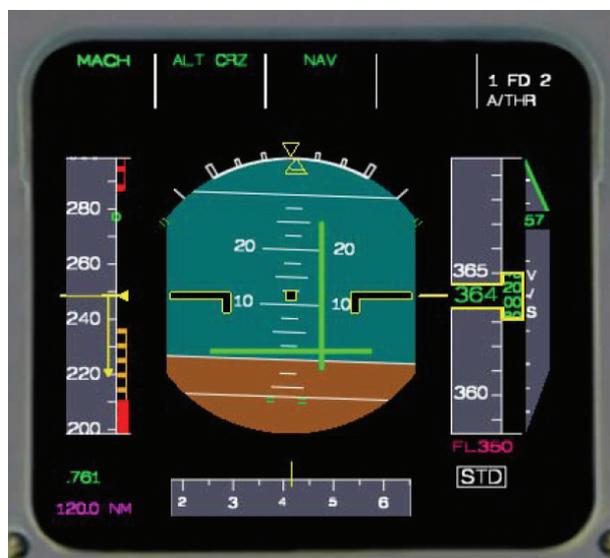
Figure 6 - Reconstitution of display on the PFD during climb at 01 h 00 min 49

modifying the range of his ND. The PNF's attention was drawn to the announcement to the cabin crew. This prioritisation occurred at the expense of monitoring essential parameters such as pitch angle, altitude and the FMA strip during the climb phase. Neither pilot was aware that the AP had been disengaged. The following visual displays were not detected (see Figure 6):

- ❑ Nose-up attitude, which had reached 12° pitch up,
- ❑ High vertical speed, which had reached 5,700 ft/min,
- ❑ The flashing frame around the altitude display on the PFD when the altitude passed 35,200 ft,
- ❑ The position of the FD cross bars,
- ❑ Altitude until it reached more than 38,000 ft,
- ❑ The "AP1" display which had disappeared from the FMA strip,
- ❑ The amber ECAM "AP OFF" message which remained displayed for 9 seconds after the AP disengagement.

It should be noted that perception of these displayed items was made more difficult due to the absence of specific corresponding aural warnings and the level of turbulence which made instrument reading more difficult.

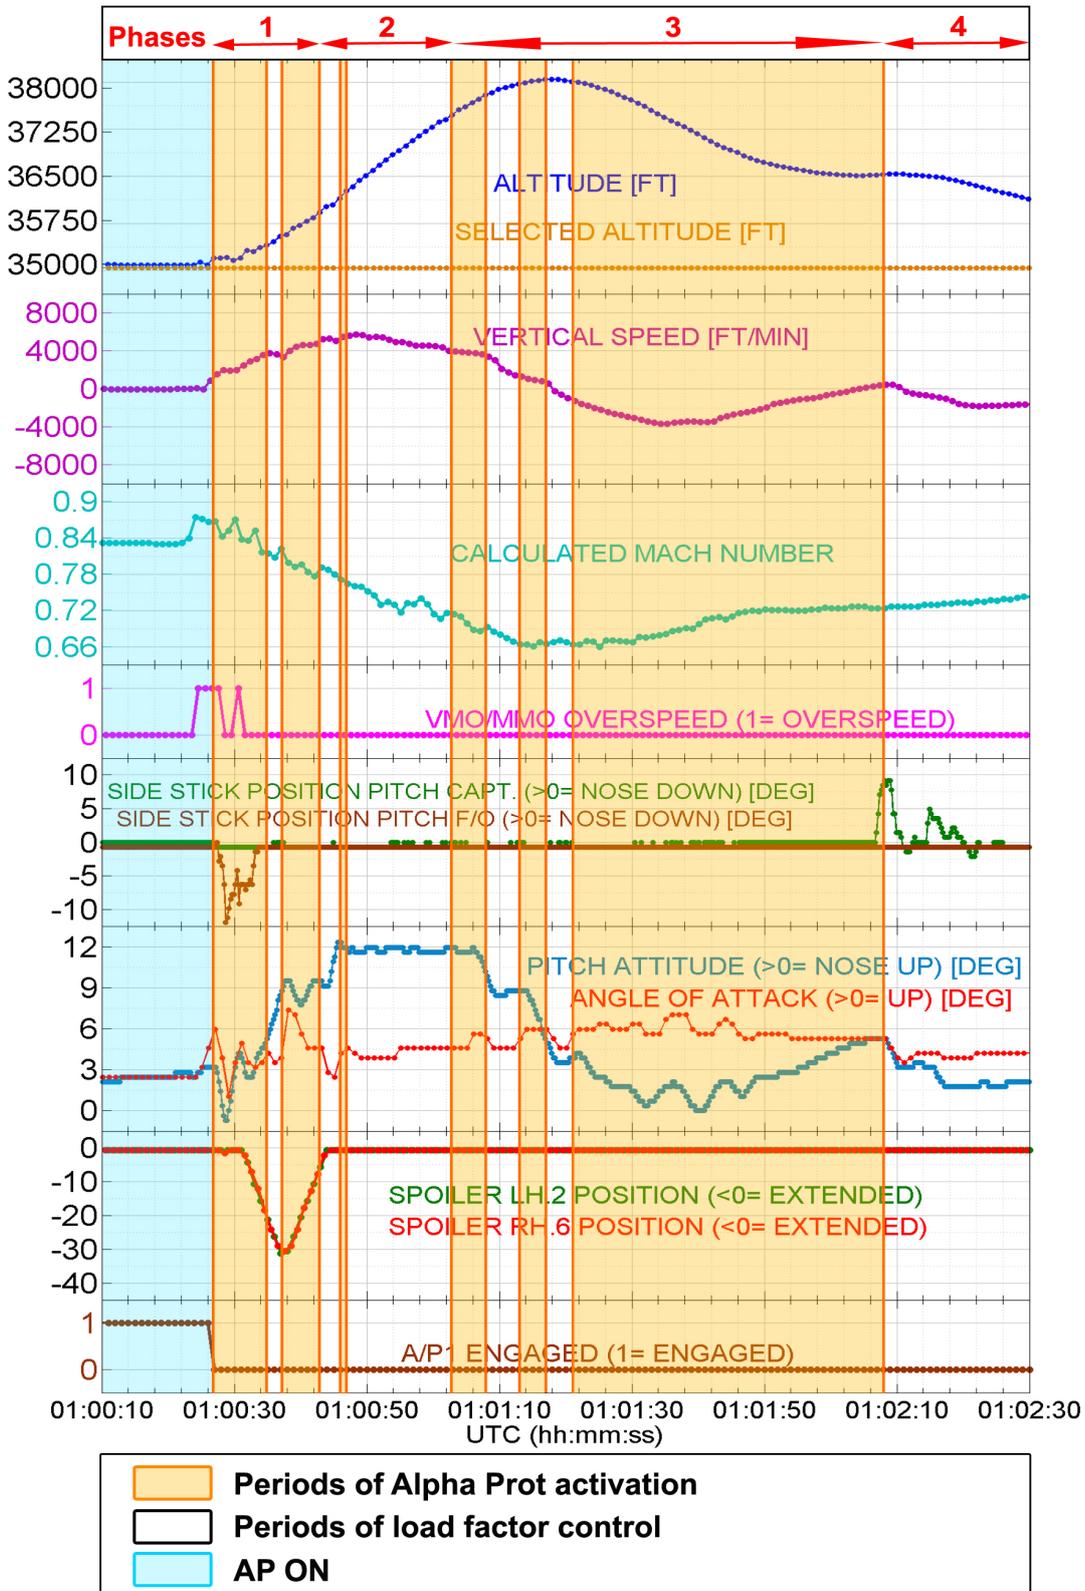
- ❑ Phase 1: Initially, a gust of headwind⁽¹⁾ generated overspeed and the activation of the "OVERSPEED" warning. A few seconds later, a rising gust caused an increase in the angle of attack and vertical speed. Then, the PNF disengaged the autopilot and made a pitch-up input for 6 seconds while the PF extended the speedbrakes. From the start of the pitch-up input, the angle of attack being greater than Alpha Prot, the high angle of attack protection was activated. Then, for 2 seconds, the angle of attack moved briefly below Alpha Prot, with the sidestick in neutral, which meant it exited the protections. The combined effects of turbulence, sidestick input and the extension of the speedbrakes led to increases in pitch, vertical speed and altitude. An angle of attack spike greater than Alpha Prot activated the high angle of attack protection again. The angle of attack continued to increase and passed Alpha MAX, which caused the automatic retraction of the speedbrakes.

- ❑ Phase 2: The intensity of the turbulence decreased and the angle of attack again became less than Alpha Prot (except for 2 seconds). In the absence of sidestick input, the high angle of attack protection deactivated. The load factor control law then maintained the rising trajectory of the aeroplane. During the climb, since the vertical speed exceeded the capacity to climb at constant speed, the aeroplane speed decreased. When lift became less than weight, the pitch decreased. Maintaining the load factor at 1 g induced a slight increase in the angle of attack.

- ❑ Phase 4: The angle of attack was equal to Alpha Prot therefore less than Alpha MAX. Consequently, the PF's pitch-down input for more than one second on the sidestick caused the high angle of attack protection to be exited and the longitudinal control law returned to load factor. The pitch attitude decreased then stabilised until the crew re-engaged the autopilot.
