Report

Serious incident on **22 July 2011**
in cruise at FL350, north Atlantic Ocean
to the **Airbus A340-313**
registered **F-GLZU**
operated by **Air France**

BEA

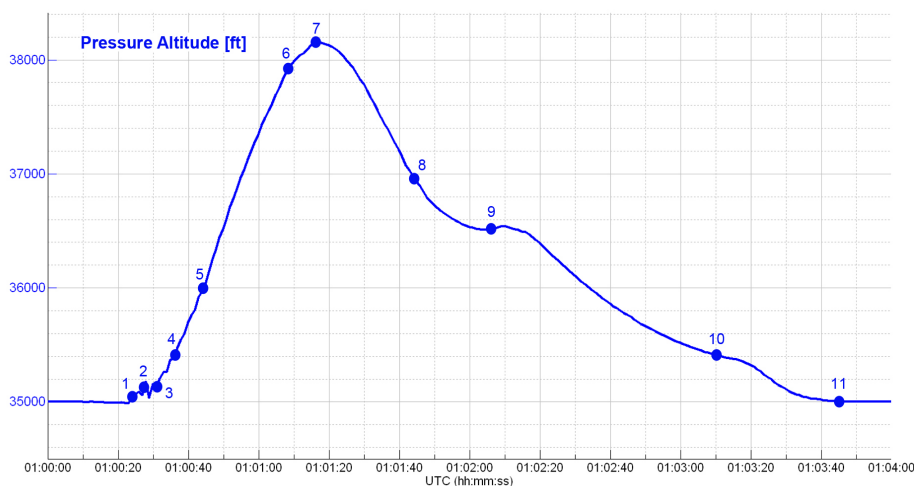
Figure 1 - Vertical flight path

At 1 h 00 min 24 (point n°1 on Figure 1), about 2 NM after passing coordinates 18N 60W, the aeroplane entered a zone of moderate turbulence. The overspeed warning ("OVERSPEED") was triggered⁽³⁾ and the "Master Warning" warning light came on. The crew stated that they were very surprised by this warning. Mach reached 0.87.

At 1 h 00 min 27 (point n°2), the PNF manually disengaged the AP by pressing the takeover pushbutton on the side-stick. A pitch-up input on the PNF's side-stick going as far as $\frac{3}{4}$ to stop was recorded for 6 seconds. This input was accompanied by an input to bank to the right then left. The PNF stated that he did not remember these inputs.

At 1 h 00 min 31 (point n°3), the PF extended the speedbrakes. Mach was 0.84 and started to decrease 2 seconds later.

At 1 h 00 min 37 (point n°4), the speedbrakes started to retract automatically. Pitch attitude then varied between 8° and 10°.

At 1 h 00 min 44 (point n°5), the aeroplane was at FL360. The speedbrakes were retracted. Pitch attitude increased to about 12° in 2 seconds. The aeroplane continued to climb and Mach decreased.

At 1 h 01 min 08 (point n°6), while the aeroplane was at 37,950 ft in climb, the PF disengaged the A/THR and moved thrust levers forward to the TO/GA detent.

At 1 h 01 min 17 (point n°7), altitude reached maximum: 38,150 ft. Mach was 0.66.

At 1 h 02 min 06 (point n°9), the aeroplane descended past 36,520 ft. The PF then became aware of the disengagement of the AP and made a pitch-down input on his sidestick. Pitch attitude began to decrease 2 seconds later.

From 35,400 ft (point n°10), the PF re-engaged AP1, altitude stabilised at FL350 (point n°11), and A/THR was re-engaged.

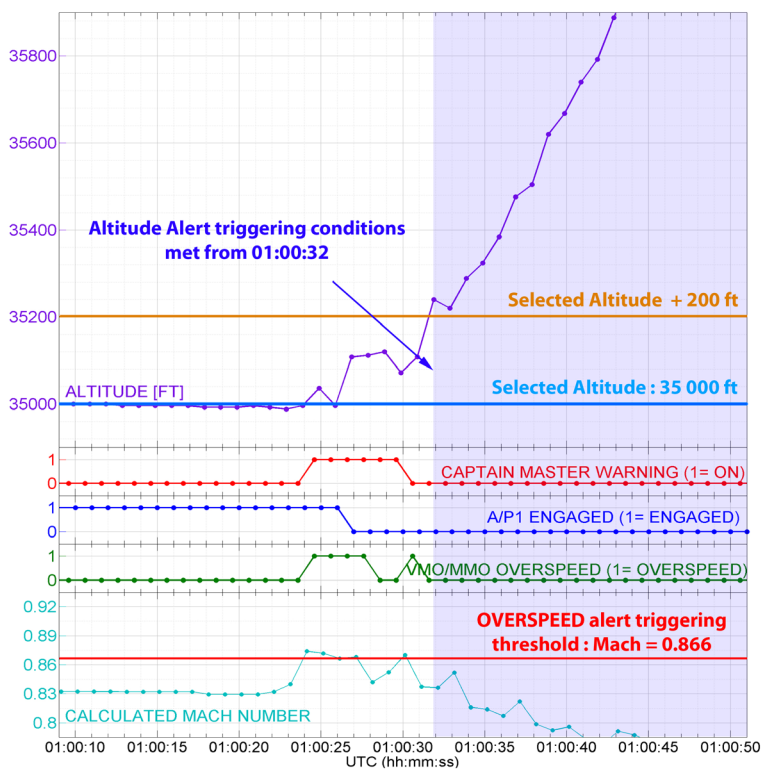
Figure 5 - Warnings recorded

The recorded data showed that there was initially an OVERSPEED warning, which generated a CRC aural warning. This warning was active as long as the Mach was greater than 0.866.

Three seconds later, the AP was disengaged, but as the CRC was still active, the “Cavalry Charge” aural warning was not generated, as it was masked by the CRC. While it was not generated, it could not be cancelled by a possible 2nd press on the sidestick takeover pushbutton.

The moment the 1st OVERSPEED stopped corresponded to the end of the 1.5 second maximum sounding of the “Cavalry Charge”, which was therefore not activated. The “Master Warning” continued to be active between the 1st and the 2nd OVERSPEED as the disengagement of the AP generates a “Master Warning” of 3 seconds if it is not cut off.

The moment of theoretical triggering of the “C-chord” warning, at 35,200 ft, was one second after the end of the 2nd OVERSPEED. Pressing the “Master Warning” warning light, at 36,900 ft, the PNF cancelled the “Altitude alert” about 20 seconds after it appeared. In the absence of a CVR recording, it was not possible to confirm what the real duration of the “C-chord” warning was.

- **EASA evaluate the possibility of requiring that the autopilot disengagement aural warning for all aeroplanes of a maximum mass on take-off of more than 5.7 t be triggered in compliance with paragraphs AMC 25.1322 and AMC 25.1329(j) of the CS-25. [Recommendation FRAN-2012-022]**

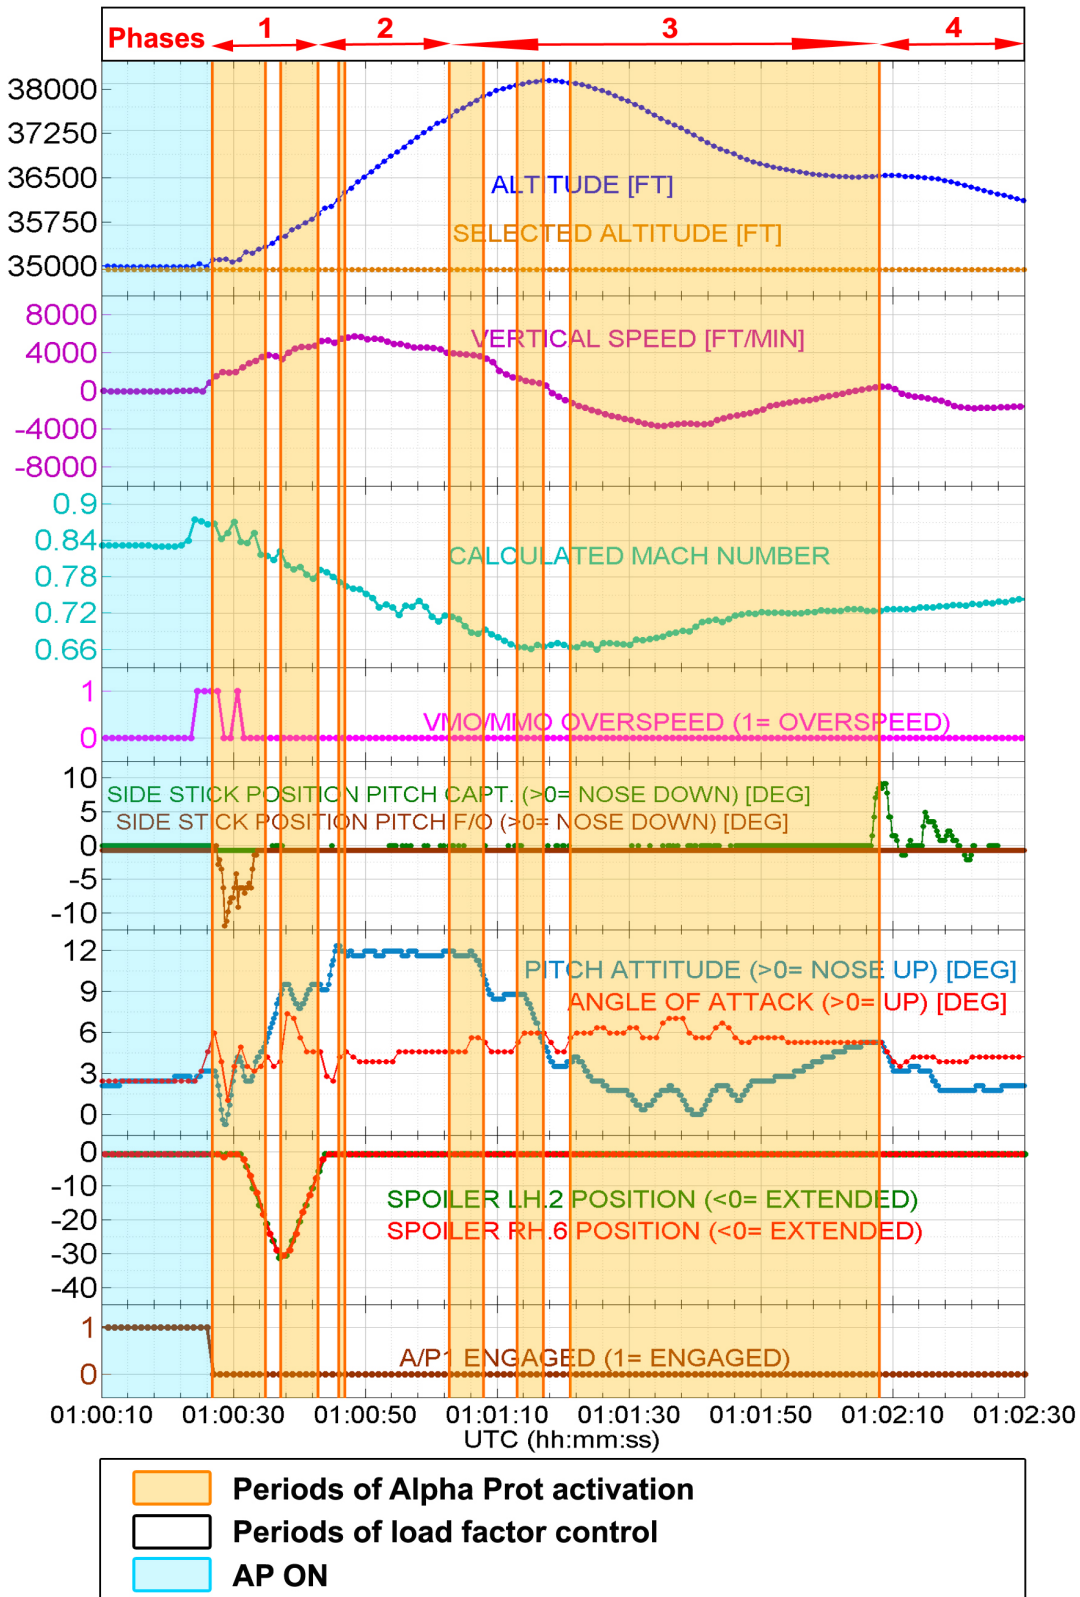
The level bust can be divided into 4 phases:

- ❑ Phase 1: Initially, a gust of headwind⁽¹⁾ generated overspeed and the activation of the "OVERSPEED" warning. A few seconds later, a rising gust caused an increase in the angle of attack and vertical speed. Then, the PNF disengaged the autopilot and made a pitch-up input for 6 seconds while the PF extended the speedbrakes. From the start of the pitch-up input, the angle of attack being greater than Alpha Prot, the high angle of attack protection was activated. Then, for 2 seconds, the angle of attack moved briefly below Alpha Prot, with the sidestick in neutral, which meant it exited the protections. The combined effects of turbulence, sidestick input and the extension of the speedbrakes led to increases in pitch, vertical speed and altitude. An angle of attack spike greater than Alpha Prot activated the high angle of attack protection again. The angle of attack continued to increase and passed Alpha MAX, which caused the automatic retraction of the speedbrakes.

- ❑ Phase 2: The intensity of the turbulence decreased and the angle of attack again became less than Alpha Prot (except for 2 seconds). In the absence of sidestick input, the high angle of attack protection deactivated. The load factor control law then maintained the rising trajectory of the aeroplane. During the climb, since the vertical speed exceeded the capacity to climb at constant speed, the aeroplane speed decreased. When lift became less than weight, the pitch decreased. Maintaining the load factor at 1 g induced a slight increase in the angle of attack.

- ❑ Phase 4: The angle of attack was equal to Alpha Prot therefore less than Alpha MAX. Consequently, the PF's pitch-down input for more than one second on the sidestick caused the high angle of attack protection to be exited and the longitudinal control law returned to load factor. The pitch attitude decreased then stabilised until the crew re-engaged the autopilot.
