FINAL REPORT

AIRBUS A380-800, REGISTRATION 9V-SKD

SMOKE IN LAVATORY

31 JANUARY 2011

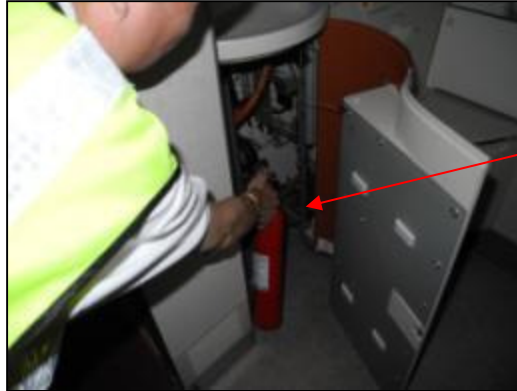
Figure 2: CIC discharging fire extinguisher (illustration only)

Smoke emitting from base of wall panel under the sink

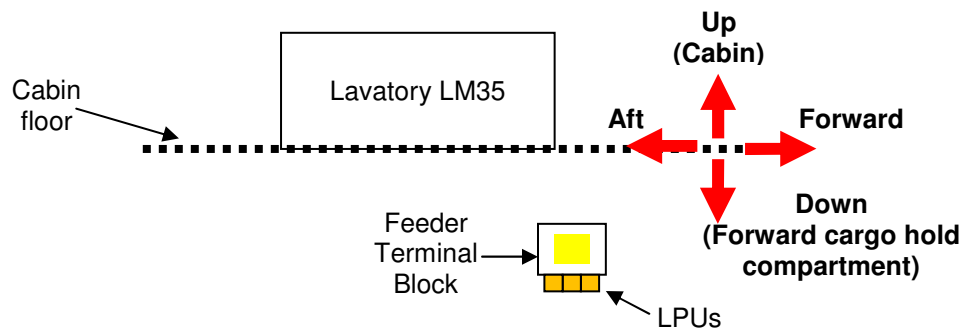
Figure 3: Location of feeder terminal block

1.2.1 The aircraft was inspected after landing in Singapore. Signs of burning were found on the feeder terminal block for the No.1 VFG located in the forward cargo compartment below lavatory LM35 (see **Figure 3**), on the feeder cables connected to the feeder terminal block and on the insulation blankets around the feeder block (see **Figure 4**). The inner surface of the cover of the feeder terminal block was partially covered with soot but did not show any sign of heat damage.

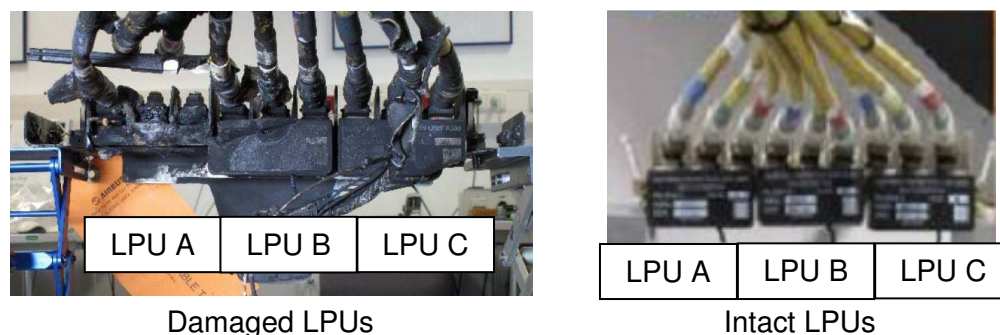
Figure 5: Damaged LPUs as compared with intact ones⁶

- 1.2.2 The Lightning Protection Units (LPUs) connected to the feeder terminal block showed signs of melting (see **Figure 5**).

- 1.4.2.2 An examination of the damage on the LPUs suggested that the damage was caused by excessive current flowing through the LPUs.
- 1.4.3 Flow of Fire Extinguishing Agent

- (b) The VFG output voltage continued to increase beyond the breakdown voltage of the LPUs, causing the LPUs to conduct. The LPUs, designed for lightning strike (high transient voltage of short duration), conducted for a duration longer than they were designed for. This resulted in a short circuit between the feeder cables attached to the feeder terminal block and the electrical ground, causing excessive currents to flow through the feeder cables. The design of the lightning protection system was such that it did not prevent the feeder cables from being shorted to the electrical ground when excessive voltage is output by the VFG.

- (c) The excessive current flowing through the feeder cables overheated and damaged the feeder terminal block and the LPUs. The Over-Current protection was eventually triggered and limited the damage due to overheating.

- 4.1 The aircraft manufacturer, as holder of the type certificate, review the design of the lightning protection system to prevent short circuiting of the feeder cables when excessive voltage is output by the Variable Frequency Generator. [AAIB Recommendation R-2012-002]

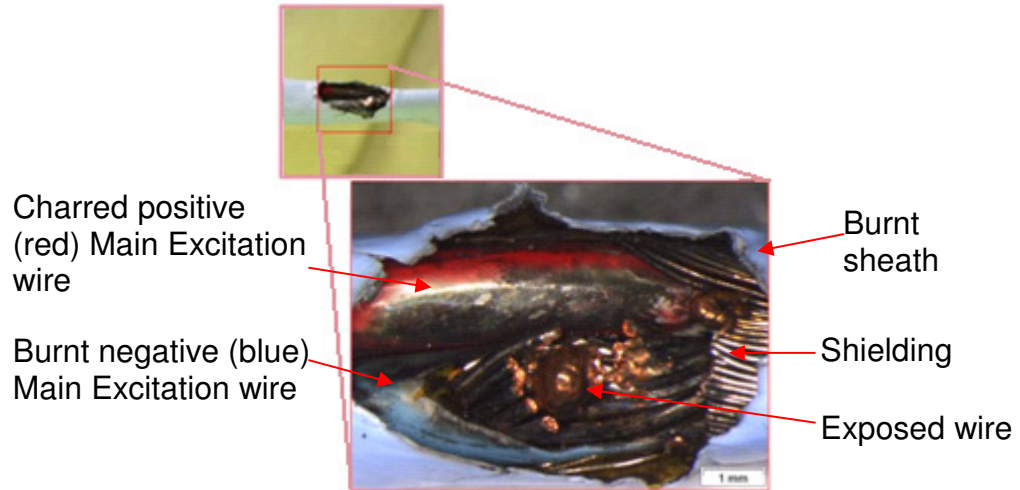
Figure 6: Main Excitation Cable damage

- 1.2.5 During the subsequent troubleshooting⁸, the Main Excitation Cable⁹ was found to be degraded. The sheath and shielding of the Main Excitation Cable and the insulation of the negative (blue) Main Excitation Wire were damaged (see **Figure 6**).

- 1.2.6 There was no heat or stress damage found in the proximity of the Main Excitation Cable damage. There was no maintenance work performed on the Main Excitation Cable since the aircraft was delivered to the operator. Figure 7 illustrates the locations of the various components.

- 1.4.1.4 Failure analysis of the Main Excitation Cable revealed that the negative Main Excitation Wire was damaged by electrical arcing between the negative Main Excitation Wire and the cable shielding that enveloped the positive and negative Main Excitation Wires.

2.1.2 Failure analysis of the Main Excitation Cable revealed that the negative Main Excitation Wire was damaged by electrical arcing (see paragraph 1.4.1.4). The electrical arcing could explain the damage to the feeder terminal block for the No.1 VFG and the LPUs connected to the feeder terminal block:

2.1.3 The electrical arcing also suggests that there might be prior damage to or imperfection of the insulation of the negative Main Excitation Wire. However, this cannot be ascertained. According to the operator, there had been no maintenance work performed on the Main Excitation Cable since the aircraft was delivered to the operator. Therefore it seems unlikely that the insulation damage, if there really was, occurred after aircraft delivery. The insulation damage or imperfection could also have arisen during the aircraft manufacturing process, but there is no evidence in this regard.

3.4.1 The aircraft manufacturer revised the troubleshooting procedure on 1 October 2011. The revised procedure requires an insulation check of the excitation line circuit (which includes the Main Excitation Cable) to be performed.

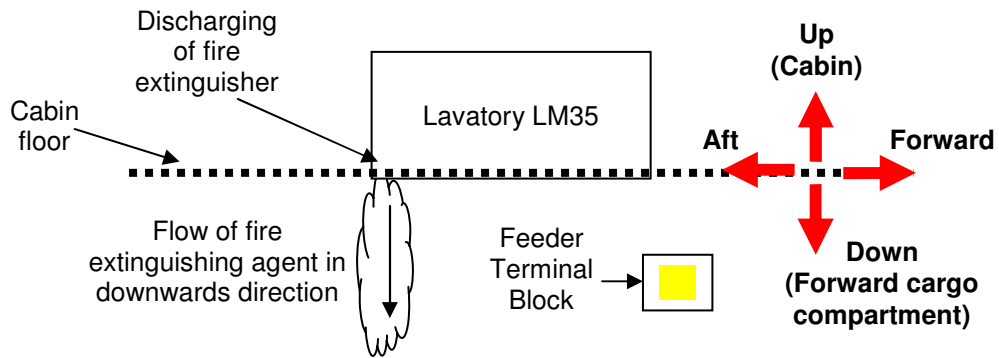
Figure 9: Flow of Fire Extinguishing Agent

- 1.4.3.1 When the CIC demonstrated to the investigation team how he had discharged the fire extinguisher, it was observed that the fire extinguishing agent did not reach the feeder terminal block (see diagram (not to scale) in **Figure 9**).

- 2.5 Fire Detection and Suppression
 - 2.5.1 There was no fire detection or suppression system installed on the aircraft to detect fire in the vicinity of the feeder terminal block nor was there a means for the cabin crew to access the damaged feeder terminal block to fight any fire there. The flow of the fire extinguishing agent discharged from lavatory LM35 (see **Figure 2** and **Figure 9**) could not reach a fire at the feeder terminal block.
 - 2.5.2 The fire that damaged the feeder terminal block had probably extinguished by itself but it remains a concern that there is no sure way of detecting and extinguishing a fire in that area.

- 4.2 The aircraft manufacturer, as holder of the type certificate, review the need for fire detection and suppression in the vicinity of the feeder terminal block. [AAIB Recommendation R-2012-003]
