Final Report No. 2016

concerning the serious incident

involving aircraft ATR 42-320, registration HB-AFC
operated by the FARNAIR company, flight FAT6932

on 29 March 2006

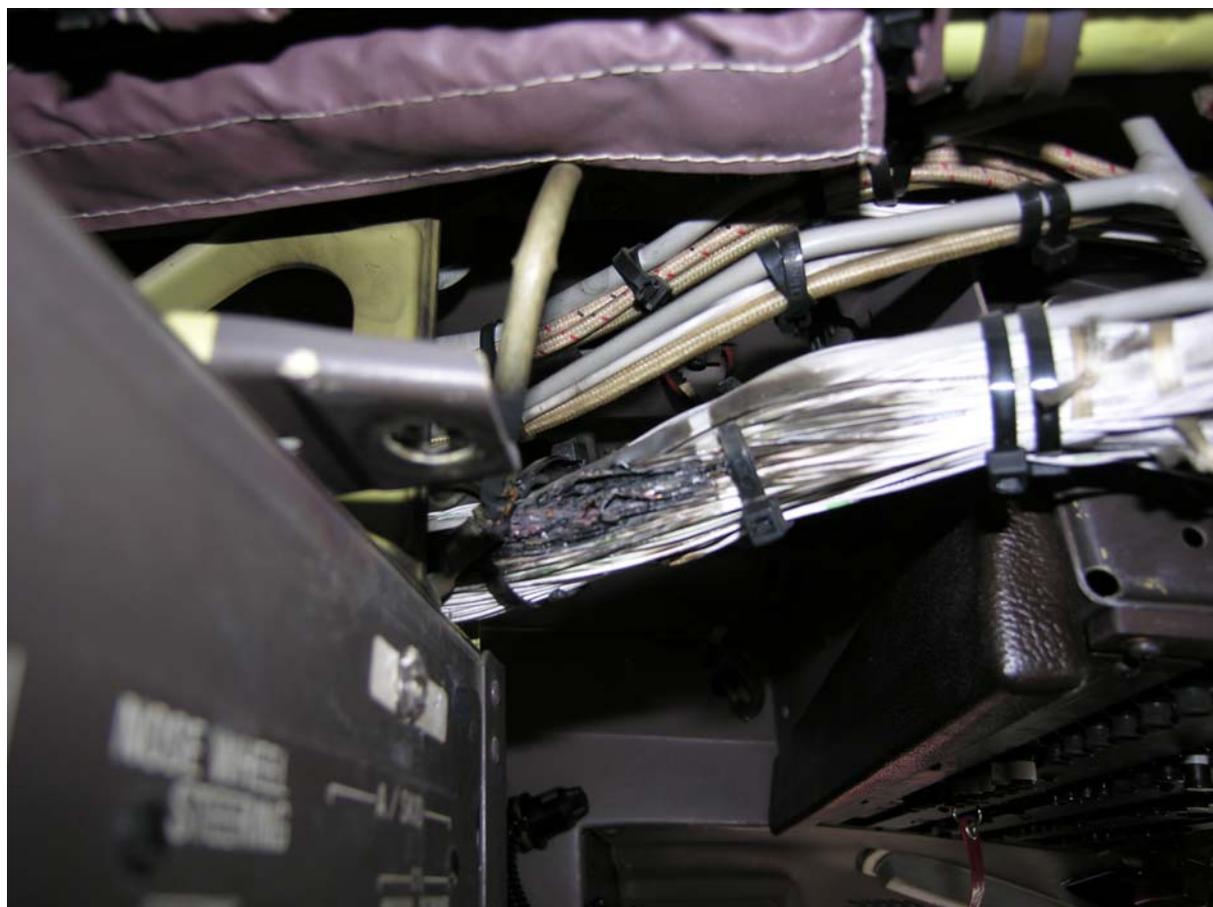
Annexe 1: Wiring strand damaged by the fire

A strand consisting of several hundred electrical wires, fixed by collars to a tubular structure, runs in the 120VU compartment located above the 121VU circuit breaker panel. Forty-eight of these exhibited damage caused by electrical arcing over a length of around 10 cm and over a surface area of approximately 20 cm²; the insulation had broken down and the metal had partially melted. Black traces left by combustion products covered the damaged area of the strand and also extended over some 15 centimetres of the spindle. The onboard systems linked to the damaged wires were not damaged.

The tubular support in contact with the burnt wires was damaged. At this point, the strand touched an earth cable which also exhibited traces of fire.

At one corner of the internal wall's surface of the 120VU compartment, there was a small area bearing trace of fire.

- an earth cable was fitted incorrectly. As a result, its lower terminal was in direct contact with the wiring strand, whereas a space of at least 12.5 mm (0.5 in) is required between these two items;
- the tubular support onto which the strand was tied was deformed; the routing of the bundle of wires which had been modified in this way no longer permitted compliance with the minimum separations required between the structure and other cables;
- the collars fixing the strand to the tubular structure were not tightened correctly;
- the damaged strand contained more electrical wires than the original one because of modifications resulting from application of service bulletins; its diameter had therefore increased.

The lower terminal of the earth cable was in direct contact with the badly clamped, and therefore insufficiently tightened, electrical wires of a strand which was bulkier than its original design and mounted on a deformed tubular support. Its compactness was thus reduced and there was sufficient play between the wires to allow friction between them and with the earth cable. This phenomenon caused a reduction in the dielectric properties of the insulation of wires touching the earth cable terminal. As a result of wear, this insulation broke down, allowing direct metal-to-metal contact between two conductors, which was the cause of the major short-circuit.

The damage caused by the fire, described in section 1.3.1, is indicative of the development of a fire following a cascade process of electrical arcs giving rise to the phenomenon termed general conflagration: the first short-circuit results in vaporisation of the conducting metal, generating very high temperatures and pressures in its immediate vicinity. The heat resulting from this vaporisation and from the electrical arc itself then break down the insulation of adjacent wires, leaving them exposed and in contact with each other. There is then a progressive cascade of arcs and combustion between the wires in the strand, which only ceases when the overvoltage protection systems activate, i.e. the circuit-breakers trip. To human perception, this succession of short-circuits is virtually instantaneous.

On 14 September 2006, the European Aviation Safety Agency (EASA) issued an airworthiness directive (AD) requesting inspection before 31 December 2006 of all ATR 42/72 aircraft in which the risk of a short-circuit resulting from this assembly defect might exist (Annex 2). The details of this operation and of the measures to be taken if necessary are given in Service Bulletins Nos. ATR42-92-0012 and no. ATR72-92-1013.
