Avoiding Convective Weather Linked to Ice-Crystal Icing Engine Events

Understanding the weather conditions that have been linked to ice-crystal icing can help pilots avoid situations that may put airplane engines at risk for power loss and damage.

By **Matthew L. Grzych**, Meteorologist, Atmospheric Physics and Flight Test Engineering

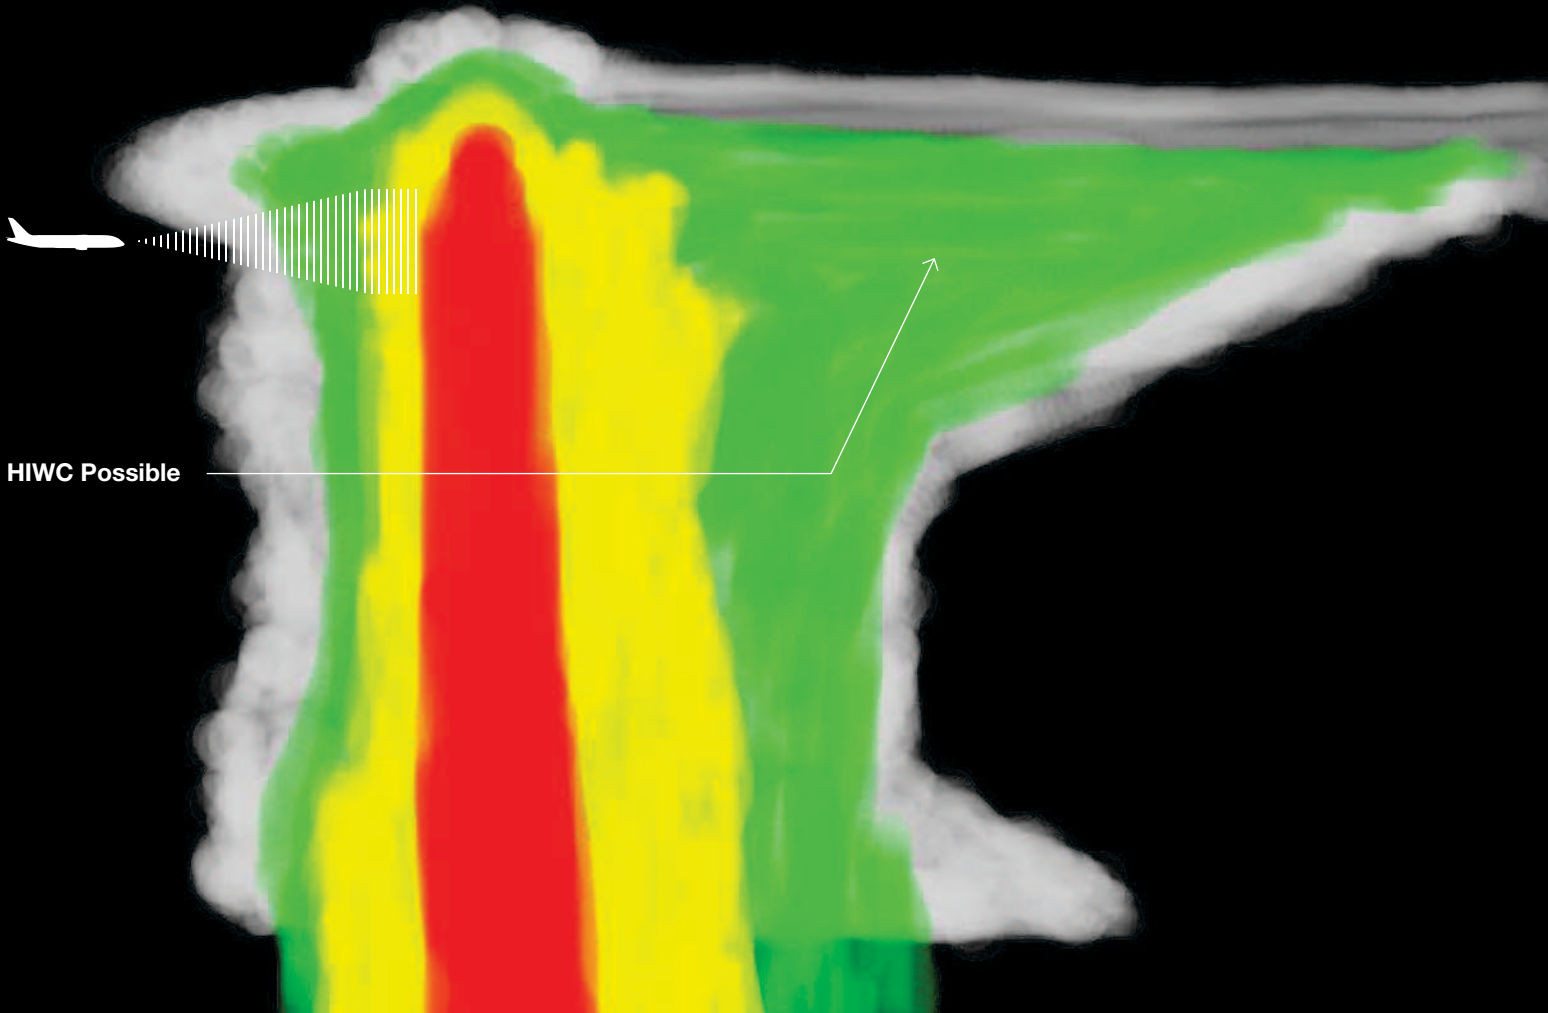
Figure 1: Classic convection: Cores readily detectable by radar

This image depicts a vertical cross-section view as an airplane is headed for a classic convective cell. Colors represent standard airplane radar returns where green is light, amber is moderate, and red is heavy. In this scenario, the radar beam pointed straight ahead detects heavy precipitation and the airplane diverts and avoids the weather. There is, however, an area of high ice water content (HIWC) possible in the anvil cloud downwind from the convective core that pilots need to be aware of and avoid.

Classic convection: Classic convection has vigorous updrafts, is typically found over land, and will have moderate to heavy radar signatures present up to high altitudes, making the core areas and danger zones detectable so the flight crew can avoid them (see fig. 1). Because this region of convective weather can be detected by the airplane's radar system, pilots can avoid the cell by diverting to the upwind side. In

these more typical convective clouds, engine events have been recorded in the anvil cloud downwind from the cell's core. In the anvil, even though there can be HIWC, ice particles return only enough radar energy to occasionally record green signatures on the pilot's radar. At other times, there may be no radar returns at all.

Pilots should avoid the region of anvil cloud downwind from heavy cores near these typical convective cells, especially if light radar returns are present at high altitudes. However, in the majority of ice crystal engine events, pilots unknowingly pass directly over heavy convective precipitation through the anvil cloud into regions of high ice content within

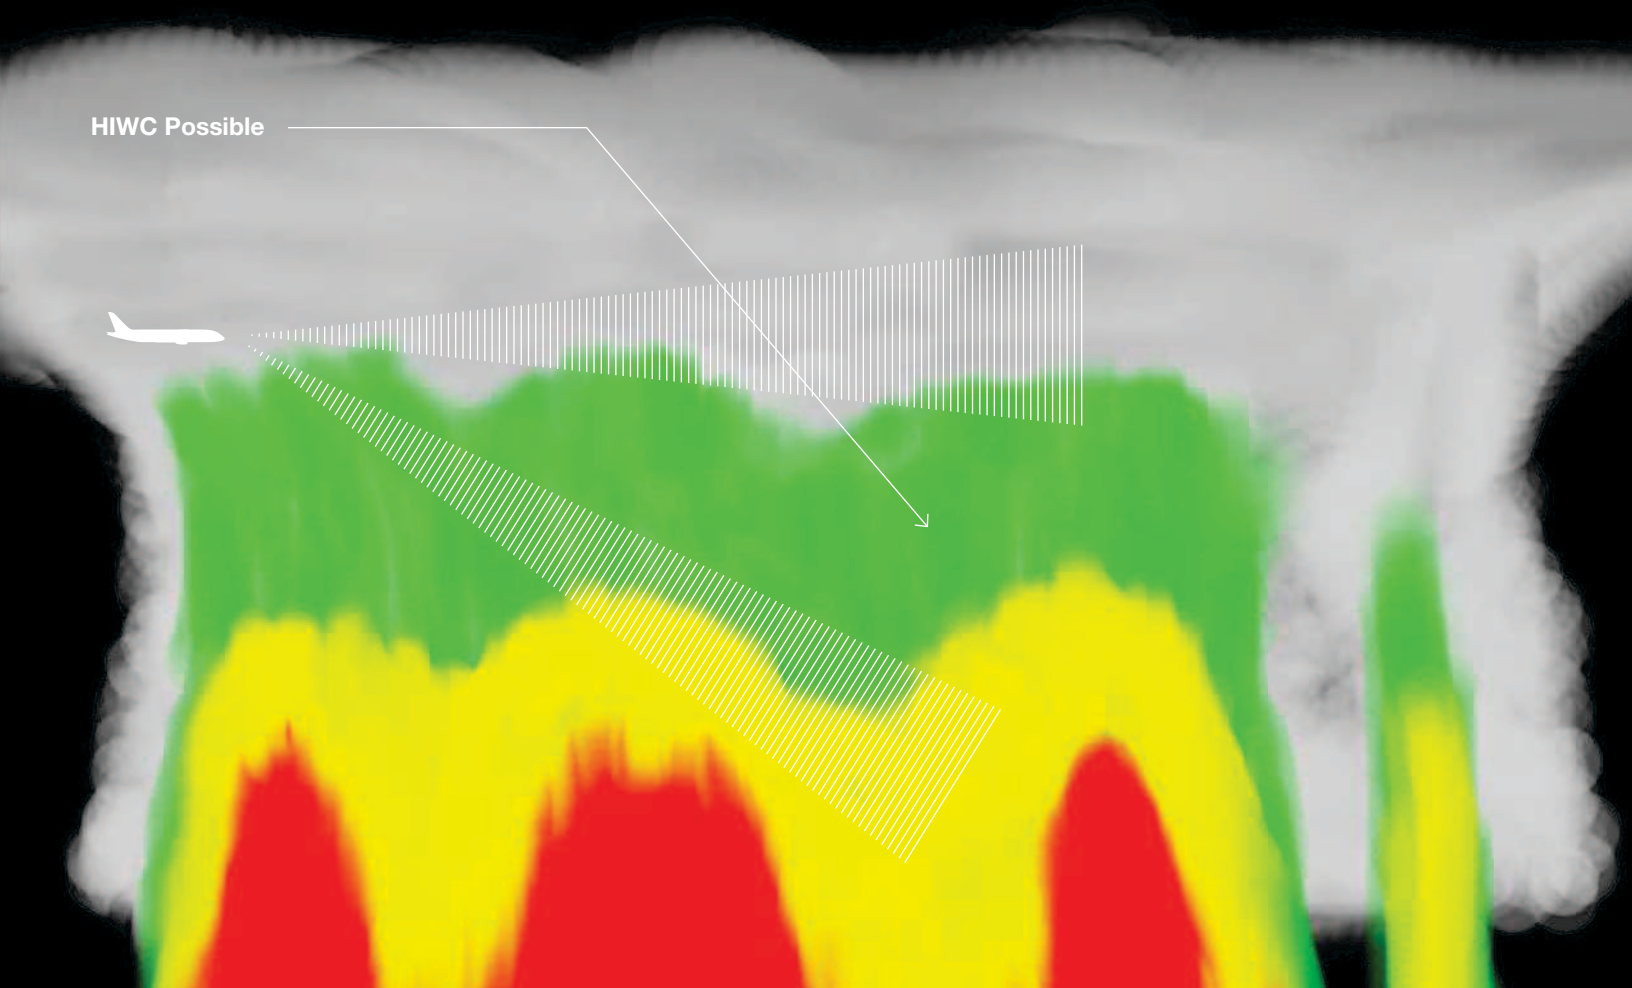
Figure 2: Radar view of typical ice crystal engine conditions

This image depicts a cross-section view as an airplane is headed for a nonclassic convective system. During a typical ice crystal engine event, the airplane will be flying in convective cloud with light radar returns at flight level. However, if the pilot uses the radar tilt function to scan below the airplane, moderate to heavy radar returns will be seen. These are regions to avoid because they are associated with regions of HIWC.

Nonclassic convection: The type of weather that is most associated with ice crystal icing and subsequent engine events is not what is generally considered typical convection, which has vigorous cores that can be detected at flight level. Instead, the convective weather that is of greatest concern is associated with nonclassic convective clouds that have weak updrafts, regions of decaying convection, and regions of HIWC aloft, but lacks reflectivity at flight level, making it more difficult for pilots to identify (see fig. 2).

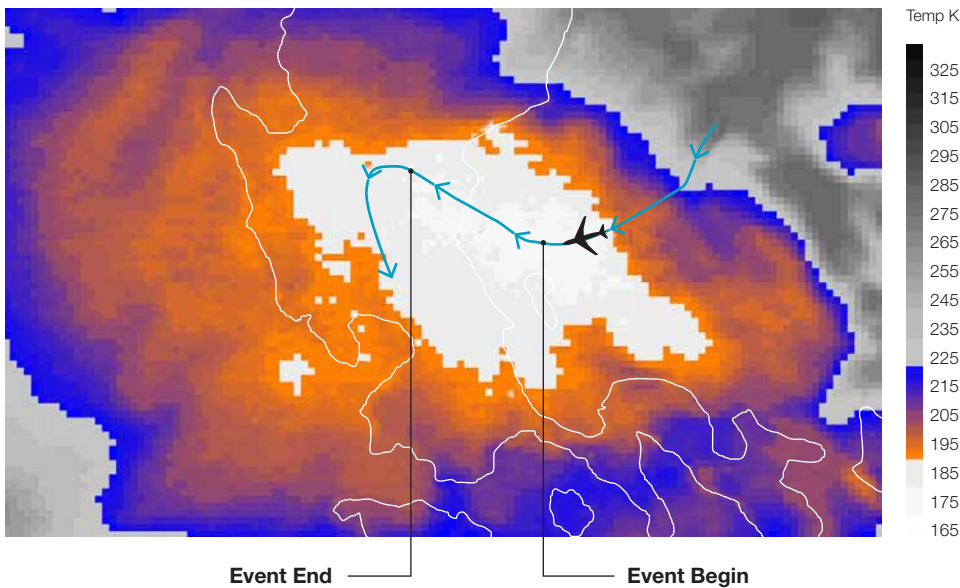
Figure 3: Infrared satellite image of a large convective system where an engine icing event occurred

This satellite image shows a typical scenario for ice crystal engine events in which an airplane enters a large convective system while on ascent or descent at temperatures well below freezing.

Airlines can gain valuable insights into convective weather associated with engine power loss and damage by examining an actual engine icing event (see fig. 3). In the enhanced infrared satellite image of a large convective system where an engine icing event occurred, the colored areas represent regions of deep convection and the bright white region is where cloud tops have penetrated through the tropopause into the lower stratosphere. The airplane flew along the path from right to left, entering a large anvil cloud associated with a tropical convective system. A TAT anomaly was observed shortly after the airplane entered

the anvil cloud, followed by a series of engine events as the airplane penetrated the deepest part of the storm at temperatures well below freezing. The engines recovered quickly, and the airplane continued safely to its destination.

In this region of the convective system, large amounts of moisture are lifted, converted to ice crystals, and then lofted to high altitudes. This event represents a fairly typical scenario for ice crystal engine events in which an airplane enters a large tropical-like convective system while on ascent or descent at temperatures well below freezing. The engine event then occurs while passing through a region of deep glaciated convective cloud with moderate to heavy rain below the airplane.

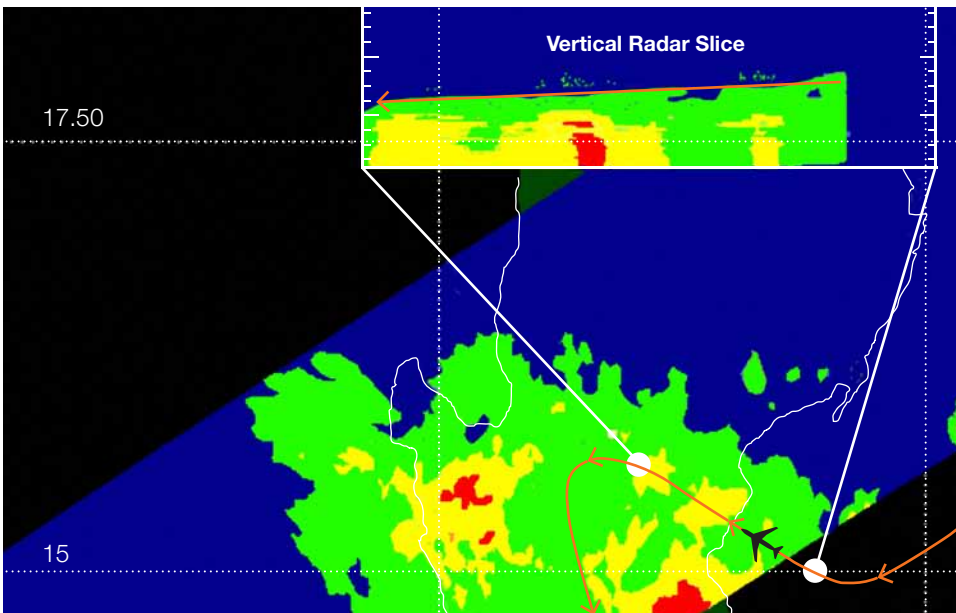
Figure 4: Satellite-based radar view of convective system where an engine icing event occurred

Radar data for this event shows a top-down view (main image) and a vertical slice looking northeast through the storm (inset). The red arrow depicts the airplane flight trajectory.

Radar data provides another view of this ice crystal engine event (see fig. 4). The red arrow represents the airplane's flight trajectory; a series of engine events occurred between the white dots. Low-level radar returns along the path were mostly moderate with some embedded heavy return regions. However, at flight level — where the series of events occurred — radar returns were only scattered light return (green) areas. Using the radar's tilt function to scan below the airplane would have revealed moderate to heavy returns below.

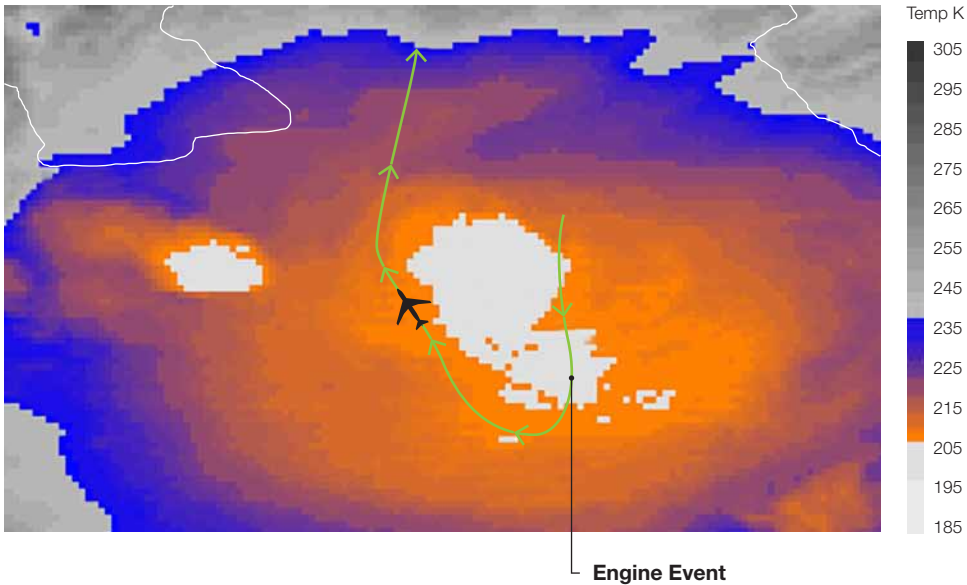
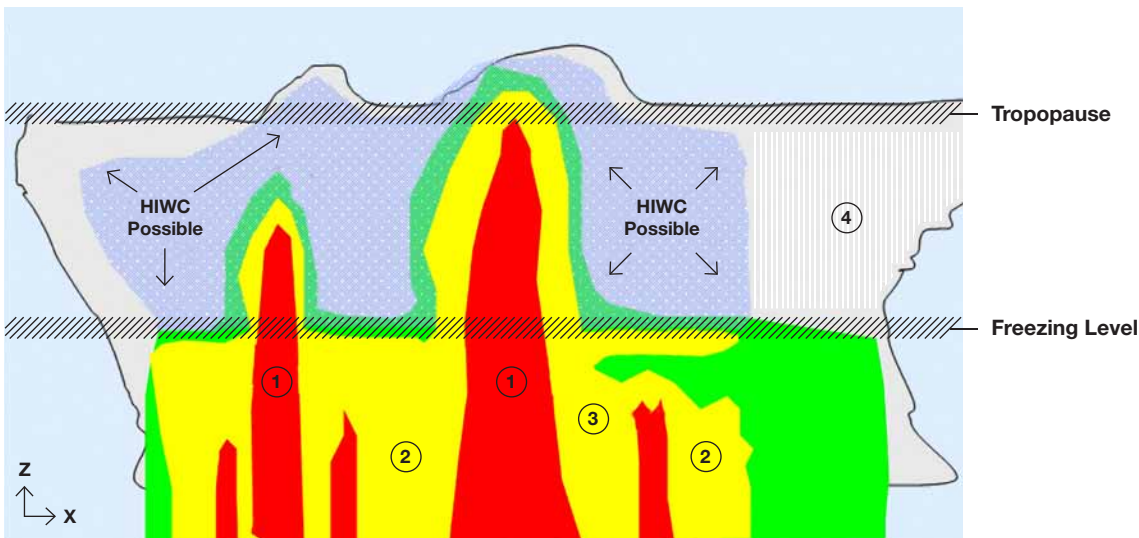
Figure 5: Conceptual model showing areas of high ice content

An infrared satellite image of a tropical mesoscale convective system where an engine event occurred (top) and an idealized east-west vertical cross-section through the storm's center viewing it from south looking north (bottom). Green, yellow, and red areas represent light, moderate, and heavy radar return regions, respectively. Ice content is labeled HIWC.

A conceptual model helps illustrate where areas of high ice content might be found (see fig. 5). In these systems, there can be several areas of active convection where heavy returns may be present to high altitudes, as well as broad regions of decaying

convection and moderate to heavy stratiform precipitation regions at lower levels.

Engine event threat areas include regions above the freezing level either adjacent to or downwind of heavy convective cores or above moderate to heavy rain associated with decaying convection or stratiform regions within the convective system. Both regions are labeled “HIWC Possible” in figure 5.
