INCIDENT REPORT

Runway Excursion Incident

Boeing 777-200 Registration 9V-SRG

AIB/AAI/CAS.016

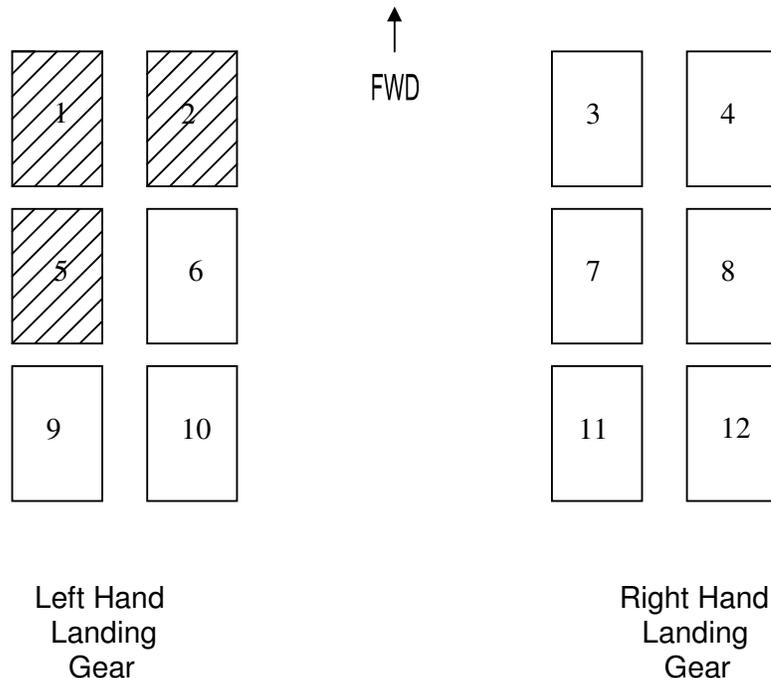
1.18.1 All six tyres on the left hand landing gear had rubber reversion⁶, indicating reverted rubber aquaplaning had occurred. Three of the six tyres at positions 1, 2 and 5 were deflated. Below is a sketch showing the layout of the main landing gear tyres of the Boeing 777 aircraft.

Notes: Number in the box is the wheel position number.
Deflated tyres are shown shaded in the sketch above.

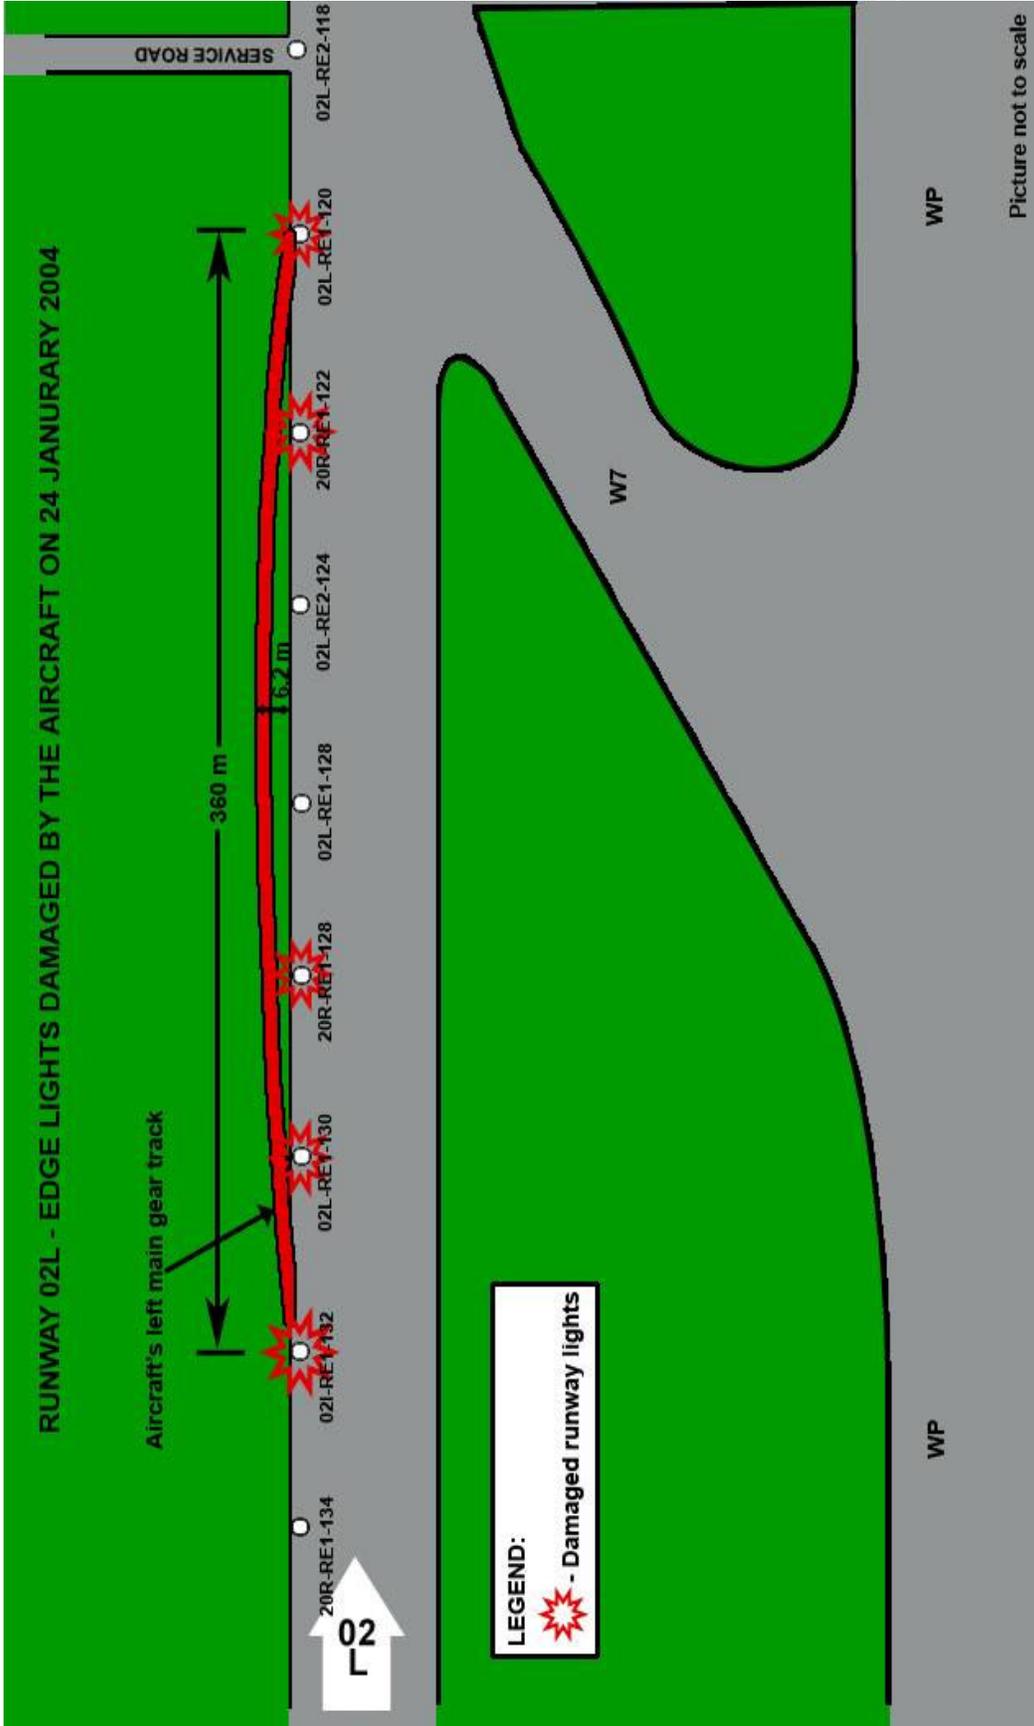
Appendix 1: Schematic of Runway 02L edge lights damaged by the aircraft

- 1.1.15 The left hand landing gear of the aircraft departed the runway for about six seconds. From the wheel tracks in the soft ground, it was determined that the left hand landing gear had rolled about 360 m on the grass verge with the maximum displacement of about 6.2m from the runway edge (see **Appendix 1**).

- 1.4 **Other damage**
- 1.4.1 There was no damage to the runway surface. Five runway edge lights along the western side of Runway 02L between Taxiways W9 and W7 were damaged.

- 1.4.2 The wheel tracks on the soft ground started near the runway edge light No.132 which was about 700 m from the start of the threshold of Runway 02L and ended at runway edge light No.120. The wheel

tracks were about 360 m long and about 6.2 m at their furthest from the edge of the runway. Only the left landing gear had departed the runway.

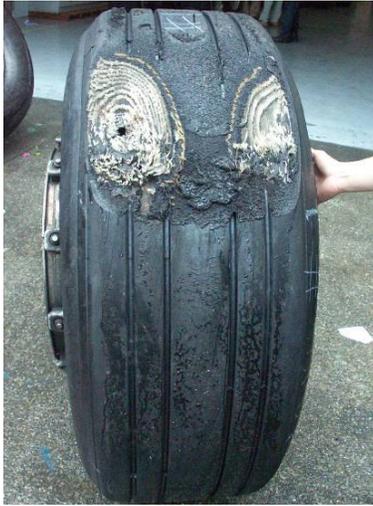
Tyre No. 1

- All six tyres on the left hand landing gear suffered rubber reversion. Tyres number 1, 2 and 5 were deflated. (See **Appendix 2**)
 - Two wing-to-body fairing panels aft of the wheel well were damaged.

- 1.18.2 Two tyres fitted at the No.1 and No.9 positions were sent to the tyre manufacturer, by the operator, for examination and analysis. The report from the tyre manufacturer indicated that both tyres had severe flat spotting and exposed belt plies. The damage appeared to have been initiated by reverted-rubber aquaplaning. The level of abrasion on the tyres also indicates that the tyres were blocked from rolling for some period, while in contact with the runway surface.

- 1.18.3 The report also indicated that the tread wear pattern of No.1 tyre showed an overload condition or partial or full loss of pressure, which resulted in the shoulder areas abrading more than the centre tread area. This tyre was apparently blocked from rolling for a greater distance than the No.9 tyre as the amount of tread rubber abrasion was much more.

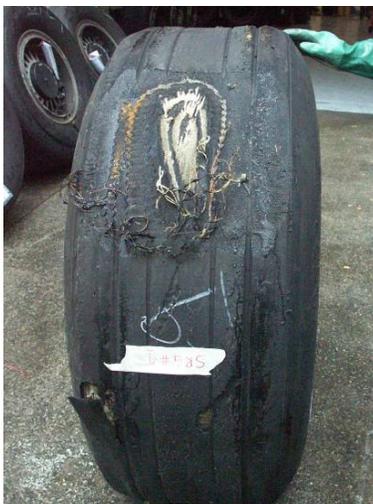
Tyre No. 9

- 1.18.4 No. 9 tyre's tread has a flat spot consistent in size with its normal load bearing, contact area. The tyre has worn in the centre rib area exposing the steel protector ply and two layers of belt ply. The wear was not sufficient to cause any loss of pressure. The slightly more central wearing (compared to the shoulders) is consistent with normal loading of that wheel.
