INCIDENT

Aircraft Type and Registration:	Avro 146-RJ100, G-CFAE	
No & Type of Engines:	4 Lycoming LF507-1F turbofan engines	
Year of Manufacture:	2001	
Date & Time (UTC):	11 January 2006 at 0830 hrs	
Location:	Edinburgh	
Type of Flight:	Public Transport (Passenger)	
Persons on Board:	Crew - 5	Passengers - 98
Injuries:	Crew - None	Passengers - None
Nature of Damage:	Nil	
Commander's Licence:	Airline Transport Pilot's Licence	
Commander's Age:	48 years	
Commander's Flying Experience:	7,300 hours (of which 65 were on type) Last 90 days - 65 hours Last 28 days - 30 hours	
Information Source:	AAIB Field Investigation

Synopsis

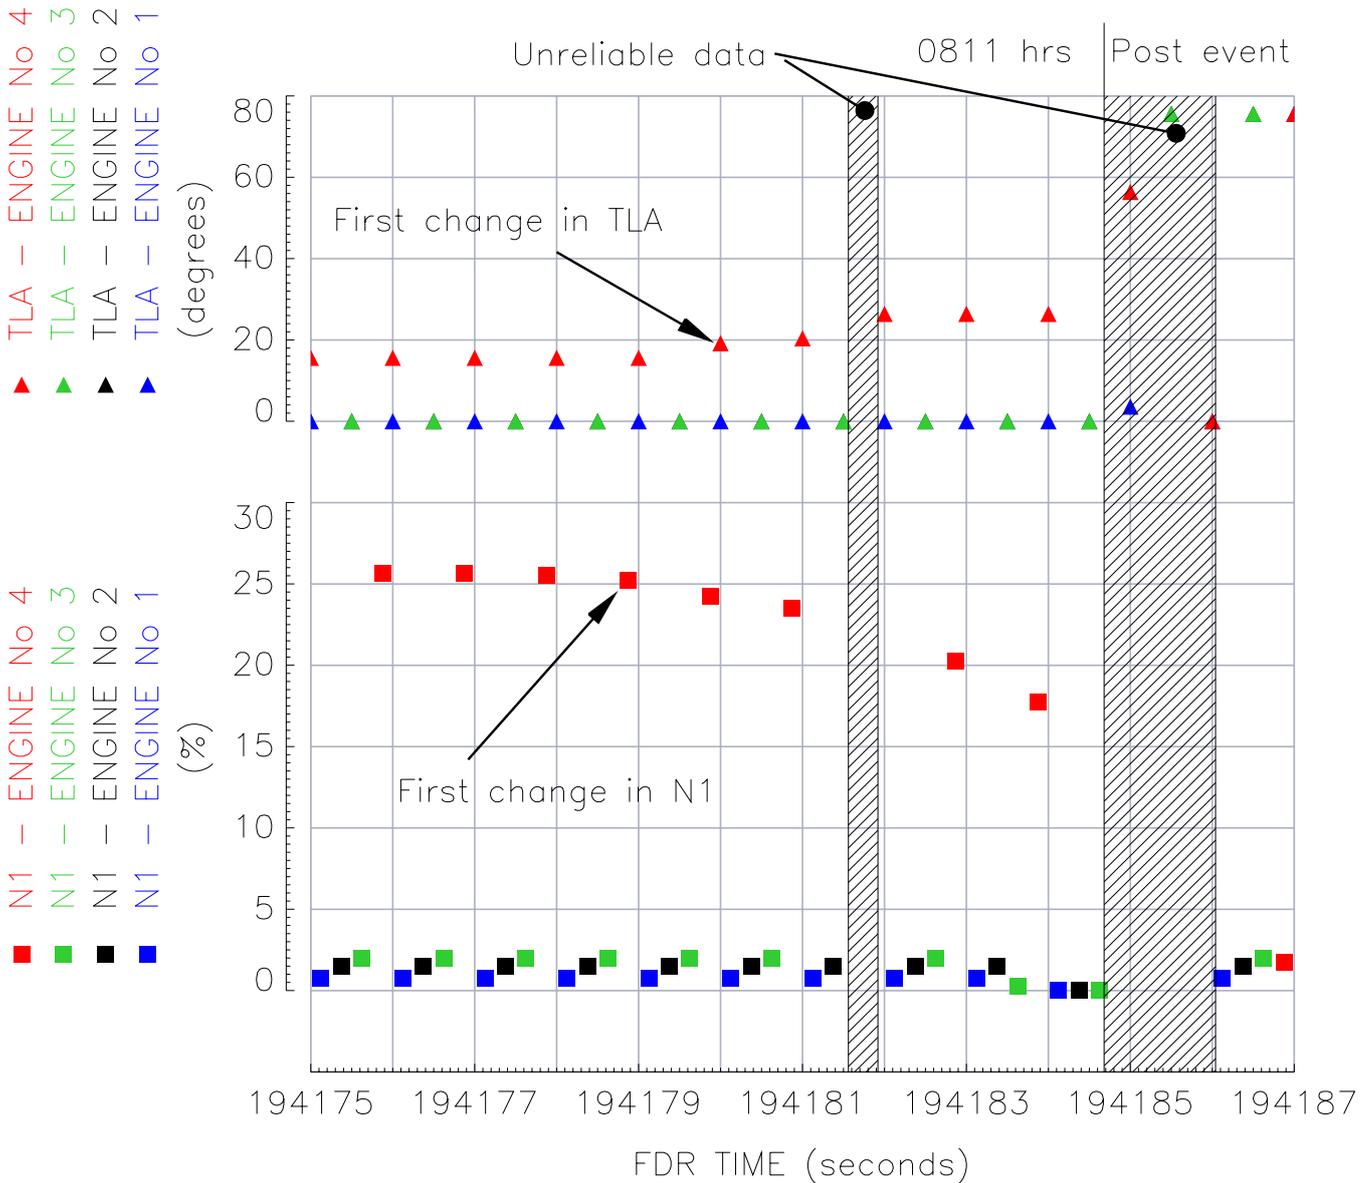
Figure 1 shows the FDR recording just prior to the loss of power. The TLA for engine No 4 did not change until after the N1 for engine No 4 started dropping. The FDR recording stopped for less than a second and then restarted briefly, operating for approximately three further seconds before it stopped again.

Within the limitations of data being recorded only once every second, there is no indication that the N1 of engine No 4 was increased above the idle state. Therefore, it is reasonable to conclude that the N2 of engine No 4 was below the required value of 65% when the start of engine No 3 was attempted.

FDR recorded N1 and TLA parameters. Note that TLA No 2 is hidden behind TLA No 3
