**SERIOUS INCIDENT**

<b>Aircraft Type and Registration:</b>	Boeing 757-236, G-TCBC	
<b>No &amp; Type of Engines:</b>	2 Rolls-Royce RB211-535E4-37 turbofan engines	
<b>Year of Manufacture:</b>	1999 (Serial no: 29946)	
<b>Date &amp; Time (UTC):</b>	17 August 2013 at 1610 hrs	
<b>Location:</b>	During go-around at Newcastle International Airport, and diversion to Manchester Airport	
<b>Type of Flight:</b>	Commercial Air Transport (Passenger)	
<b>Persons on Board:</b>	Crew - 7	Passengers - 235
<b>Injuries:</b>	Crew - None	Passengers - None
<b>Nature of Damage:</b>	Nil	
<b>Commander's Licence:</b>	Airline Transport Pilot's Licence	
<b>Commander's Age:</b>	56 years	
<b>Commander's Flying Experience:</b>	13,374 hours (of which 1,380 were on type) Last 90 days - 212 hours Last 28 days - 48 hours	
<b>Information Source:</b>	AAIB Field Investigation

**Synopsis**

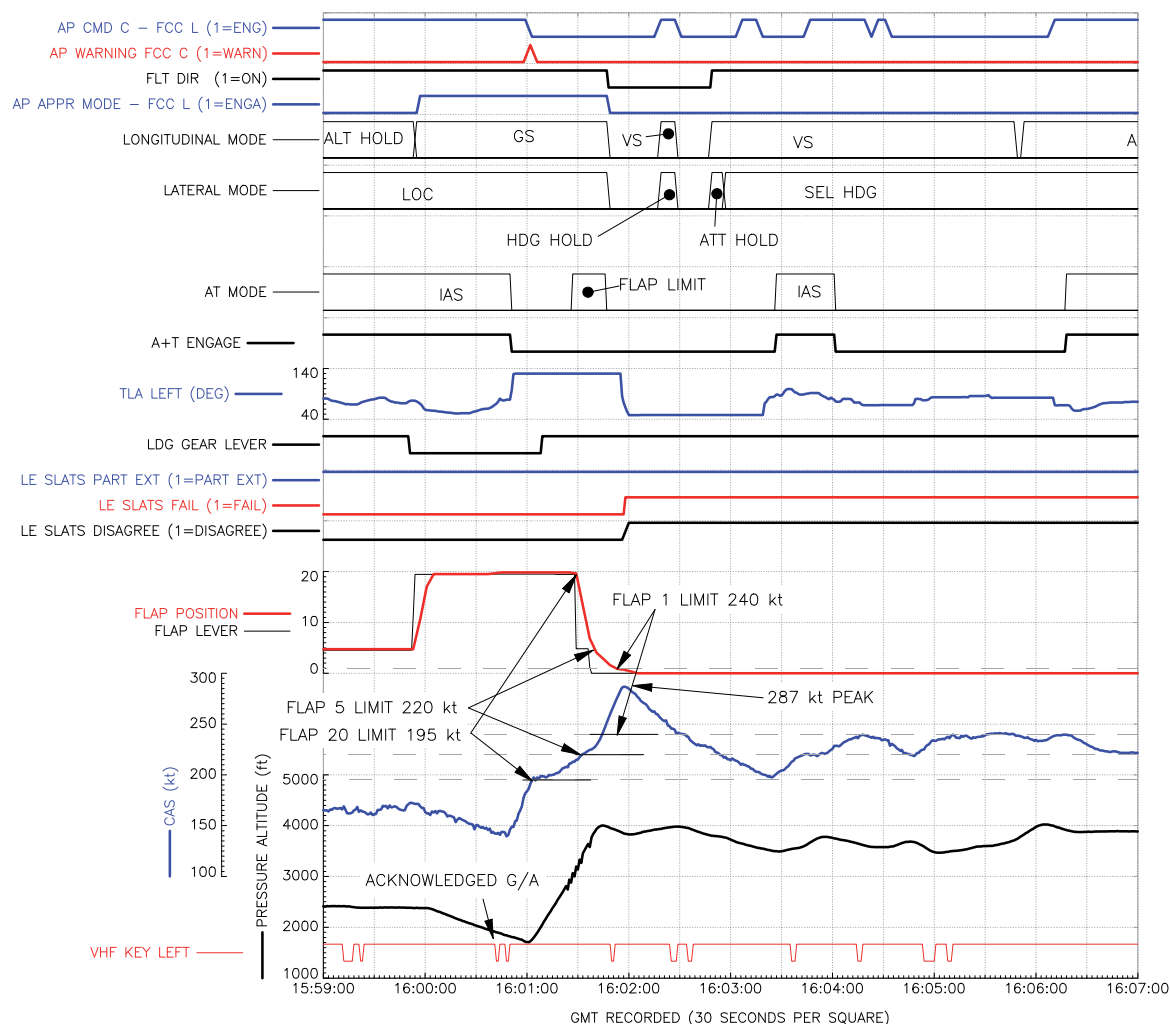
**Figure 7**

Figure 7 shows the pertinent parameters for the G/A sequence.

Go-around speeds, flap limits and automatics

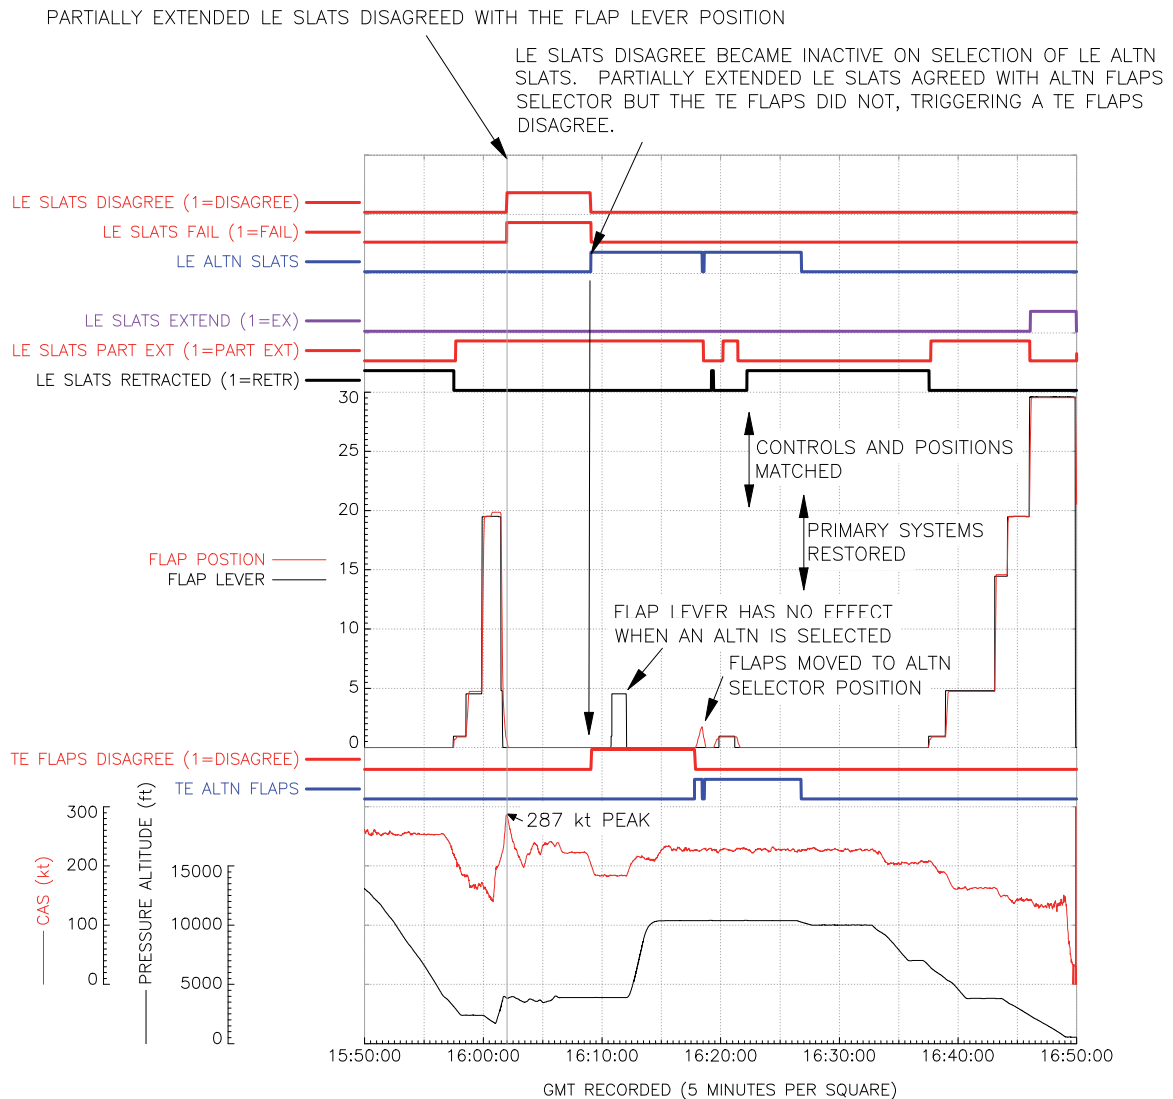
**Figure 8**

Flap and slat parameters for the G/A and remainder of the flight

The LE SLAT DISAGREE parameter, along with the partially extended state of the LE slats with the flap lever at 0, indicate that the slats could not reach the selected retracted state. This condition started when flaps retracted past FLAP 1, when the slats should have started retracting and the aircraft was above the FLAP 1 limit speed. The end of the LE SLAT DISAGREE condition coincided with the recorded selection of LE ALTN SLATS. This indicates that the LE alternate flaps switch had been pressed which:

No other flap/slat issues were recorded for the remainder of the flight and the landing was made using FLAP 30. Other than the conditions associated with excessive speed and partial slat extension, the flap and slat parameters reacted as expected for the given crew selections.

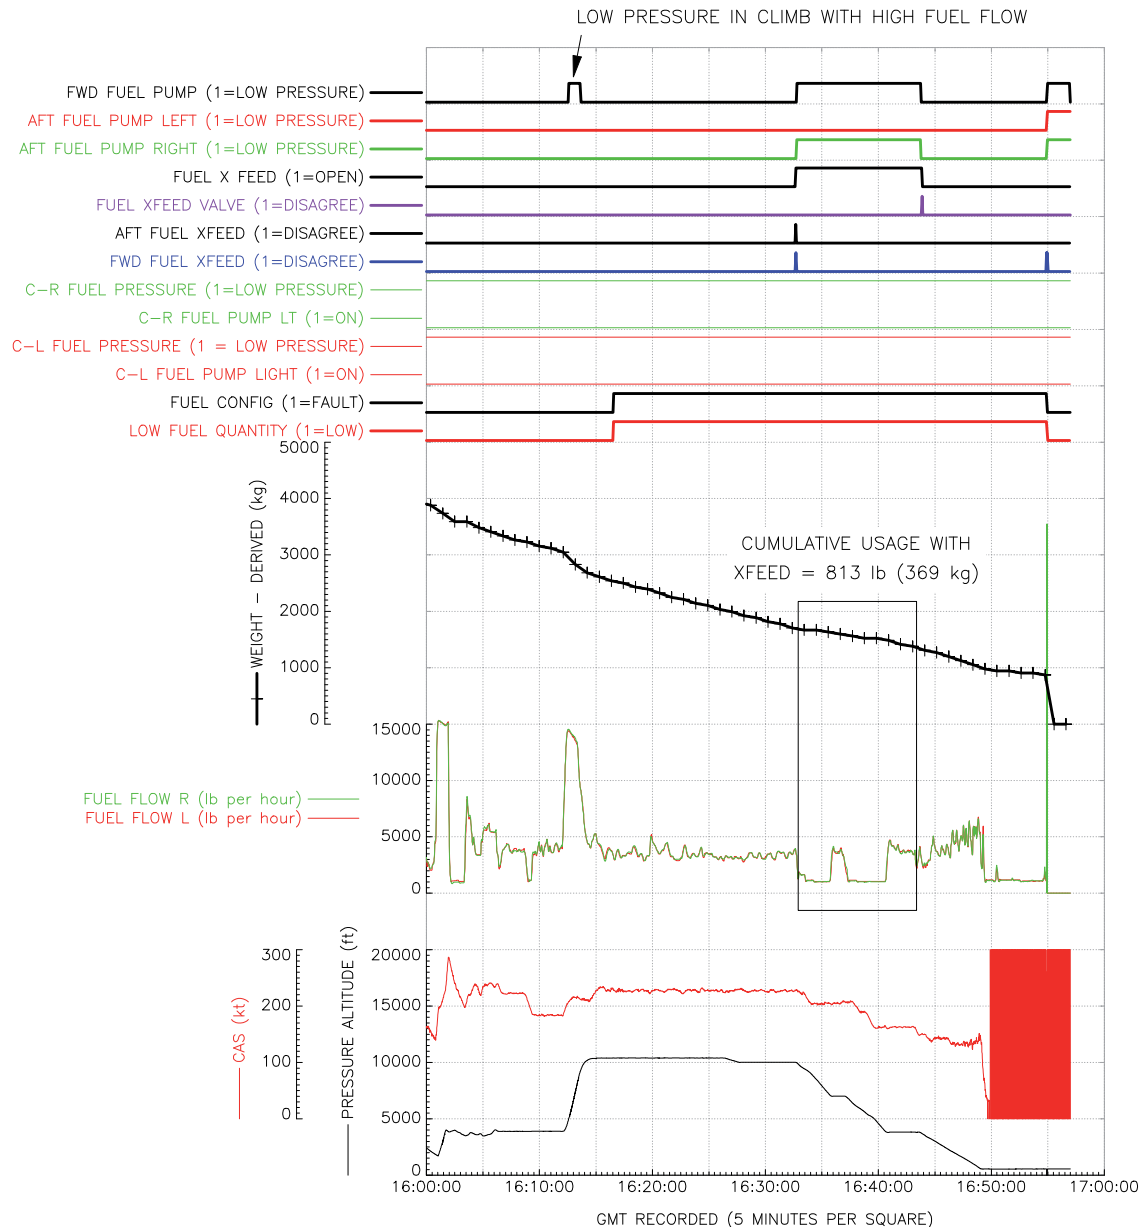
**Figure 9**  
Fuel usage

Figure 9 shows the pertinent fuel related parameters. The derived fuel weight figures are based on recorded gross weight and zero fuel weight parameters, recorded once every 64 seconds. The CVR captured the crew agreeing the remaining fuel at two points during the flight. These were approximately 150 kg more than the derived figures indicate. However, the final derived fuel figure of 871 kg is close to the reported 900 kg final fuel figure. Part of the mismatch may be associated with timing and the quality and resolution of the source values. The fuel figures quoted in the earlier *History of the flight* section are the figures that were acknowledged by the crew.

After the G/A a forward fuel pump low pressure condition was recorded for a period during the climb from 4,000 ft. This was probably associated with the geometry of the fuel tank and aircraft attitude during the climb. The low fuel quantity parameter started indicating LOW FUEL soon after the top of climb and remained in that state for the rest of the flight. The parameters relating to crossfeeding became active at 1632 hr for approximately 11 minutes. The majority of this time was in the descent with relatively low fuel flow. The fuel flow figures indicate that approximately 813 lb (369 kg) of fuel was used during this period.
