AIRCRAFT ACCIDENT REPORT 3/2005

**Report on the serious incident to
Boeing 757-236, G-CPER
on 7 September 2003**

Air Accidents Investigation Branch

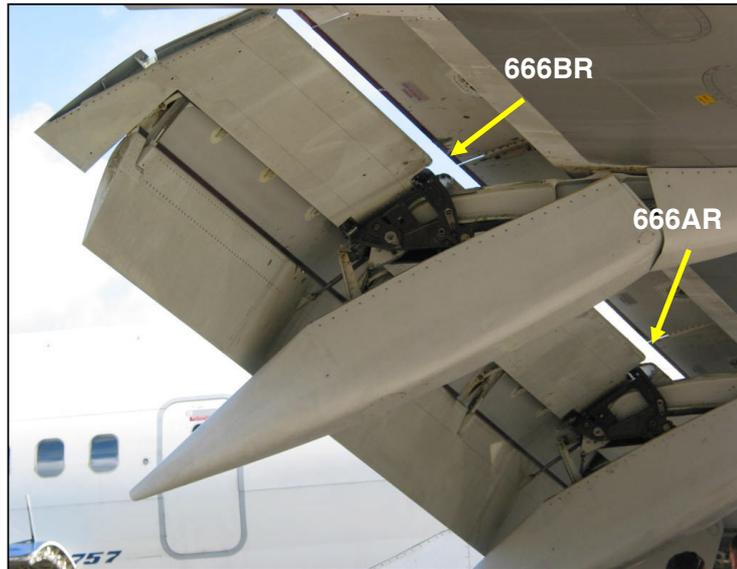
Figure 1

On examining the aircraft with the flaps down, access panels 666AR and 666BR were found to be missing from the outboard flap on the right wing (Figure 1). The panels are approximately 300 mm x 200 mm in size and are installed at the forward attachments for the main flap. Their purpose is to maintain the aerodynamic profile of the flap leading edge.

The panels had not been refitted during the recent maintenance. They were found on a storage rack in Hangar Bay 13 in Technical Block 'D' ('TBD') at

G-CPER R/H Outboard Flap showing locations of missing access panels 666AR and 666BR

After fitting the missing panels, a proving flight was made to verify the integrity of the aircraft before returning it to passenger service. This proved satisfactory, with no reported handling problems with flaps up or down.

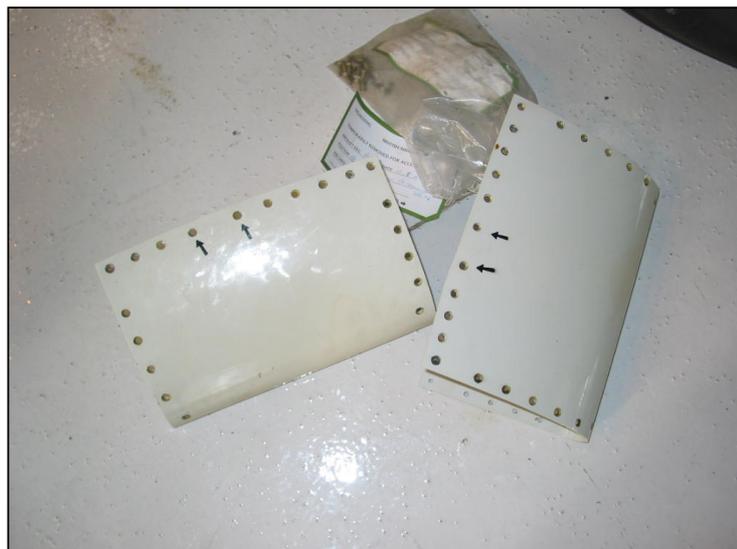
Figure 2

London Heathrow, where the maintenance had been performed. The panels were tagged with 'Temporarily Removed for Access' labels and the attaching screws were found in bags tied to the panels (Figure 2). Examination of the maintenance records showed that the job cards to install the panels had been stamped to certify that the panels had been fitted (Appendix 1). Both job cards had been certified by the same individual. There was no requirement for the panels to be independently inspected after fitting, as they are not considered to be safety critical items.

Flap Panels 666AR and 666BR, found on storage racks in 'TBD' Bay 13 Hangar

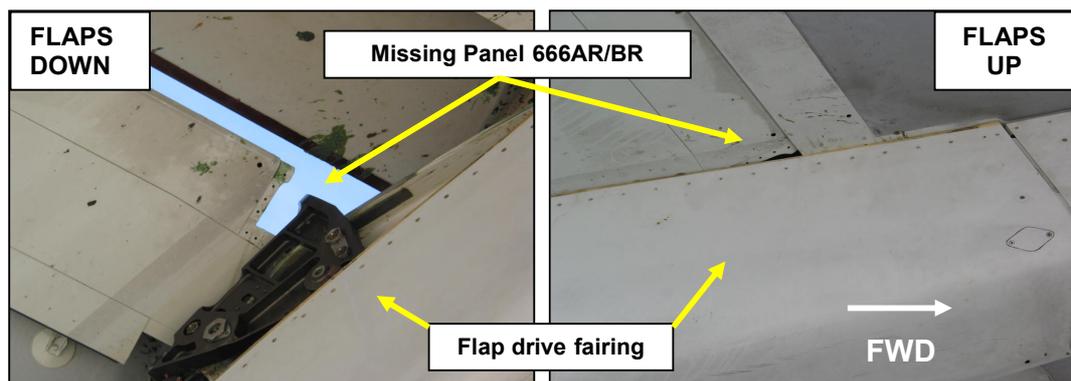
The outboard flap forward attachments to the flap carriages are accessed by removing panels 666AR and 666BR. The panels are secured to the main flap with screws secured by anchor nuts. The panel identification numbers are ink stamped on the inside of the panels. The location of the panels is illustrated in Chapter 06-44-00 of the Boeing 757 Maintenance Manual (Appendix 3). These panels are almost completely hidden by the flap drive fairings when viewed from below and the wing spoiler panels from above, when the flaps are retracted. However, they are clearly visible when the flaps are extended. Figure 3 shows the comparative visibility of the panels with flaps up and flaps down.

Figure 3
Relative visibility of missing flap access panels, flaps down and flaps up

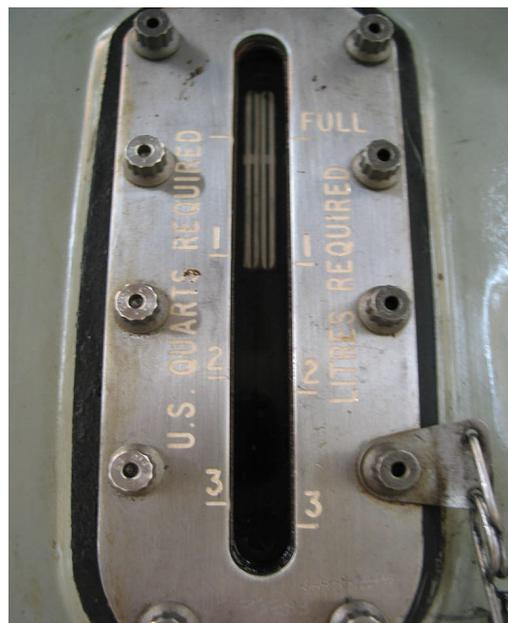
The engine oil contents were checked on the oil tank sight glass shortly after the engine runs. The left engine was found to contain 17 litres of oil and the right engine 20 litres. The oil level on the right engine was close to the 'FULL' graduation on the sight glass. The company engineers considered that the right engine oil quantity was excessive and drained two litres of oil from the engine to reduce it to a more acceptable amount. (Due to a history of oil smells in the cockpit/cabin on its Boeing 757 fleet, the Airline had adopted a policy of reducing the maximum oil fill level to one litre below the 'FULL' graduation. This was intended to reduce the potential for overfilling; a known cause of oil smells in the cabin and cockpit.)

The sight glass is marked with a 'FULL' level (corresponding to approximately 20 litres) and is graduated in litres and US quarts required to top up to the full mark. Thus an oil level corresponding to the '3' on the 'litres' scale means that three litres of oil are required to top up to the 'FULL' mark.

Figure 4
Engine oil tank sight glass

Most recently the engine oil tanks have been modified by painting green and red bands next to the sight glass to visually differentiate between an acceptable oil level and what is considered to be overfull. The placard on the engine oil servicing door was also replaced with one stating that the maximum engine oil level is the top of the green band. The maximum fill level is now two litres below the 'FULL' graduation on the sight glass, giving a greater margin of protection against overfilling.
