Runway Overrun  
American Airlines Flight 2253  
Boeing 757-200, N668AA  
Jackson Hole, Wyoming  
December 29, 2010

NTSB/AAR-12/01  
PB2012-910401

# Aircraft Incident Report

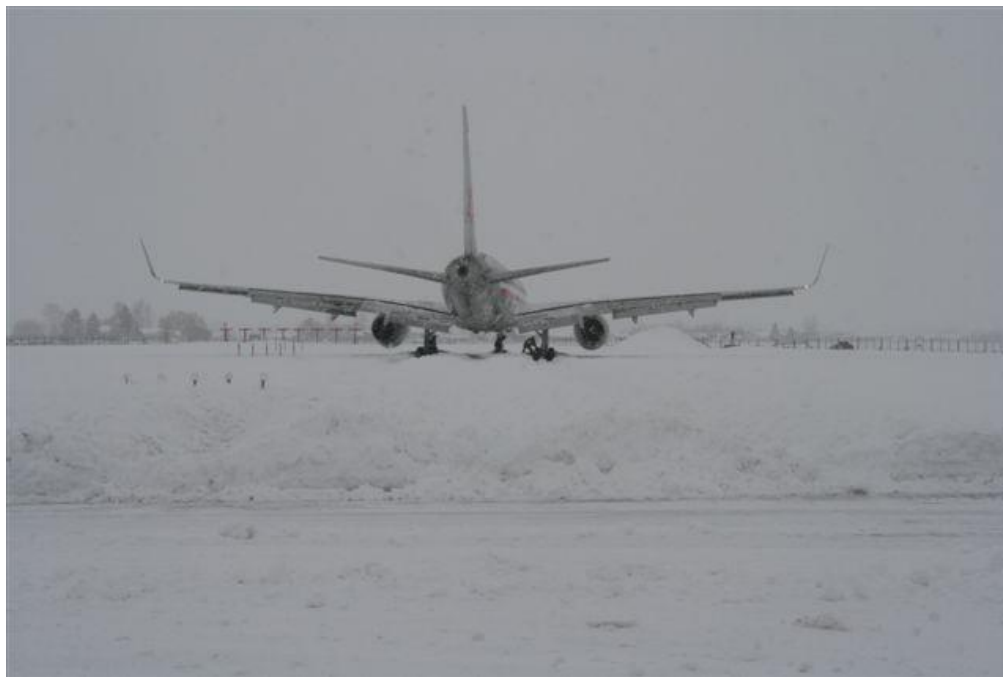
**Figure 1.** A photograph of the incident airplane, viewed from behind, where it came to a stop in the snow off the departure end of runway 19 at JAC.

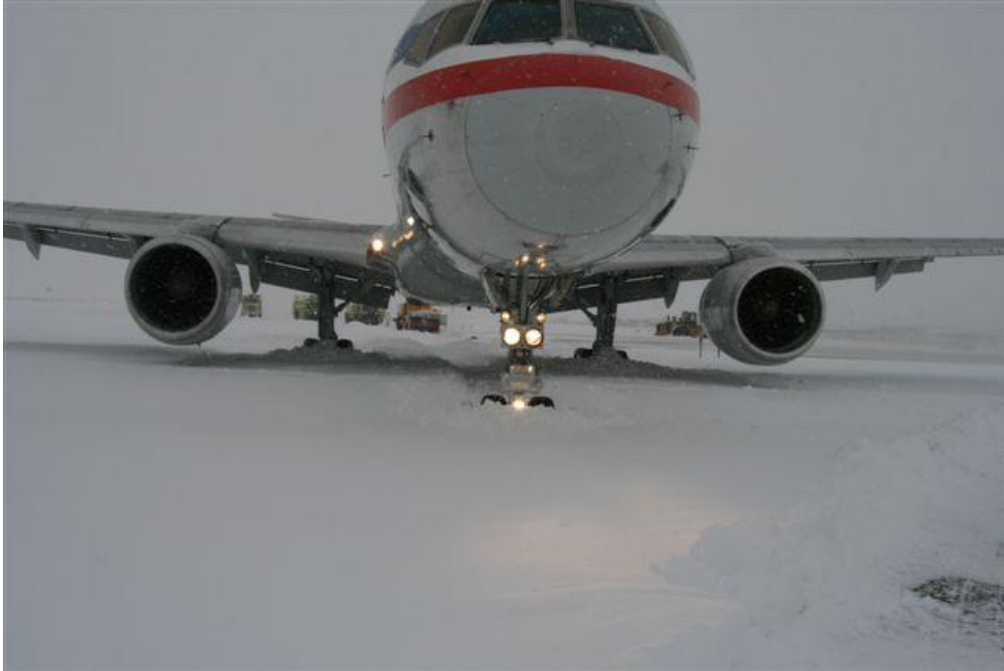
**Figure 2.** A photograph of the front of the incident airplane where it came to a stop in the snow off the departure end of runway 19 at JAC.

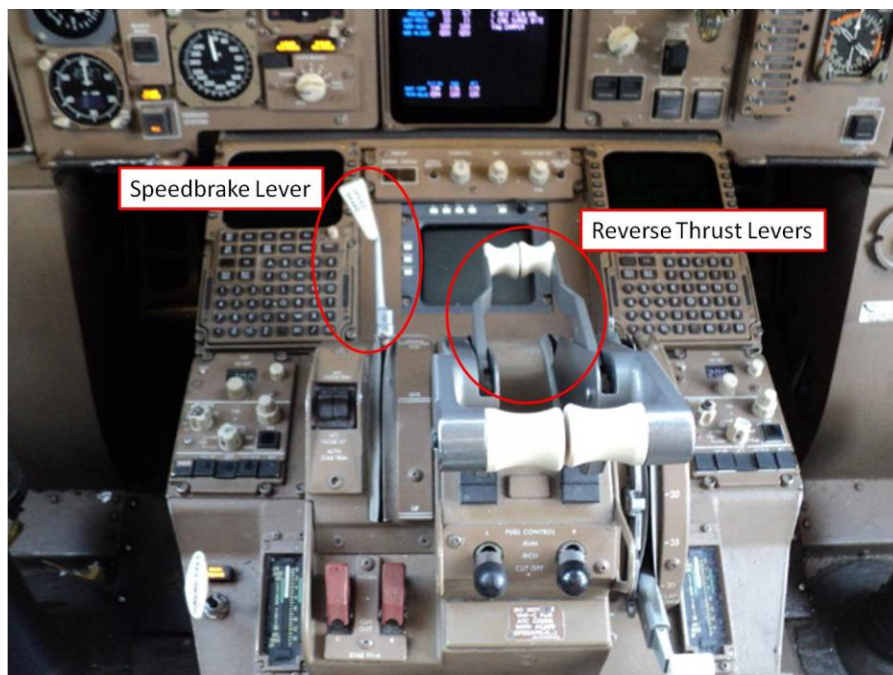
American Airlines’ procedures indicate that the pilot monitoring is to monitor the speedbrake lever and the thrust reverser and autobrake systems during the landing roll. Specifically with regard to the speedbrake lever, the procedures indicate that the pilot monitoring should observe and call out the position of the speedbrake lever after landing and that, if the speedbrakes do not automatically deploy, the captain should manually deploy the speedbrakes (regardless of which pilot had monitoring responsibilities). American Airlines’ 757/767 Operating Manual states, “Pilot awareness of the speedbrake lever during the landing phase is important in the prevention of overrun.” Further, American Airlines’ 757/767 Operating Manual also states, “Without speedbrakes deployed after touchdown, braking effectiveness may be reduced initially by as much as 60 [percent].” Figure 3 shows the throttle console in the incident airplane’s cockpit, with the reverse thrust lever and speedbrake levers marked.

**Figure 3.** A photograph of the center console in the incident airplane’s cockpit, with the reverse thrust lever and speedbrake levers marked.

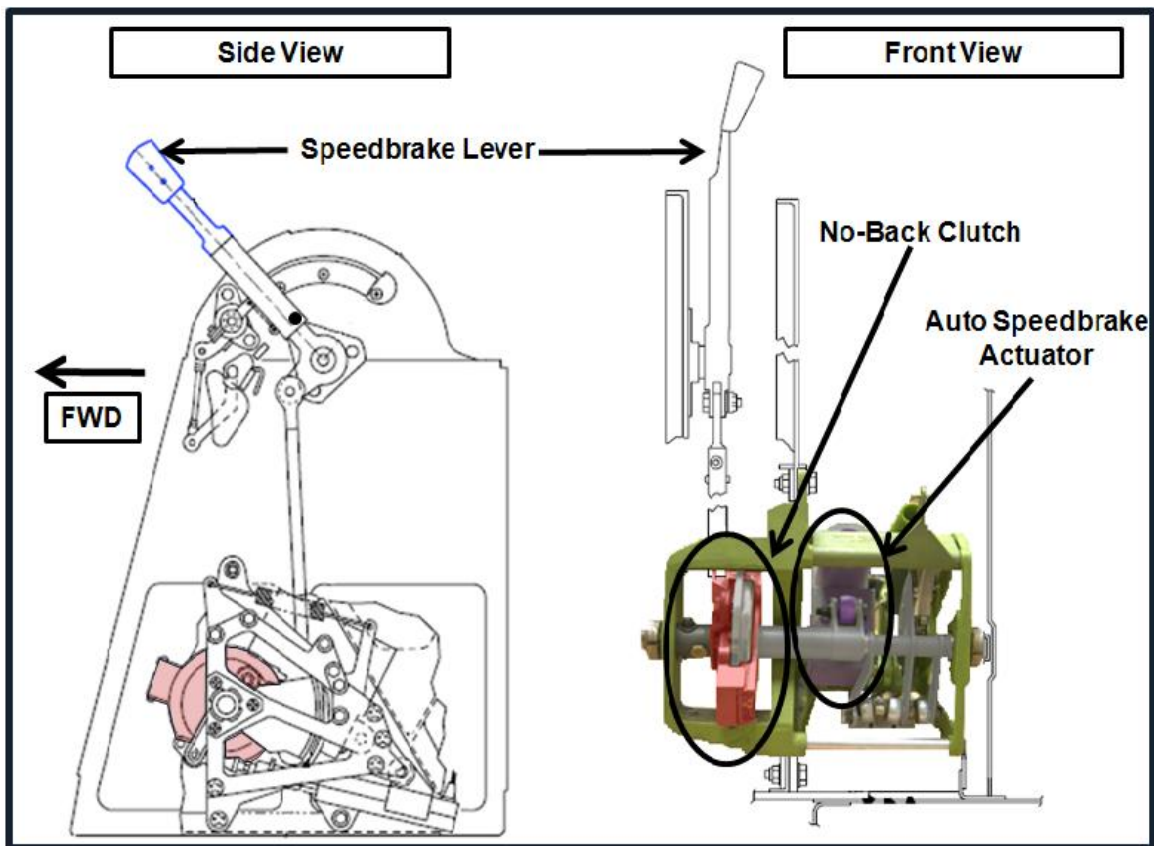
Initial examination and testing of the incident airplane’s automatic speedbrake system and its components revealed no evidence of a malfunction that would have prevented normal operation during the incident landing.<sup>33</sup> However, the automatic speedbrake mechanism was removed and examined after the incident airplane experienced another automatic speedbrake system nondeployment on March 31, 2011.<sup>34</sup> This examination revealed a latent assembly defect in the no-back clutch mechanism<sup>35</sup> that intermittently prevented the speedbrake actuator from automatically driving the speedbrake lever beyond its armed detent to extend the speedbrakes. Specifically, one of the four speedbrake lever braking pins was improperly secured, which allowed it to intermittently rotate within its assembly and prevented the no-back clutch from transmitting the torque from the automatic speedbrake actuator to the speedbrake lever. Additional testing showed that this condition would only occur when the actuator was attempting to drive the speedbrake lever towards the “up” (speedbrakes extended) position and would not occur when the actuator was retracting the speedbrake lever. Further, it was noted that this defect only affected the speedbrakes’ automatic deployment function and would not have prevented the pilots from manually deploying the speedbrakes. Figure 4 contains two diagrams showing the cockpit center console, the speedbrake lever and its linkages, and components of the automatic speedbrake system. The no-back clutch mechanism has been highlighted in the side view

**Figure 4.** Two diagrams showing the cockpit center console, the speedbrake lever and its linkages, and components of the automatic speedbrake system. The no-back clutch mechanism has been highlighted in the side view diagram on the left. A photograph of the speedbrake actuator and no-back clutch mechanisms has been superimposed on the front view to show those components' relative positions within the center console.

Because the effects of this defect were intermittent and the defect's visual detection would require disassembly of the no-back clutch mechanism (a function usually performed by the manufacturer or another external facility, not the operator), an operator would not likely have detected the defect during normal maintenance testing. When this assembly defect in the no-back clutch was identified, the manufacturer of the no-back clutch told NTSB investigators that the company was not aware of any instances involving similar anomalies in other no-back clutch units.<sup>36</sup> As a result of this investigation, the manufacturer clarified its documentation to ensure proper assembly of the no-back clutch units. In addition, in its March 7, 2012, submission for

The NTSB concludes that a manufacturing defect in the incident airplane’s speedbrake no-back clutch mechanism prevented the speedbrakes from automatically deploying during the incident landing.
