AVIATION INVESTIGATION REPORT

A09O0117

ERRONEOUS INSTRUMENT INDICATIONS RESULTING IN AIRSPEED AND ALTITUDE DEVIATIONS

LOT POLISH AIRLINES SA
BOEING 767-300 SP-LPA
NORTH BAY, ONTARIO
19 JUNE 2009

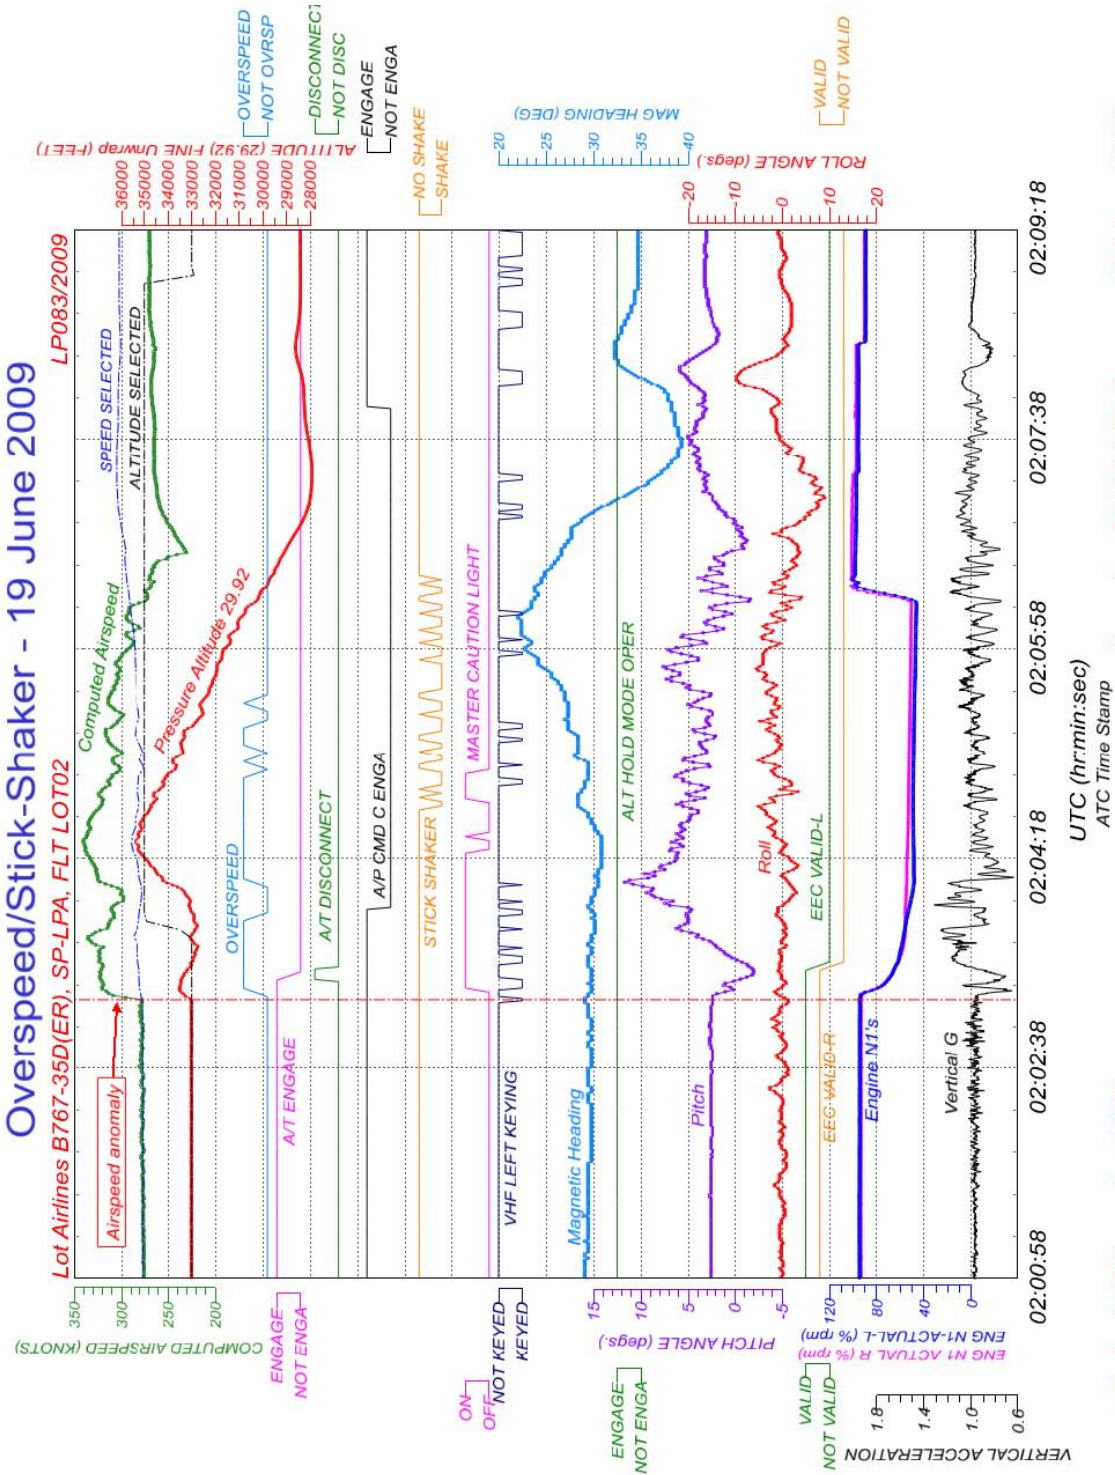
Appendix A - FDR PLOTS

At 2203¹ the captain's airspeed indicator increased from 276 to 320 knots and the captain's altimeter increased 450 feet in approximately 5 seconds. To re-capture altitude, the autopilot commanded pitch down approximately 2 degrees. An overspeed warning activated whereupon the captain retarded the throttles to idle. The autothrottles disconnected automatically but the autopilot remained engaged. The autopilot pitched down another 2 degrees before pitching up approximately 8 degrees. The overspeed warning remained on for about 41 seconds.

The captain disengaged the autopilot and manually initiated a climb. Thrust remained at idle and the captain's airspeed indicator decreased to 297 knots. The captain increased pitch to 12 degrees nose up, his airspeed indicator rapidly increased to 324 knots producing a second overspeed warning. The aircraft climbed to an altitude of approximately 35 400 feet above sea level (asl)², then started to descend. The captain's indicated airspeed reached a maximum of 339 knots, before decreasing as the aircraft started to descend.

The aircraft was descending through 34 700 feet asl with the captain's airspeed indicator decreasing through 321 knots and the overspeed warning on when the stick shaker activated (a stall warning device that noisily shakes the pilot's control column as the stalling angle of attack is neared). The overspeed warning remained on for the next 20 seconds, became intermittent for 26 seconds, then stopped. The stick shaker activated intermittently for about 1 minute and 50 seconds from its initial activation. When the aircraft had descended through approximately 30 000 feet asl with the captain's airspeed indicating 278 knots, the captain increased thrust and within 9 seconds the stick shaker stopped. As the aircraft descended through 29 100 feet asl, the captain's airspeed indicator rapidly decreased from 255 knots to 230 knots and the airspeed fluctuations stopped. The aircraft continued its descent to 27 900 feet.

The flight data recorder (FDR) installed on the aircraft was manufactured by Honeywell. The FDR contained approximately 52.5 hours of data which included the occurrence and 5 previous flights. The overspeed event and the subsequent stick shaker activations are plotted in Appendix A.
