**INCIDENT**

<b>Aircraft Type and Registration:</b>	Boeing 777-200ER, AP-BGL	
<b>No &amp; Type of Engines:</b>	2 GE 90 turbofan engines	
<b>Category:</b>	1.1	
<b>Year of Manufacture:</b>	2004	
<b>Date &amp; Time (UTC):</b>	1 March 2005 at 0910 hrs	
<b>Location:</b>	Manchester Airport, Manchester	
<b>Type of Flight:</b>	Public Transport (Passenger)	
<b>Persons on Board:</b>	Crew - 12	Passengers - 332
<b>Injuries:</b>	Crew - 0	Passengers - 31 (Minor)
<b>Nature of Damage:</b>	Slight damage to fuselage skin adjacent to door 3R, heat damage to the No 10 tyre and hydraulic hoses on the left main landing gear	
<b>Commander's Licence:</b>	Airline Transport Pilot's Licence	
<b>Commander's Age:</b>	54 years	
<b>Commander's Flying Experience:</b>	13,000 hours (of which 600 were on type) Last 90 days - 176 hours Last 28 days - 36 hours	
<b>Information Source:</b>	AAIB Field Investigation

**Synopsis**

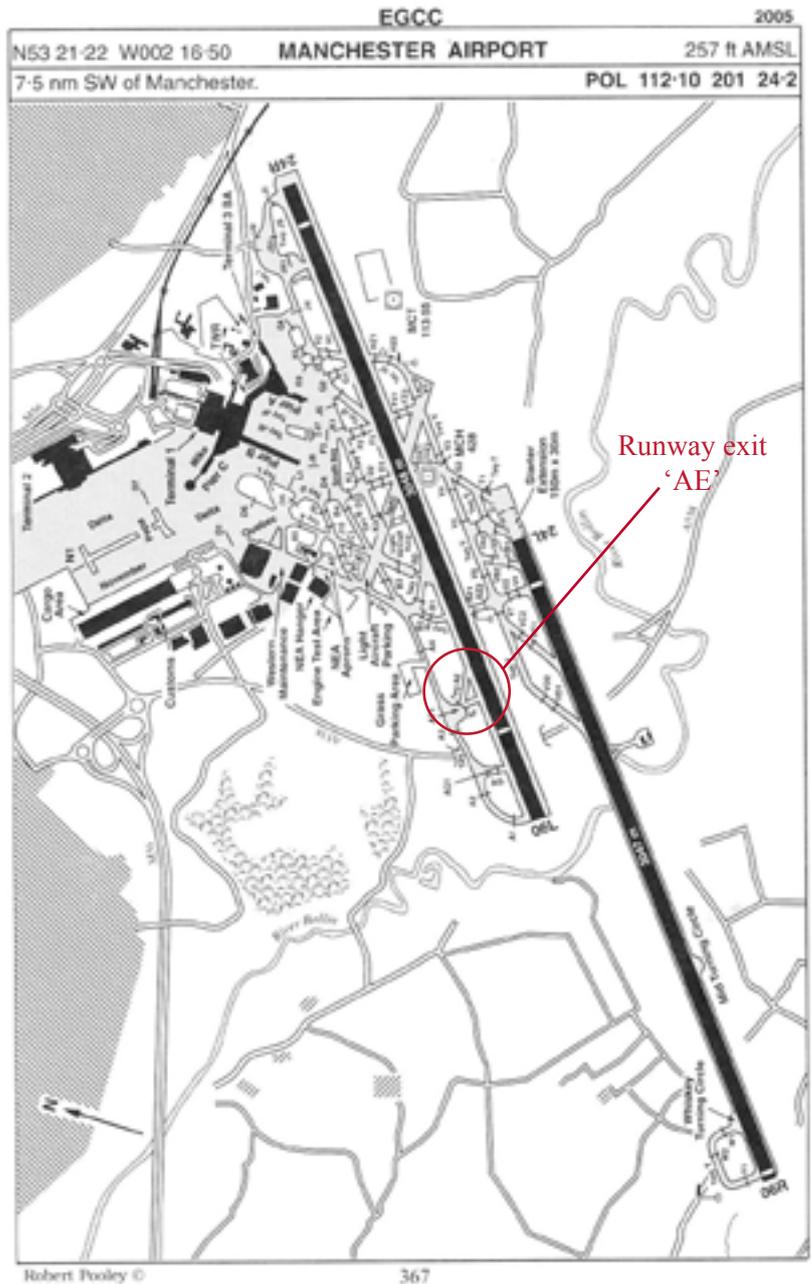
**Figure 1**

A short time later, as the aircraft was still taxiing, an aircraft on an adjacent taxiway transmitted on the GMC frequency “AND GROUND ERR (CALLSIGN) THE PIA IN FRONT HAS FIRE IN HIS LEFT - ON HIS LEFT MAIN UNDERCARRIAGE”. The GMC Controller replied “ROGER”. Initially, the crew of the Boeing 777 did not realise that this transmission about fire related to their aircraft. There was a brief exchange of communications on the GMC frequency with other aircraft, and then the GMC controller transmitted “PAKISTAN SEVEN EIGHT NINE ERR JUST GETTING THE FIRE SERVICE OUT TO CHECK YOUR UNDERCARRIAGE CAN YOU HOLD POSITION”, to which the co-pilot responded “ERR HOLDING PAKISTAN SEVEN EIGHT NINER”. The commander brought the aircraft to a halt and set the Parking Brake. The aircraft was now parked on Taxiway J9, adjacent to the north side Airport Fire Station.

The GMC controller observed the aircraft through binoculars and saw yellow and white flames coming from the left MLG. He activated the Crash Alarm, contacted the RFFS, declared an Aircraft Ground Incident (AGI) and passed the appropriate details.

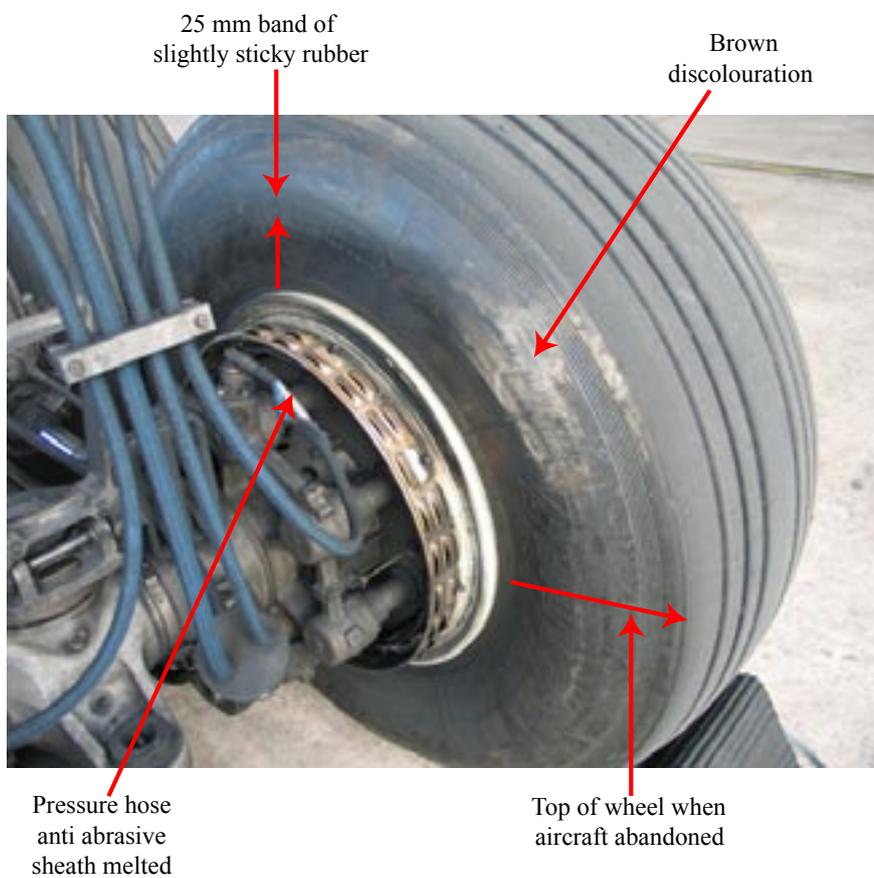
**Figure 5**

The only visible heat damage on the left MLG was melting of the anti-abrasion sheaths on the No 10 brake unit hydraulic pressure hose and temperature probe conduit.

The damage on each pipe was approximately 16 cm long and was on the side of the pipes facing the wheel. There was also slight damage to the inside of the No 10 tyre, consisting of a small brown area of discoloration at the 12 o'clock position, and two areas where the rubber had just started to turn sticky, indicating that these areas had been exposed to temperatures between 100°C and 150°C. Apart from this slight damage, the tyre appeared to be in good condition, Figure 5.
