# False Expectations

The pilots were looking out the windshield, anticipating visual contact with the runway, when the A300 descended below minimums at Birmingham.

Inadequate monitoring of the flight instruments and misuse of the 777's autoflight system led to a collision with a seawall at San Francisco.

# Mismanaged Descent

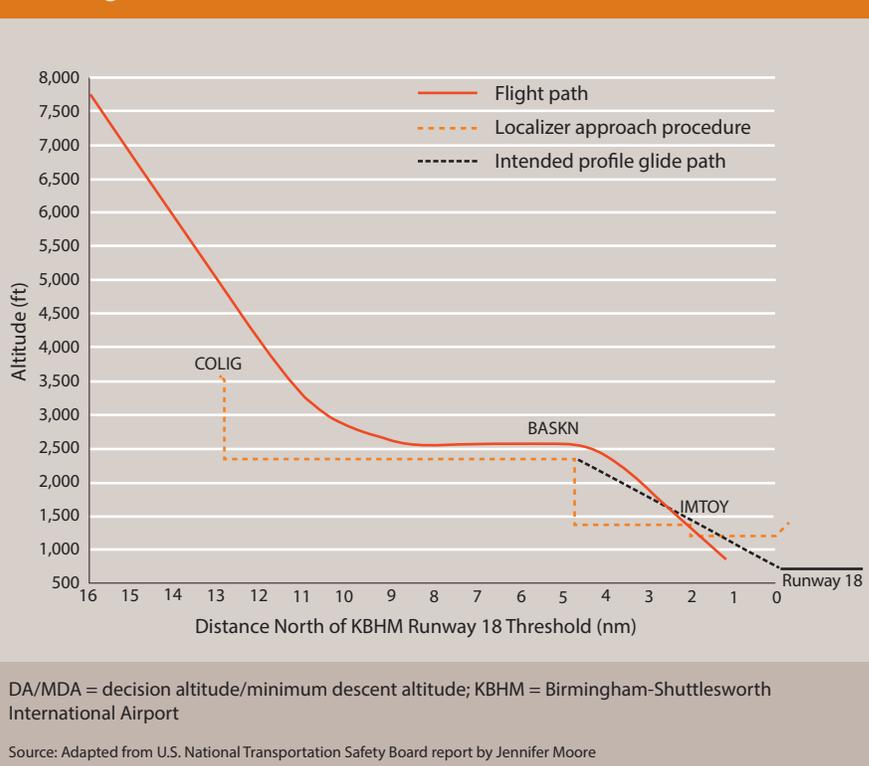
Figure 1

The localizer approach to Runway 18 at Birmingham includes an initial approach fix called “COLIG”; a final approach fix, “BASKN”; and a step-down fix, “IMTOY,” between the final approach fix and the missed approach point. The

minimum crossing altitudes are 2,300 ft at BASKN and 1,380 ft at IMTOY; and the minimum descent altitude (MDA) is 1,200 ft (Figure 1).

Because consecutive descents and level-offs are required after BASKN and after IMTOY, this is considered a step-down, or “dive and drive” approach. To illustrate the drawbacks of such approaches, the report cited FAA Advisory Circular 120-108, *Continuous Descent Final Approach*, which says, “Stepdowns flown without a constant descent will require multiple thrust, pitch and altitude adjustments inside the final approach fix (FAF). These adjustments increase pilot workload and potential errors during a critical phase of flight.”

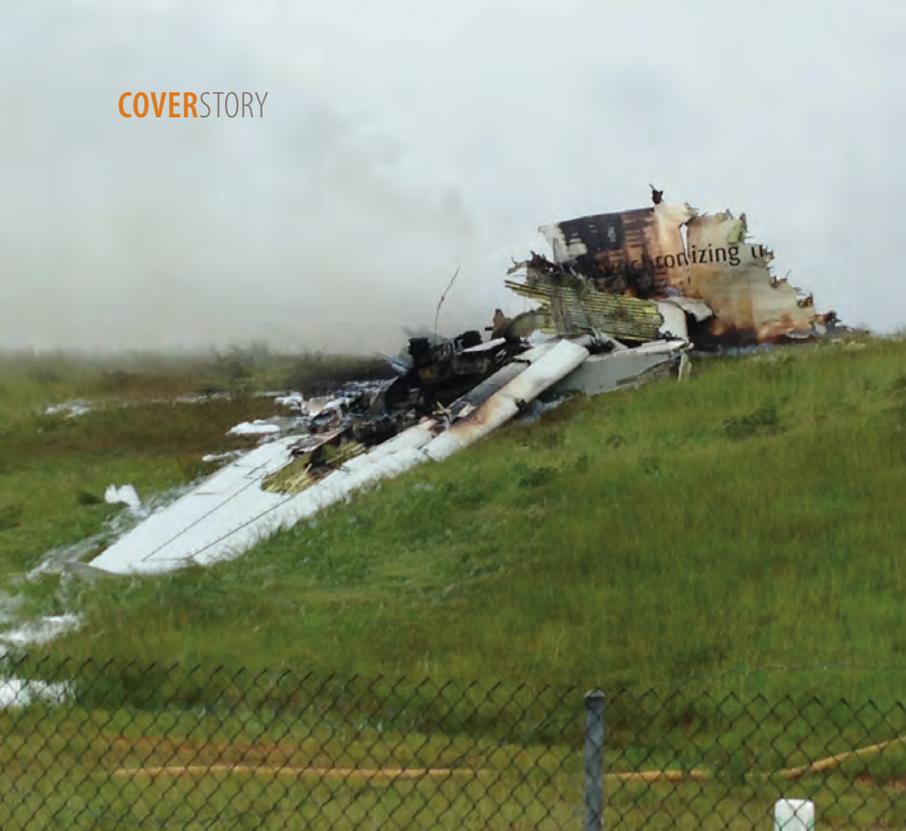
A fire engulfed the aft fuselage and wings after the A300 struck trees and crashed in a gulley.

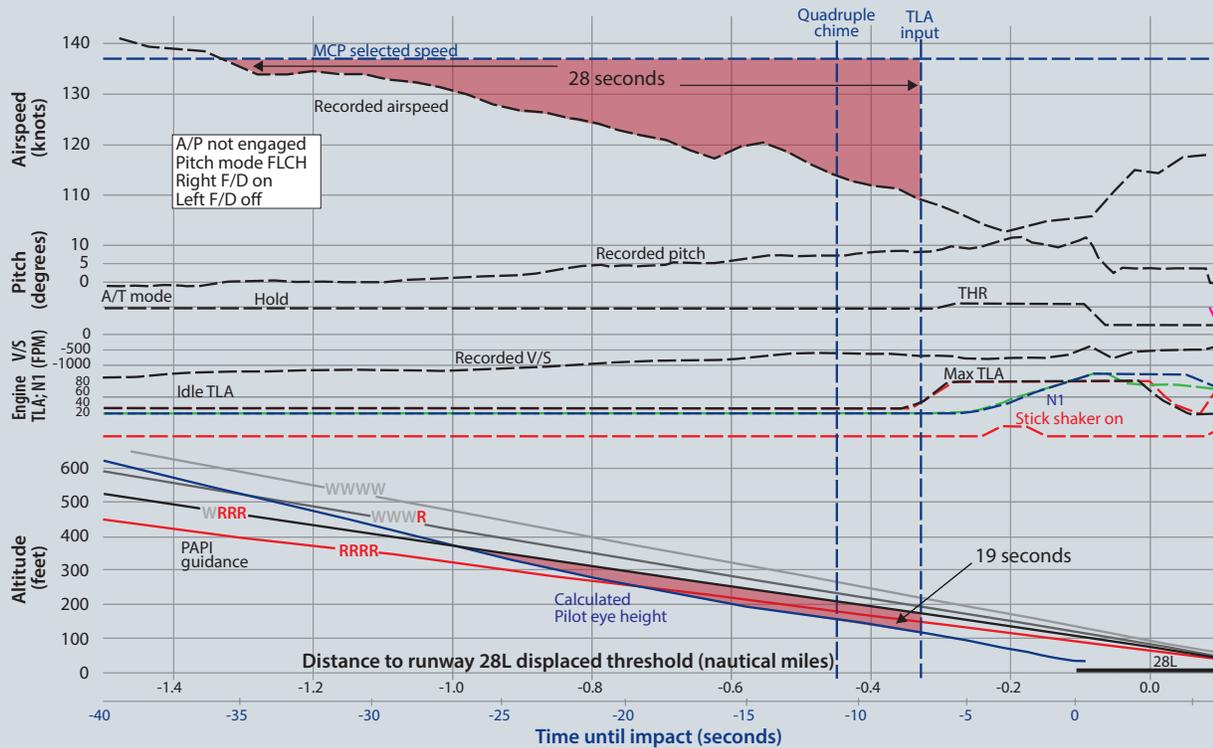
## Profile View of the Last 40 Seconds of Asiana Airlines Flight 214

moving the thrust levers to idle and manually pitching the airplane nose-down. The manual change in thrust lever position caused the autothrottle system to enter the “HOLD” mode, which effectively disengaged the system. Neither the pilots nor the observer noticed this mode change. “This is not surprising in light of human factors research demonstrating that pilots frequently do not notice mode changes on the FMA [flight mode annunciator], especially those that are unexpected,” the report said.

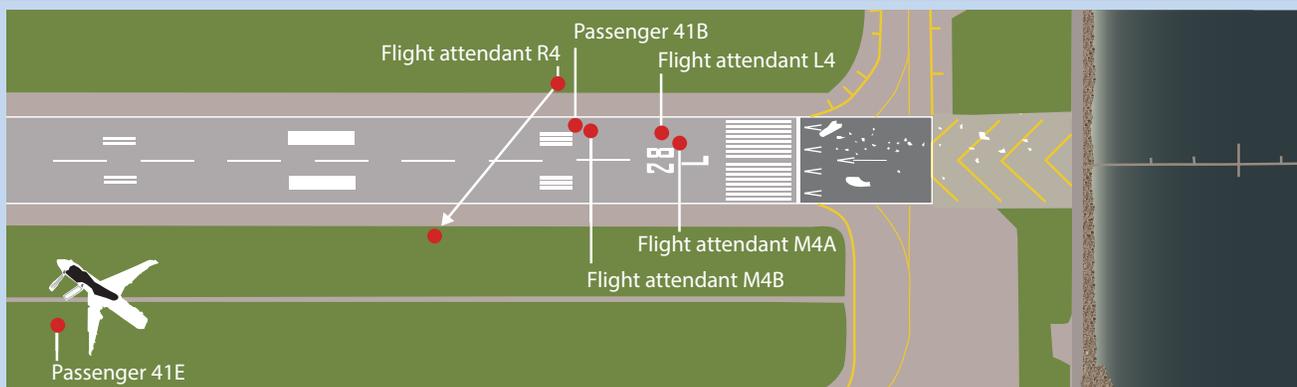
### Positions of Flight 214 Occupants Found Outside the Aircraft

A deceased 16-year-old female passenger, who had been assigned to seat 41B but reportedly occupied seat 41D for landing, was found on the right side of the runway about midway between the seawall and the main wreckage, the report said. A deceased 16-year-old female passenger, who had been in seat 41E, was found about 30 ft (9 m) in front of the airplane’s left wing and about 50 ft from the left side of the fuselage. A 15-year-old female passenger, who had been in seat 42A, “was taken to the hospital from the scene and died six days after the accident,” the report said.

After a person was seen walking across the runway toward the aircraft at 1149:41 (Figure 1) from the position where flight attendant jump seat R4 later was found, and was assisted by passengers who had evacuated, the ARFF responders conducted a search of the entire debris field between the seawall and the airplane wreckage.

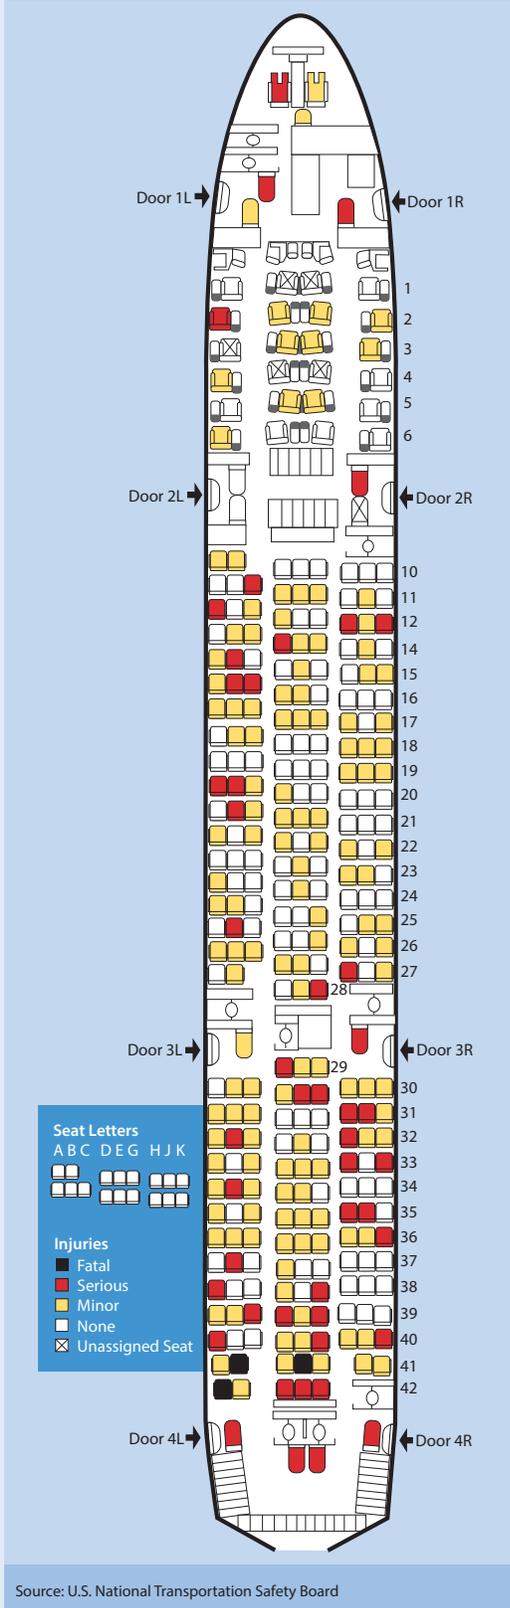
### Flight 214 Occupant Injuries

- **Injury potential from significant lateral forces, as opposed to longitudinal forces, in airplane crashes.** The research objective would be to improve understanding of what caused high thoracic spinal injuries to some occupants of Flight 214. “In this accident, the dynamics were such that occupants were thrown forward and experienced a significant lateral force to the left during the impact sequence,” the report said.
