Airplane's Low-energy Condition and Degraded Wing Performance Cited in Unsuccessful Go-around Attempt

On the night of Dec. 16, 1997, the crew of Air Canada Flight 646 (ACA 646), a Canadair Regional Jet, conducted a Category I instrument landing system (ILS) approach to Runway 15 at the airport in Fredericton, New Brunswick, Canada. The ceiling and visibility were below the minimums published for the instrument approach. Nevertheless, the runway visual range (RVR) on Runway 15 was 1,200 feet, and the crew was authorized by Canadian regulations to conduct the approach under these conditions.

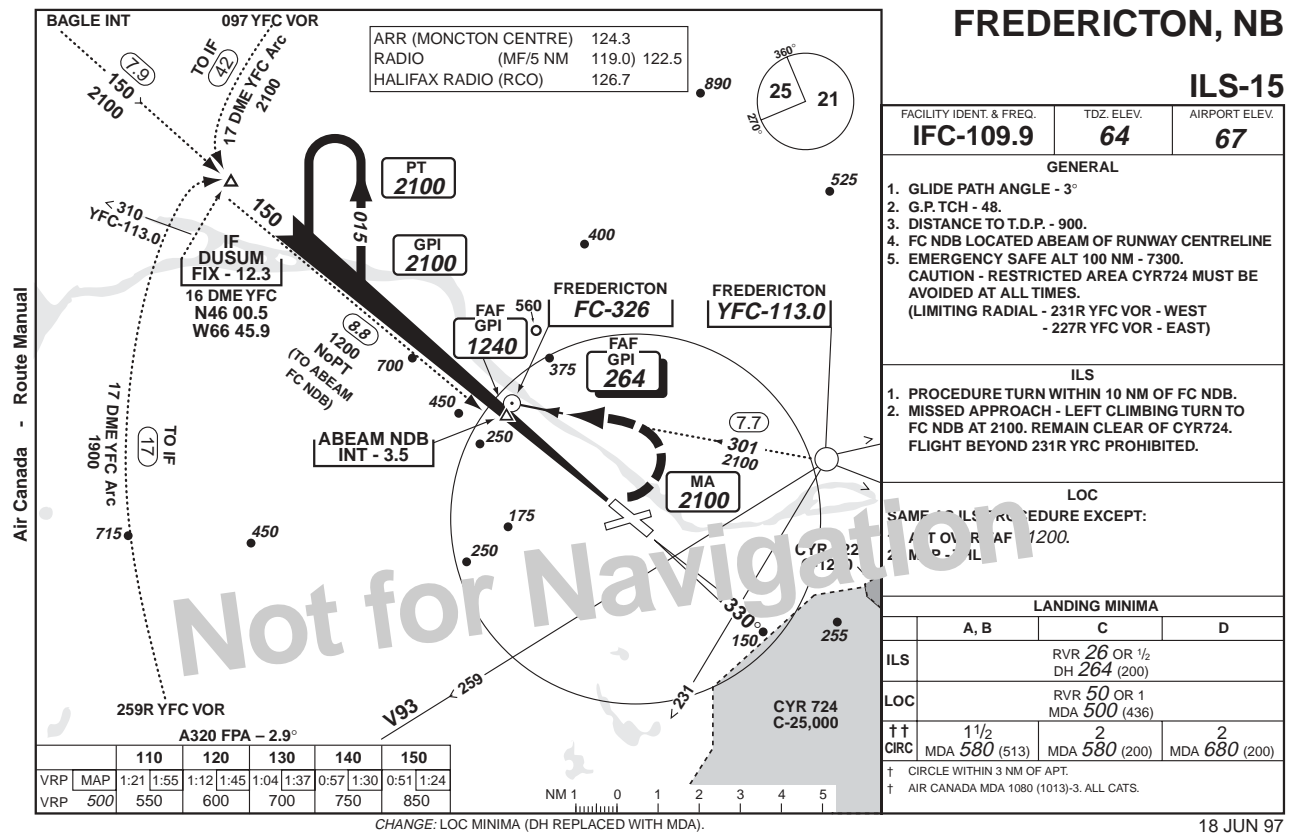
Figure 1

As the aircraft neared Fredericton, the crew briefed themselves on the ILS approach to Runway 15 and the missed-approach procedures (see Figure 1). The published minimums for the approach were 2,600 feet (793 meters) RVR or one-half mile visibility. The DH was 264 feet (200 feet above the touchdown zone elevation).

Instrument Landing System Approach to Runway 15, Fredericton, New Brunswick, Canada, Air Canada Flight 646, Dec. 16, 1997

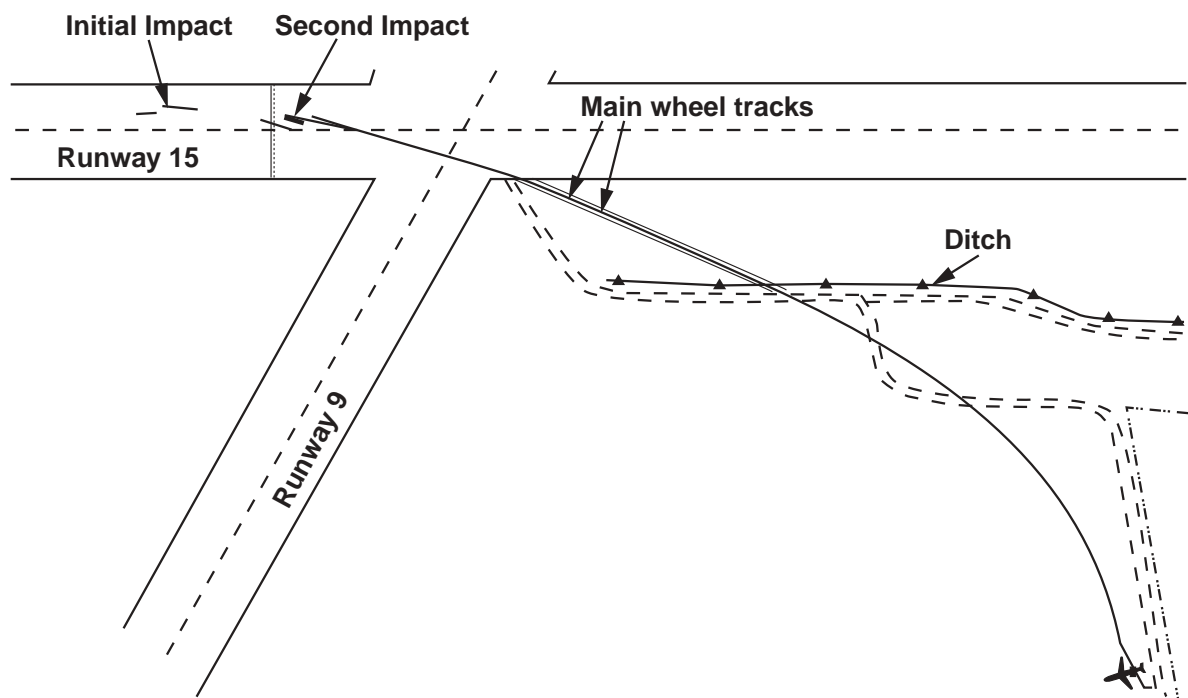
Figure 2

Impact Points and Ground Track, Air Canada Flight 646, Fredericton, New Brunswick, Canada, Dec. 16, 1997

“As the aircraft moved forward, the tree cut through the aircraft cabin to a point about nine feet [three meters] aft of the door, just left of the [centerline] of the aircraft,” said the report. “Apart from damage where the tree had torn through the aircraft, the rest of the cabin floor, seat rails, seats and overhead bins showed no sign of deformation or damage.”
